**COLORADO DIVISION OF RECLAMATION, MINING AND SAFETY  
MINERALS PROGRAM INSPECTION REPORT  
PHONE: (303) 866-3567**

<b>MINE NAME:</b> Eureka Gravel Pit	<b>MINE/PROSPECTING ID#:</b> M-1990-070	<b>MINERAL:</b> Gravel	<b>COUNTY:</b> San Juan
<b>INSPECTION TYPE:</b> Monitoring	<b>INSPECTOR(S):</b> Wallace H. Erickson	<b>INSP. DATE:</b> September 24, 2012	<b>INSP. TIME:</b> 10:30
<b>OPERATOR:</b> San Juan County	<b>OPERATOR REPRESENTATIVE:</b> None present	<b>TYPE OF OPERATION:</b> 110c - Construction Limited Impact

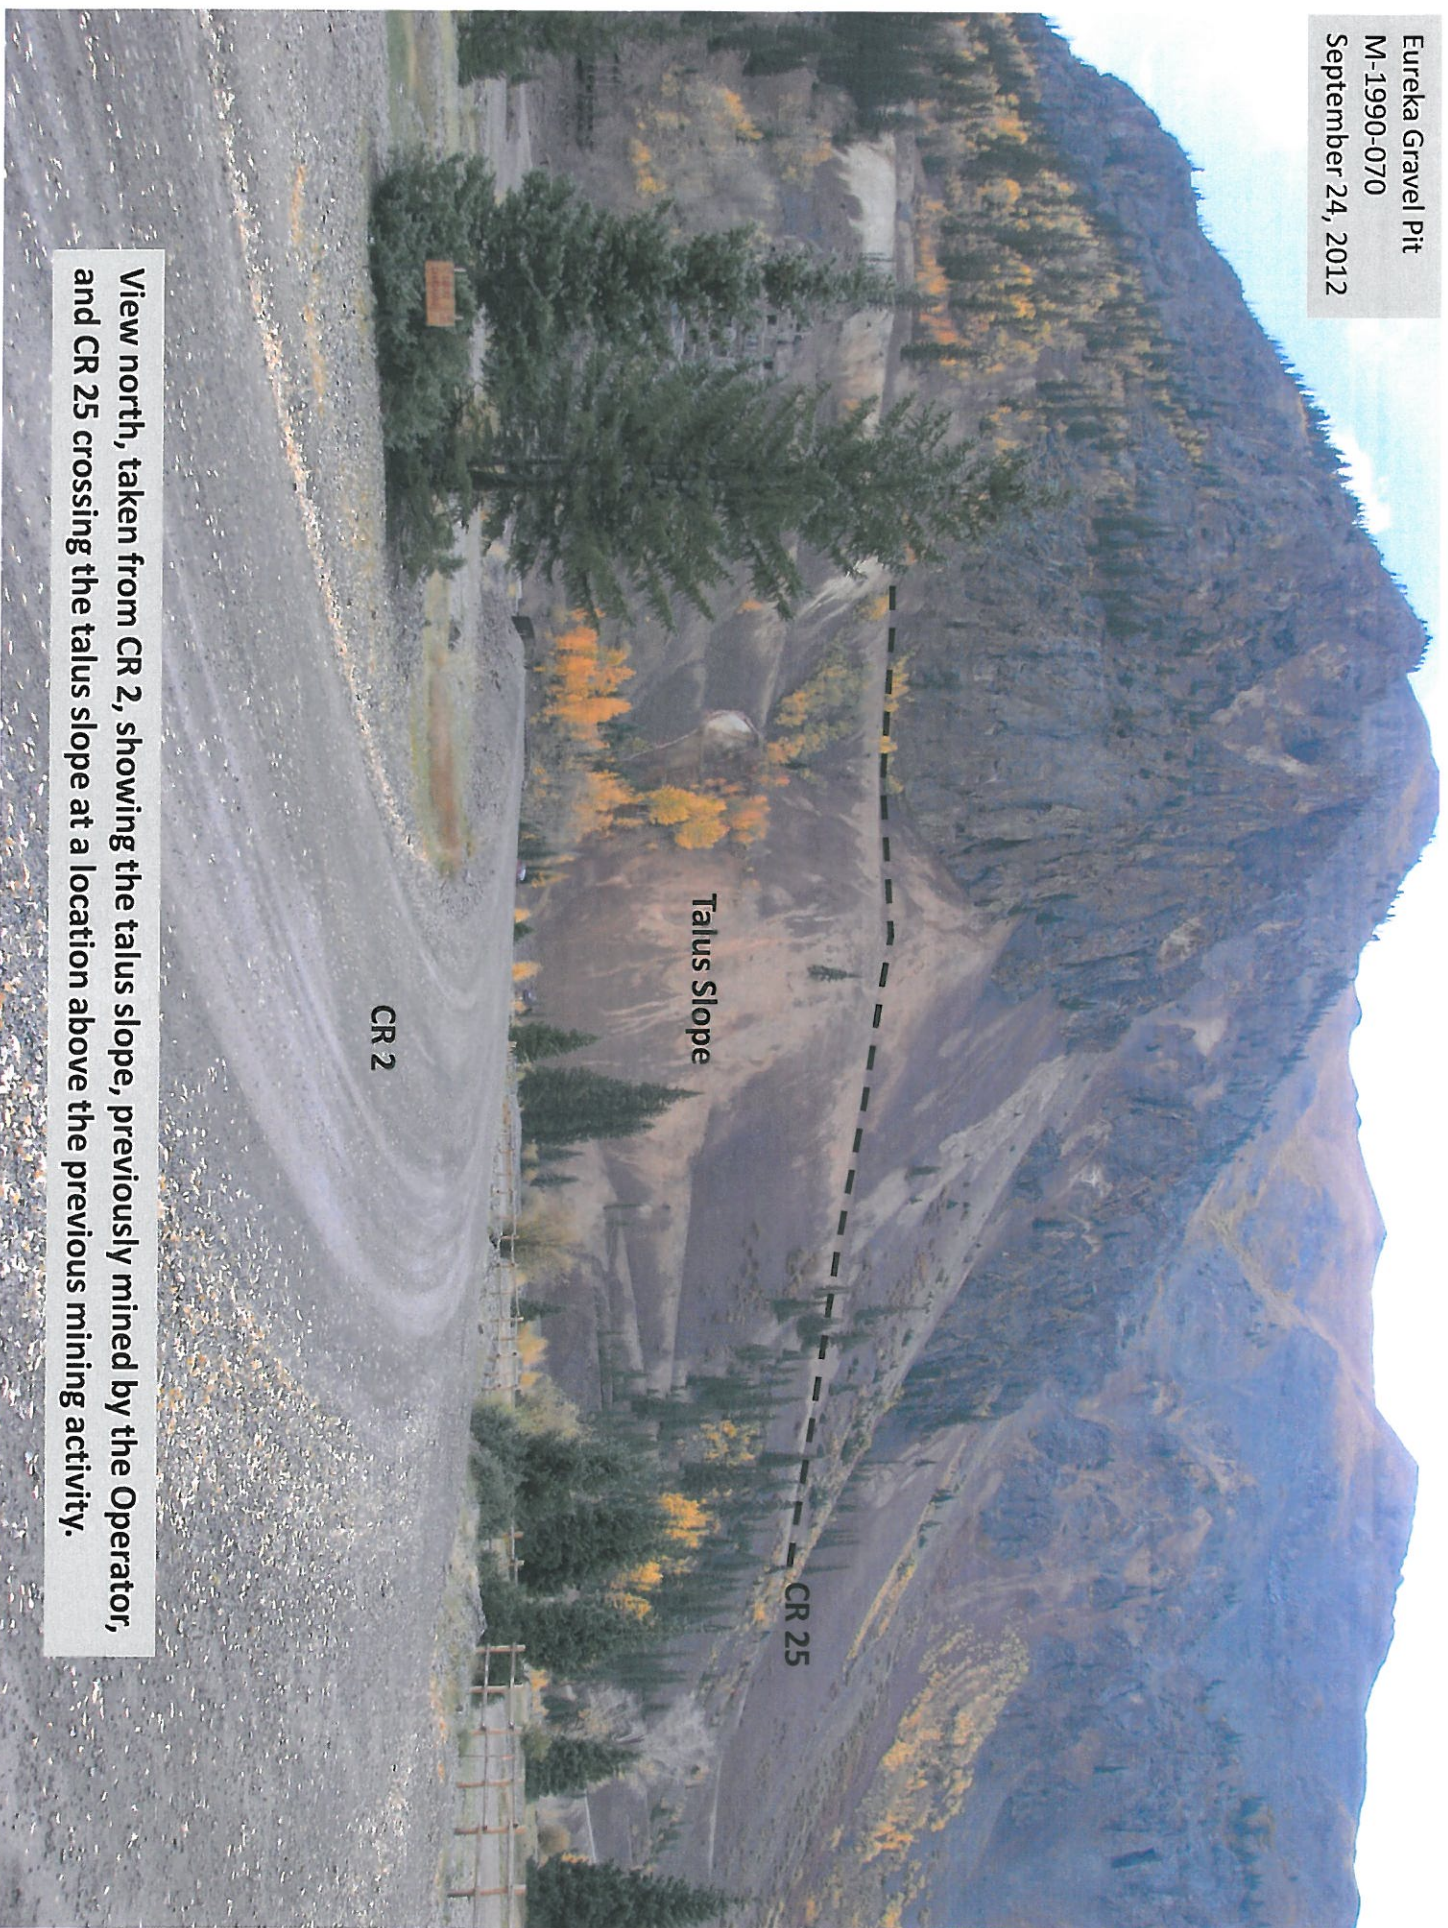
View north, taken from CR 2, showing the talus slope, previously mined by the Operator, and CR 25 crossing the talus slope at a location above the previous mining activity.

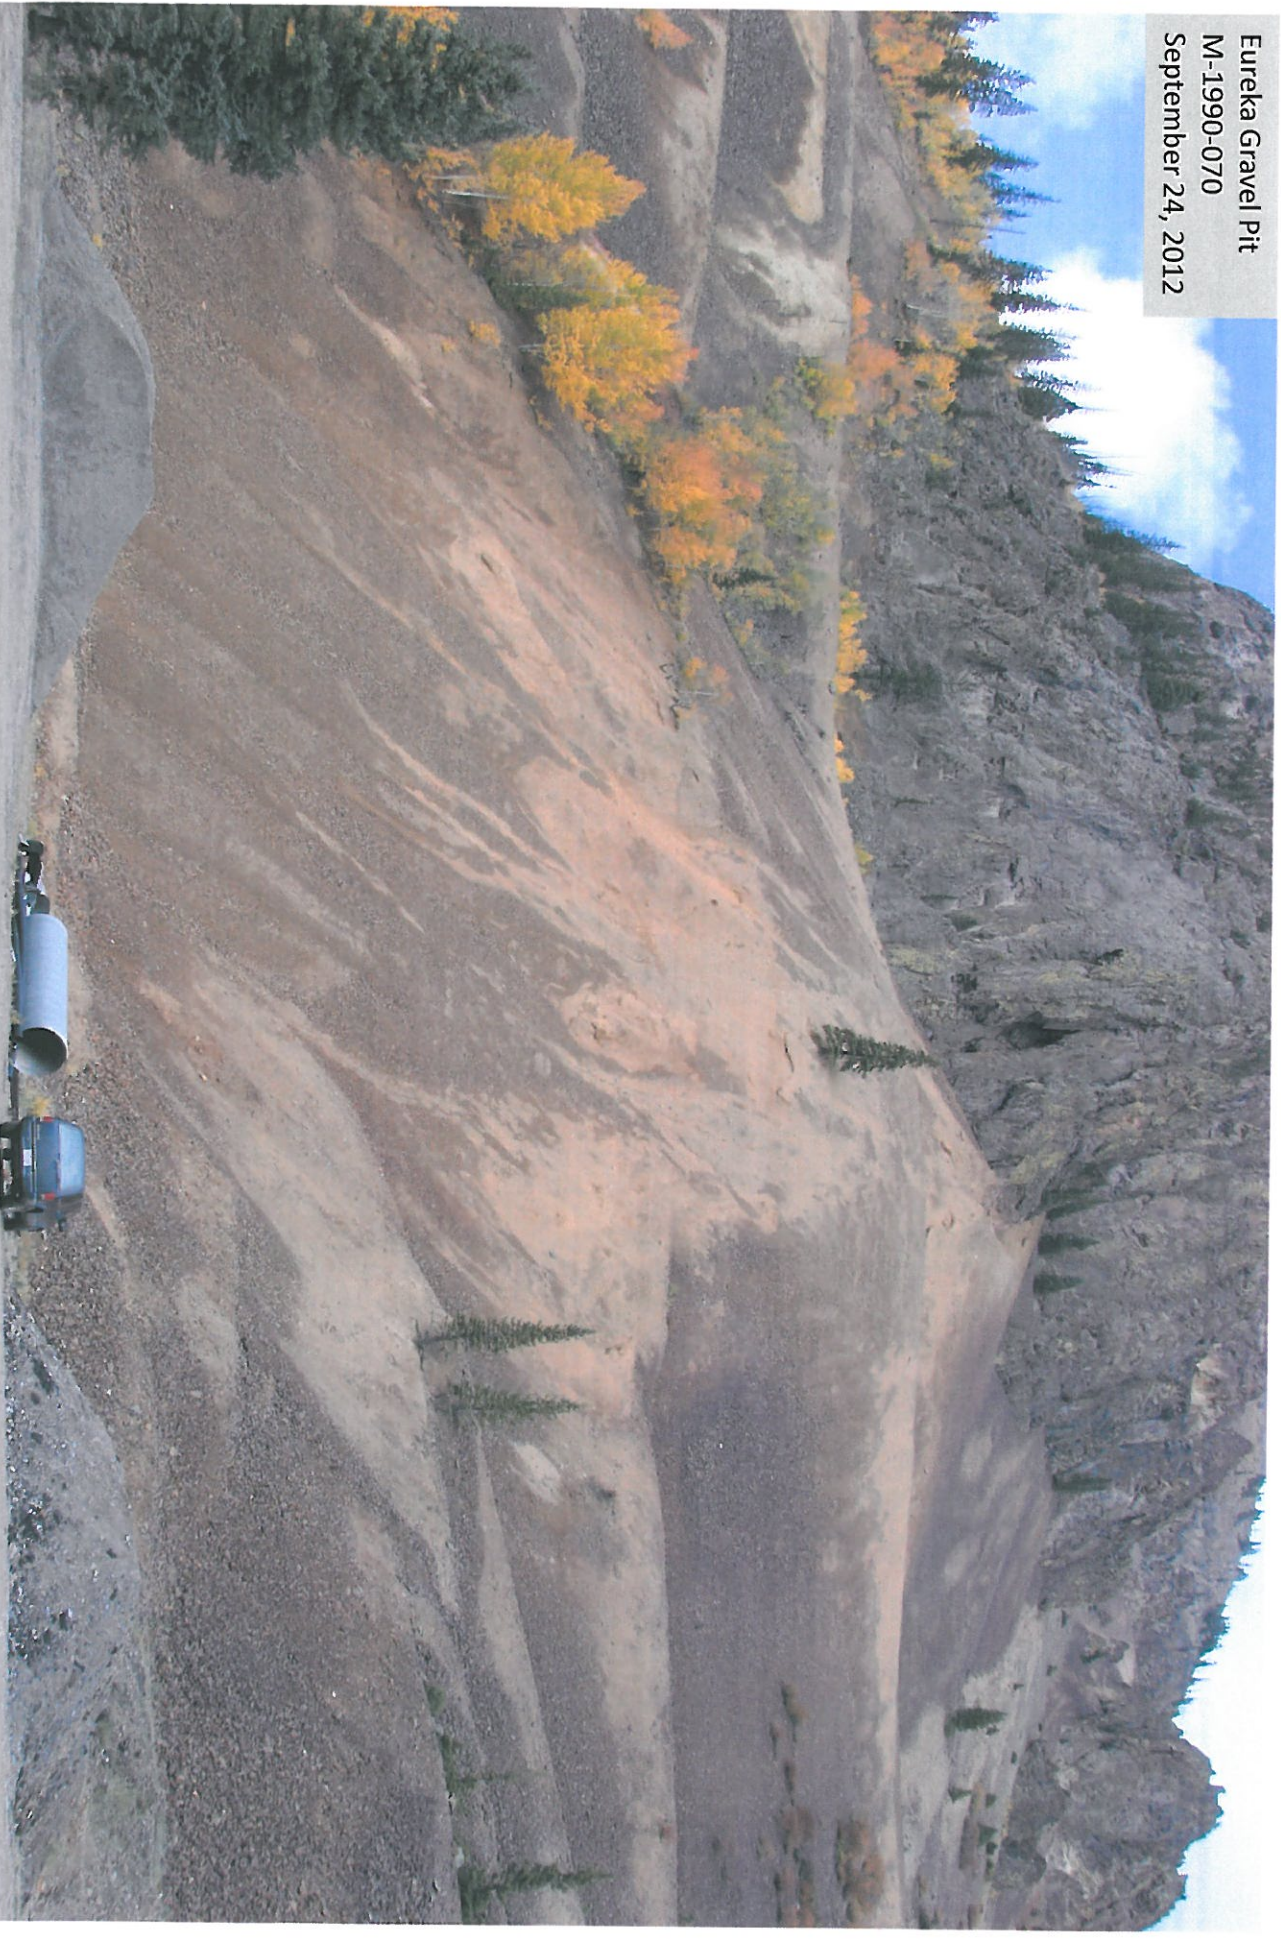
The original permit was approved to excavate materials from the toe of a talus slope. County Road 25 crosses the talus slope approximately 350 feet above the excavation area. The excavation activity ultimately over-steepened the talus slope, resulting in head ward erosion advancing up slope and terminating at a scarp located approximately 200 feet above the toe of slope and approximately 150 feet below County Road 25. The advancing head ward erosion appeared to threaten the stability of CR 25. The Operator was issued violation number MV-2004-051 on April 26, 2004, which was abated on November 22, 2004.

In response to the violation, the Operator backfilled the toe of slope and later, commenced end-dumping talus material from CR 25, this flowed down to the scarp area. As shown in the enclosed photos, the Operator's efforts appear to have stabilized the scarp; the scarp appears to have ceased up-slope migration and the previously over-steepened slope appears to be somewhat stabilizing by the additional fill materials.

**Detail photo showing current condition of the scarp and over-steepened slope resulting from previous excavation occurring at the toe of slope. The Operator has been dumping talus material on the slope, resulting from widening of CR 25, which appears to be restoring the talus slope and healing the scarp.**
