**COLORADO DIVISION OF RECLAMATION, MINING AND SAFETY
COAL PROGRAM INSPECTION REPORT**

Permit Number: C-1982-056 Mine Name: Foidel Creek Mine Operator: Twentymile Coal, LLC Operator Address: Mr Jerry Nettleton 29515 Routt County Road No. 27 Oak Creek, CO 80467	County: Routt Operation Type: Underground Permit Status: Active Ownership: Federal Operator Representative Present: Brian Watterson
Operator Representative Signature: (Field Issuance Only)

Inspection Start Date: October 1, 2012 Inspection Start Time: 13:00 Inspection End Date: October 2, 2012 Inspection End Time: 14:20		Inspection Type: Coal Complete Inspection Inspection Reason: Normal I&E Program Weather: Clear	
Joint Inspection Agency: None		Joint Inspection Contacts:	
Post Inspection Agency: None		Post Inspection Contacts:	
Inspector(s): Jason D. Musick	Inspector's Signature:

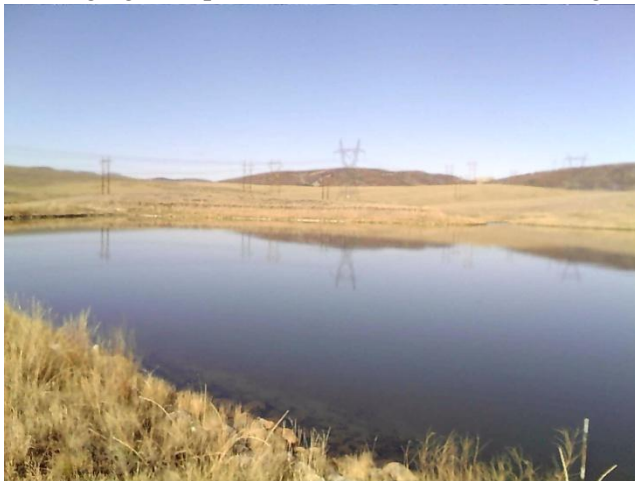
6MN Holding Pond

Drainage Control 4.05.1, 4.05.2, 4.05.3; Siltation Structures 4.05.5, 4.05.6; Discharge Structures 4.05.7, 4.05.10; Diversions 4.05.4; Effluent Limits 4.05.2; Ground Water Monitoring 4.05.13; Surface Water Monitoring 4.05.13; Drainage – Acid and Toxic Materials 4.05.8; Impoundments 4.05.6, 4.05.9; Stream Buffer Zones 4.05.18: Ponds B, C, D, E, F, G, 6NM, 18LT, 6NM sediment pond, the Fish Creek borehole ponds, the Fish Creek Tipple pond and the Pit Pond were observed during the inspection. Discharge was noted at Pond D and the Fish Creek Tipple pond. However, neither discharge was at the level of the v-notch weir. All other ponds were not discharging. All pond embankments were well vegetated and stable with no problems noted.

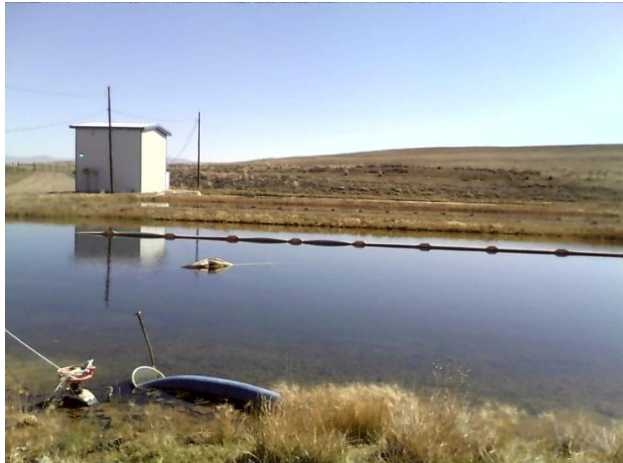
Fish Creek Borehole Pond

Brian Watterson indicated that water level at the Fish Creek Borehole was at ~36ft of freeboard and ~33ft of freeboard at the 10RT borehole.

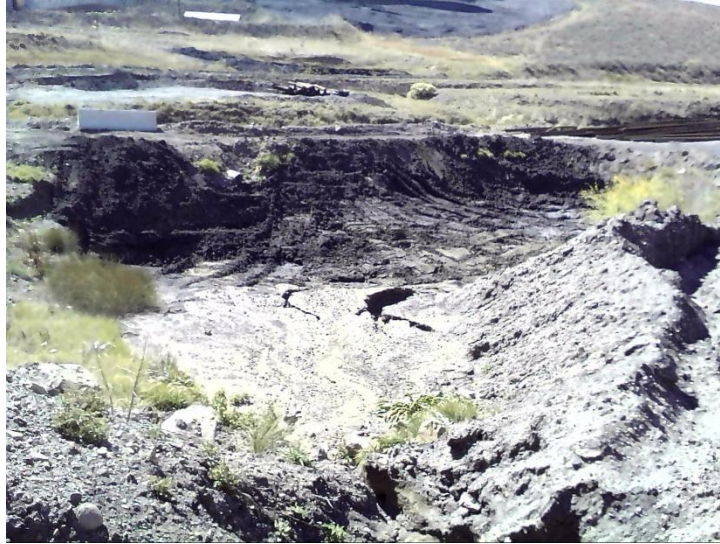
Pond B Sump

- The sump located northwest of Pond B has been cleaned of sediment with no problems noted.

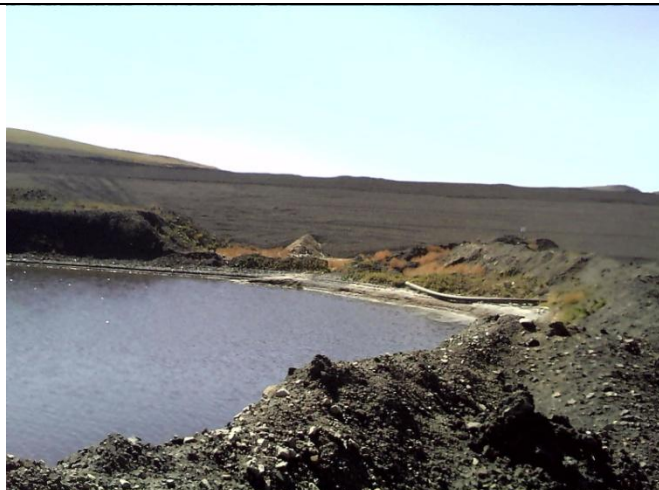
RDA Lift 1 Outslope and Underdrain Outlet

Refuse material continues to be placed in the RDA expansion area. Material was in the process of stockpiling at the time of the inspection. The RDA was well compacted and stable at the time of the inspection. The refuse material had not yet reached the head of the under-drain of the RDA. The first lift of the RDA Expansion has been completed. The exposed under-drain was stable and constructed as designed. Phase 1 of the RDA expansion is nearing completion. TR67 was approved with a stipulation that future bonding for each phase of construction will be required prior to the initiation of the next Phase. No problems were noted at the RDA, with the exception of the following:

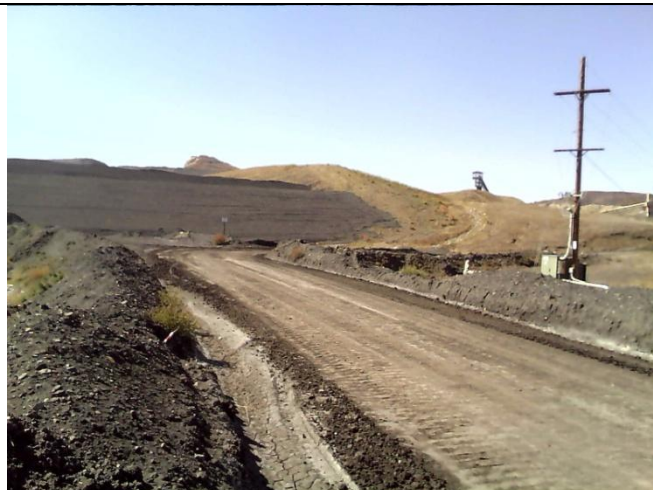
RDA Outslope

- All erosional gullies were addressed and no additional erosion features were observed during the inspection.
