COLORADO DIVISION OF RECLAMATION, MINING AND SAFETY
MINERALS PROGRAM INSPECTION REPORT
PHONE: (303) 866-3567

MINE NAME: Oyama Tunnel Exploration Project	MINE/PROSPECTING ID#: P-2011-032	MINERAL: Gold and silver	COUNTY: San Juan
INSPECTION TYPE: Mineral Prospect Inspection	INSPECTOR(S): Wallace H. Erickson	INSP. DATE: September 24, 2012	INSP. TIME: 13:00
OPERATOR: Running Sun Advisory Services LLC	OPERATOR REPRESENTATIVE: Mike Thompson	TYPE OF OPERATION: MP - Mineral Prospecting

Oyama Tunnel NOI
P-2011-032
September 24, 2012

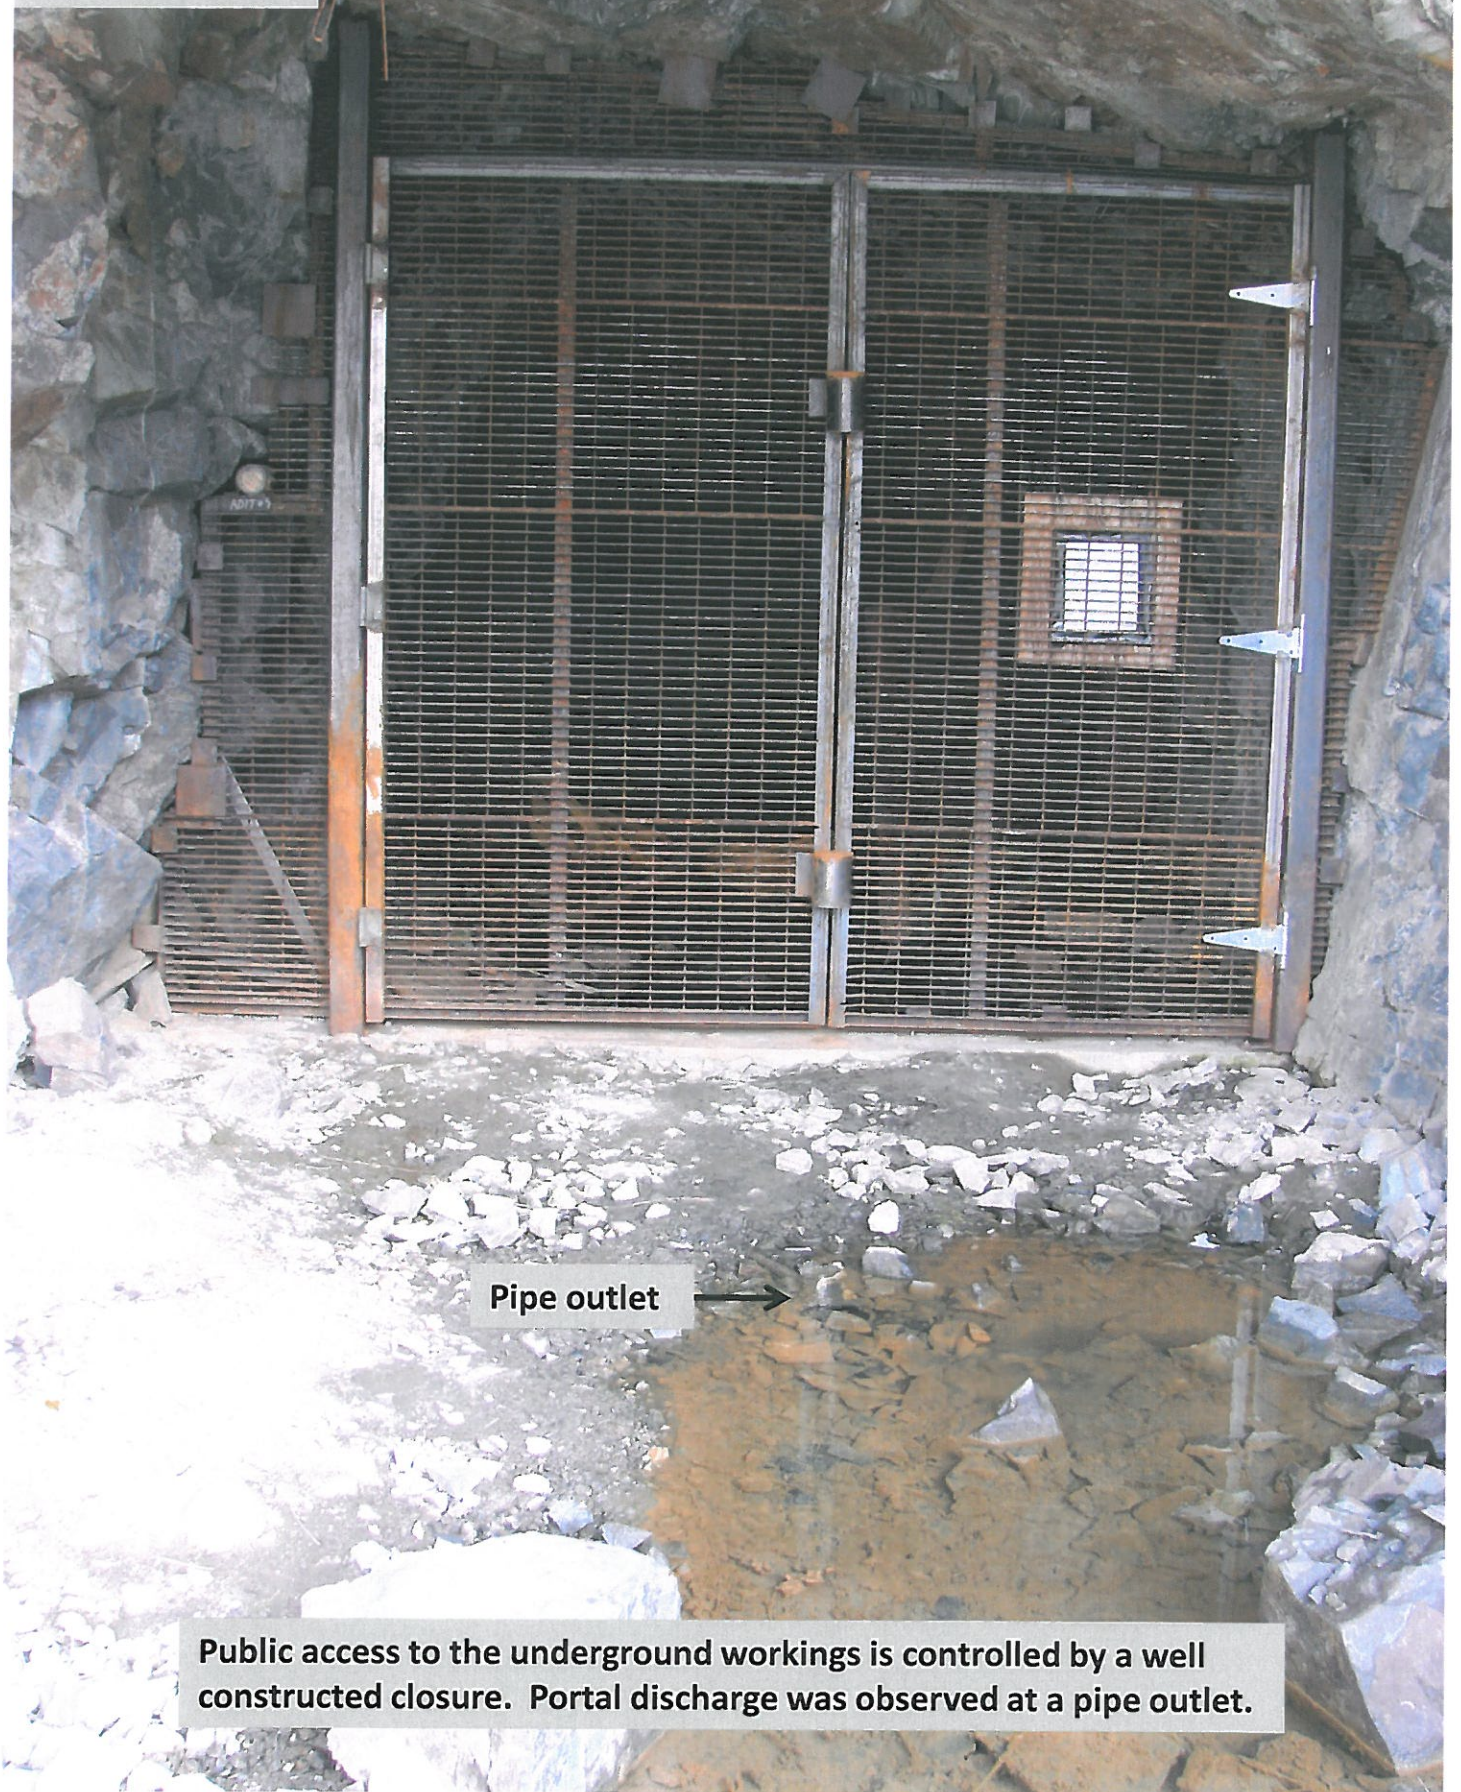
Pipe outlet →

Public access to the underground workings is controlled by a well constructed closure. Portal discharge was observed at a pipe outlet.

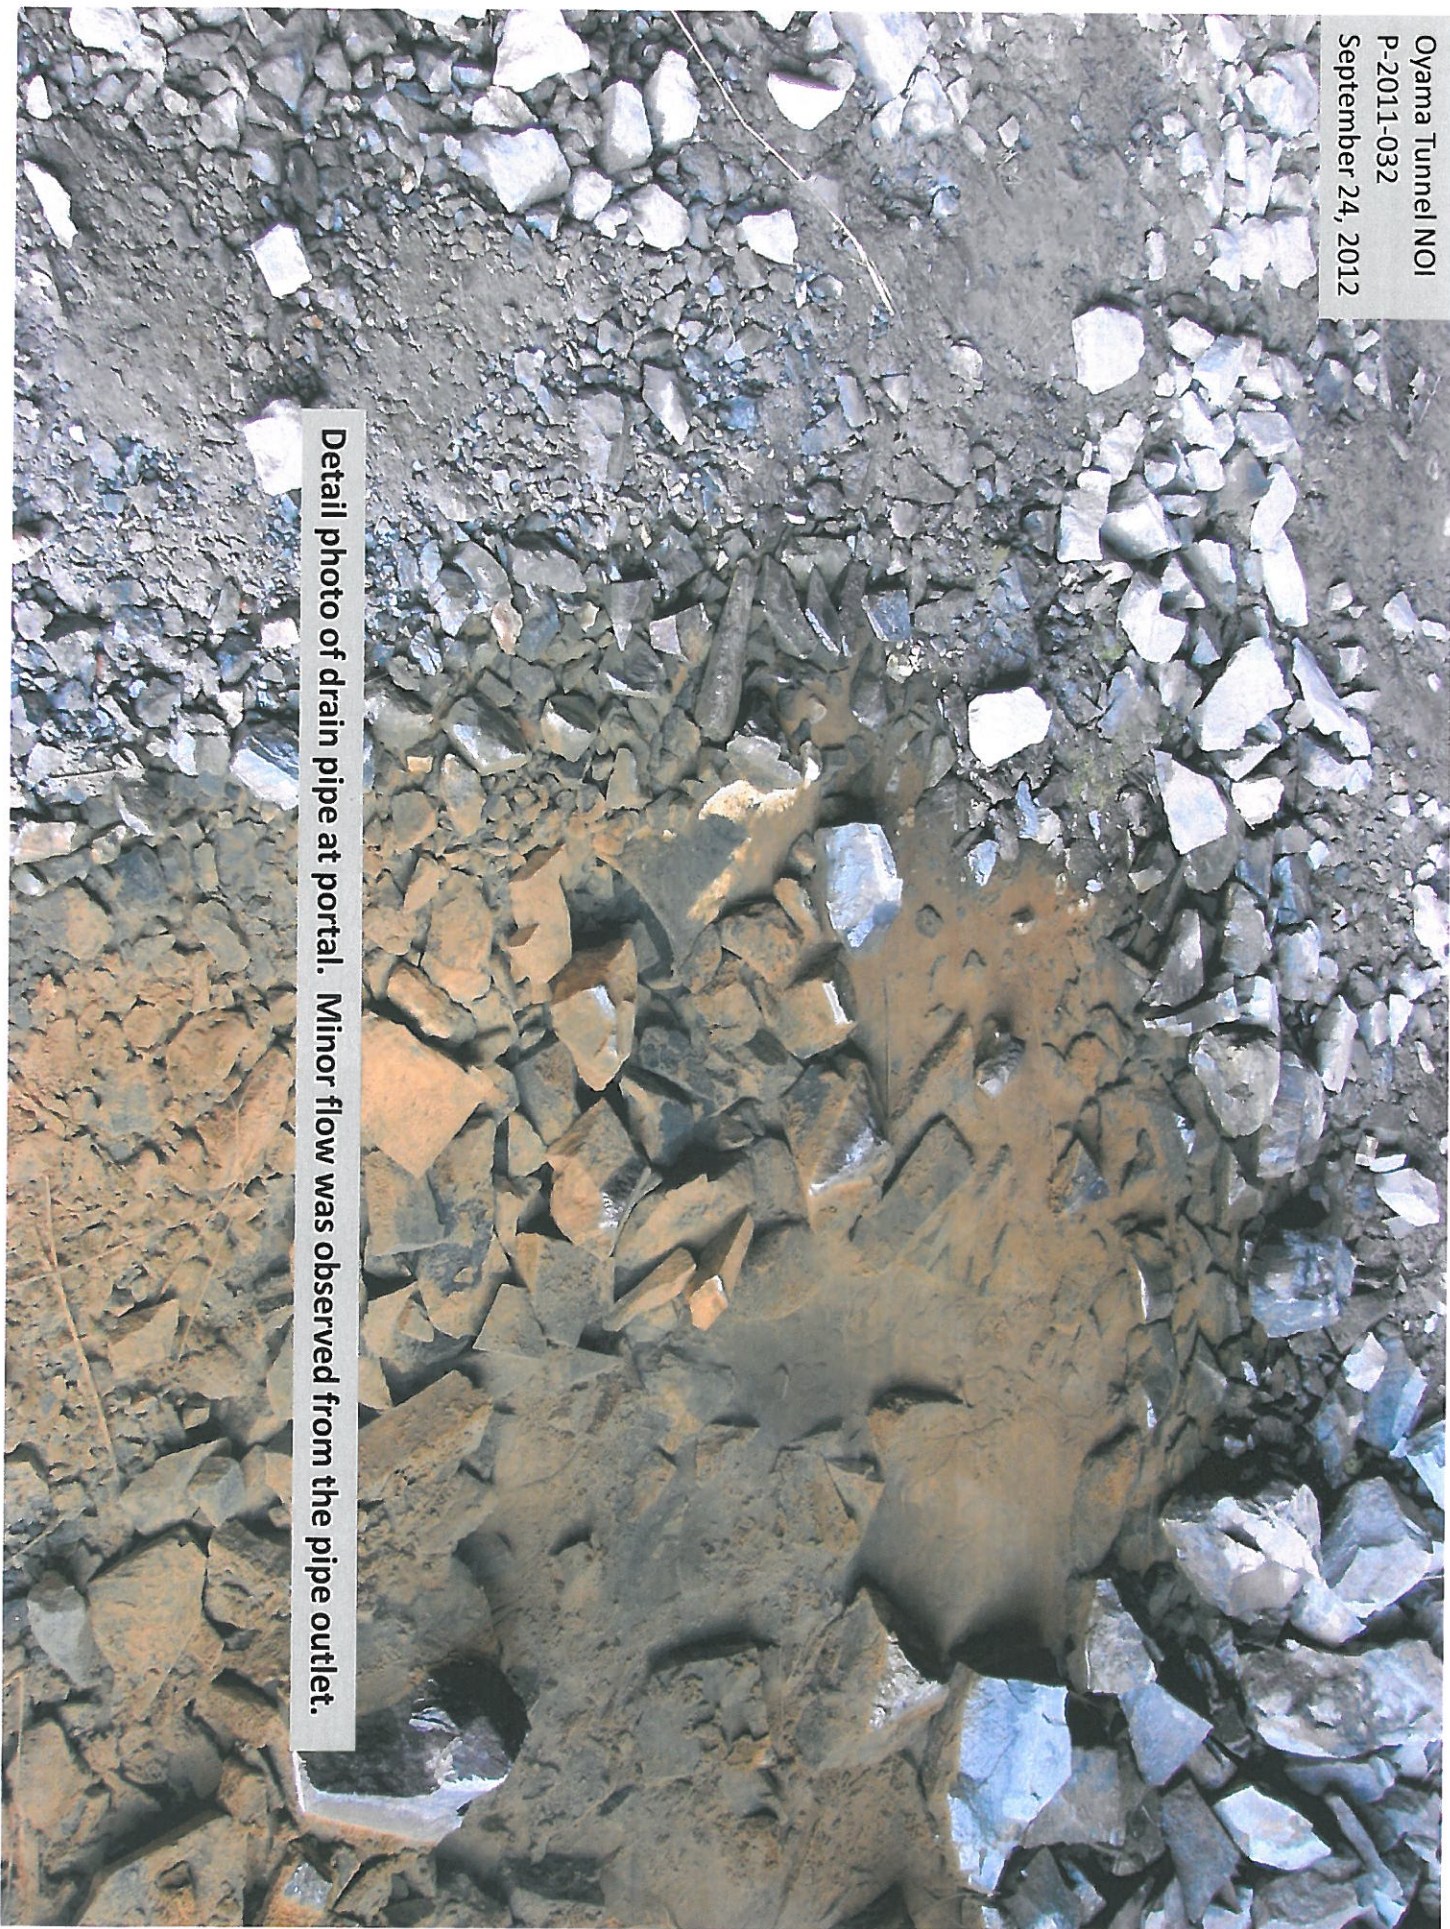
Detail photo of drain pipe at portal. Minor flow was observed from the pipe outlet.

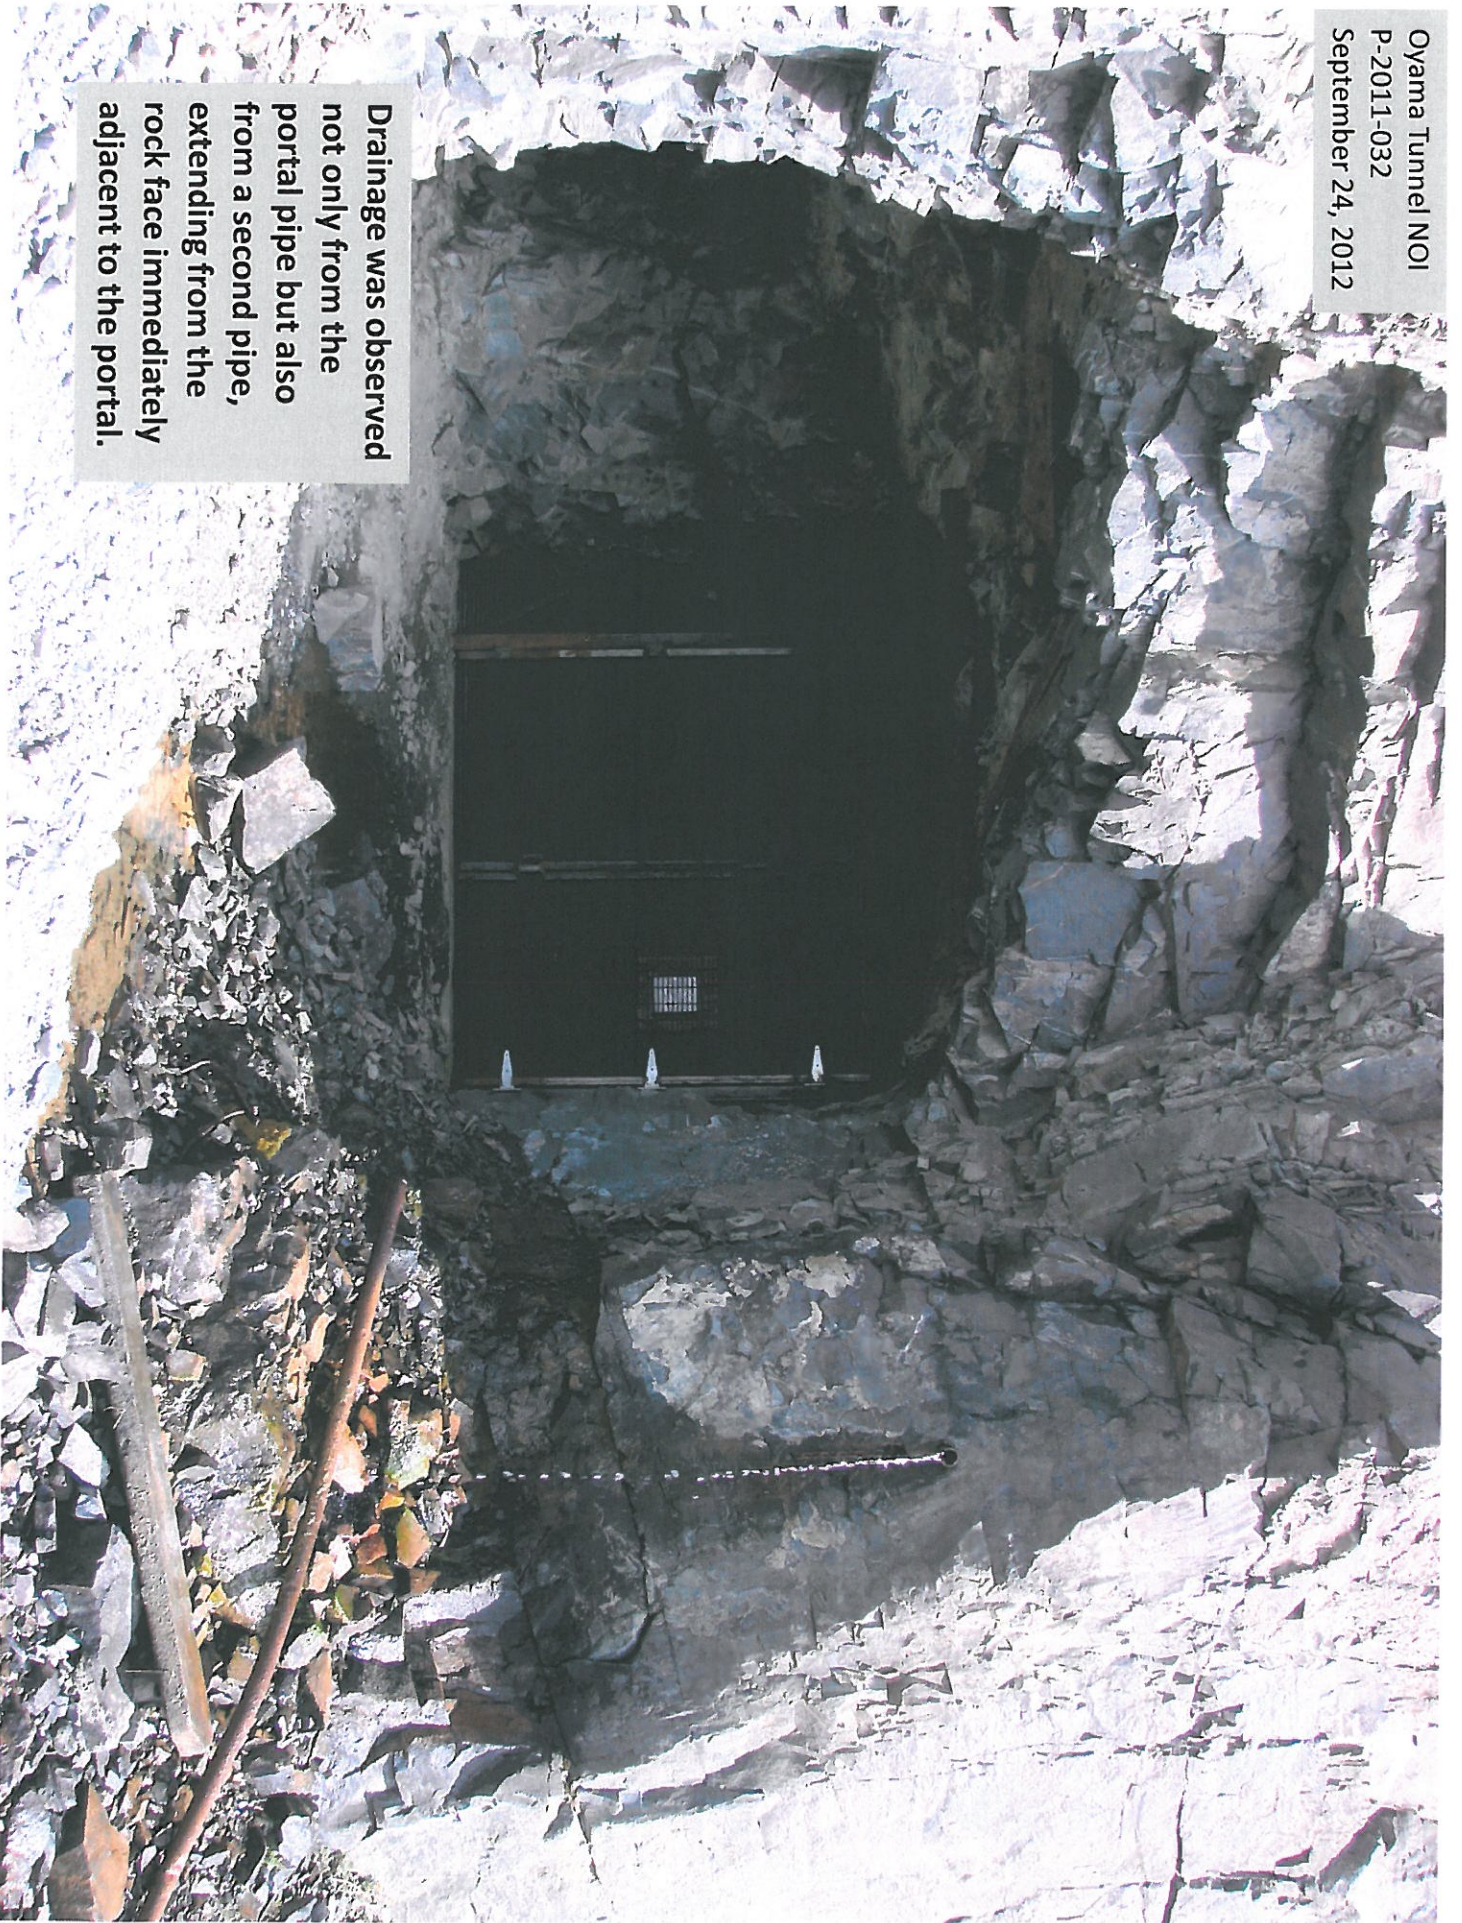
Drainage was observed not only from the portal pipe but also from a second pipe, extending from the rock face immediately adjacent to the portal.

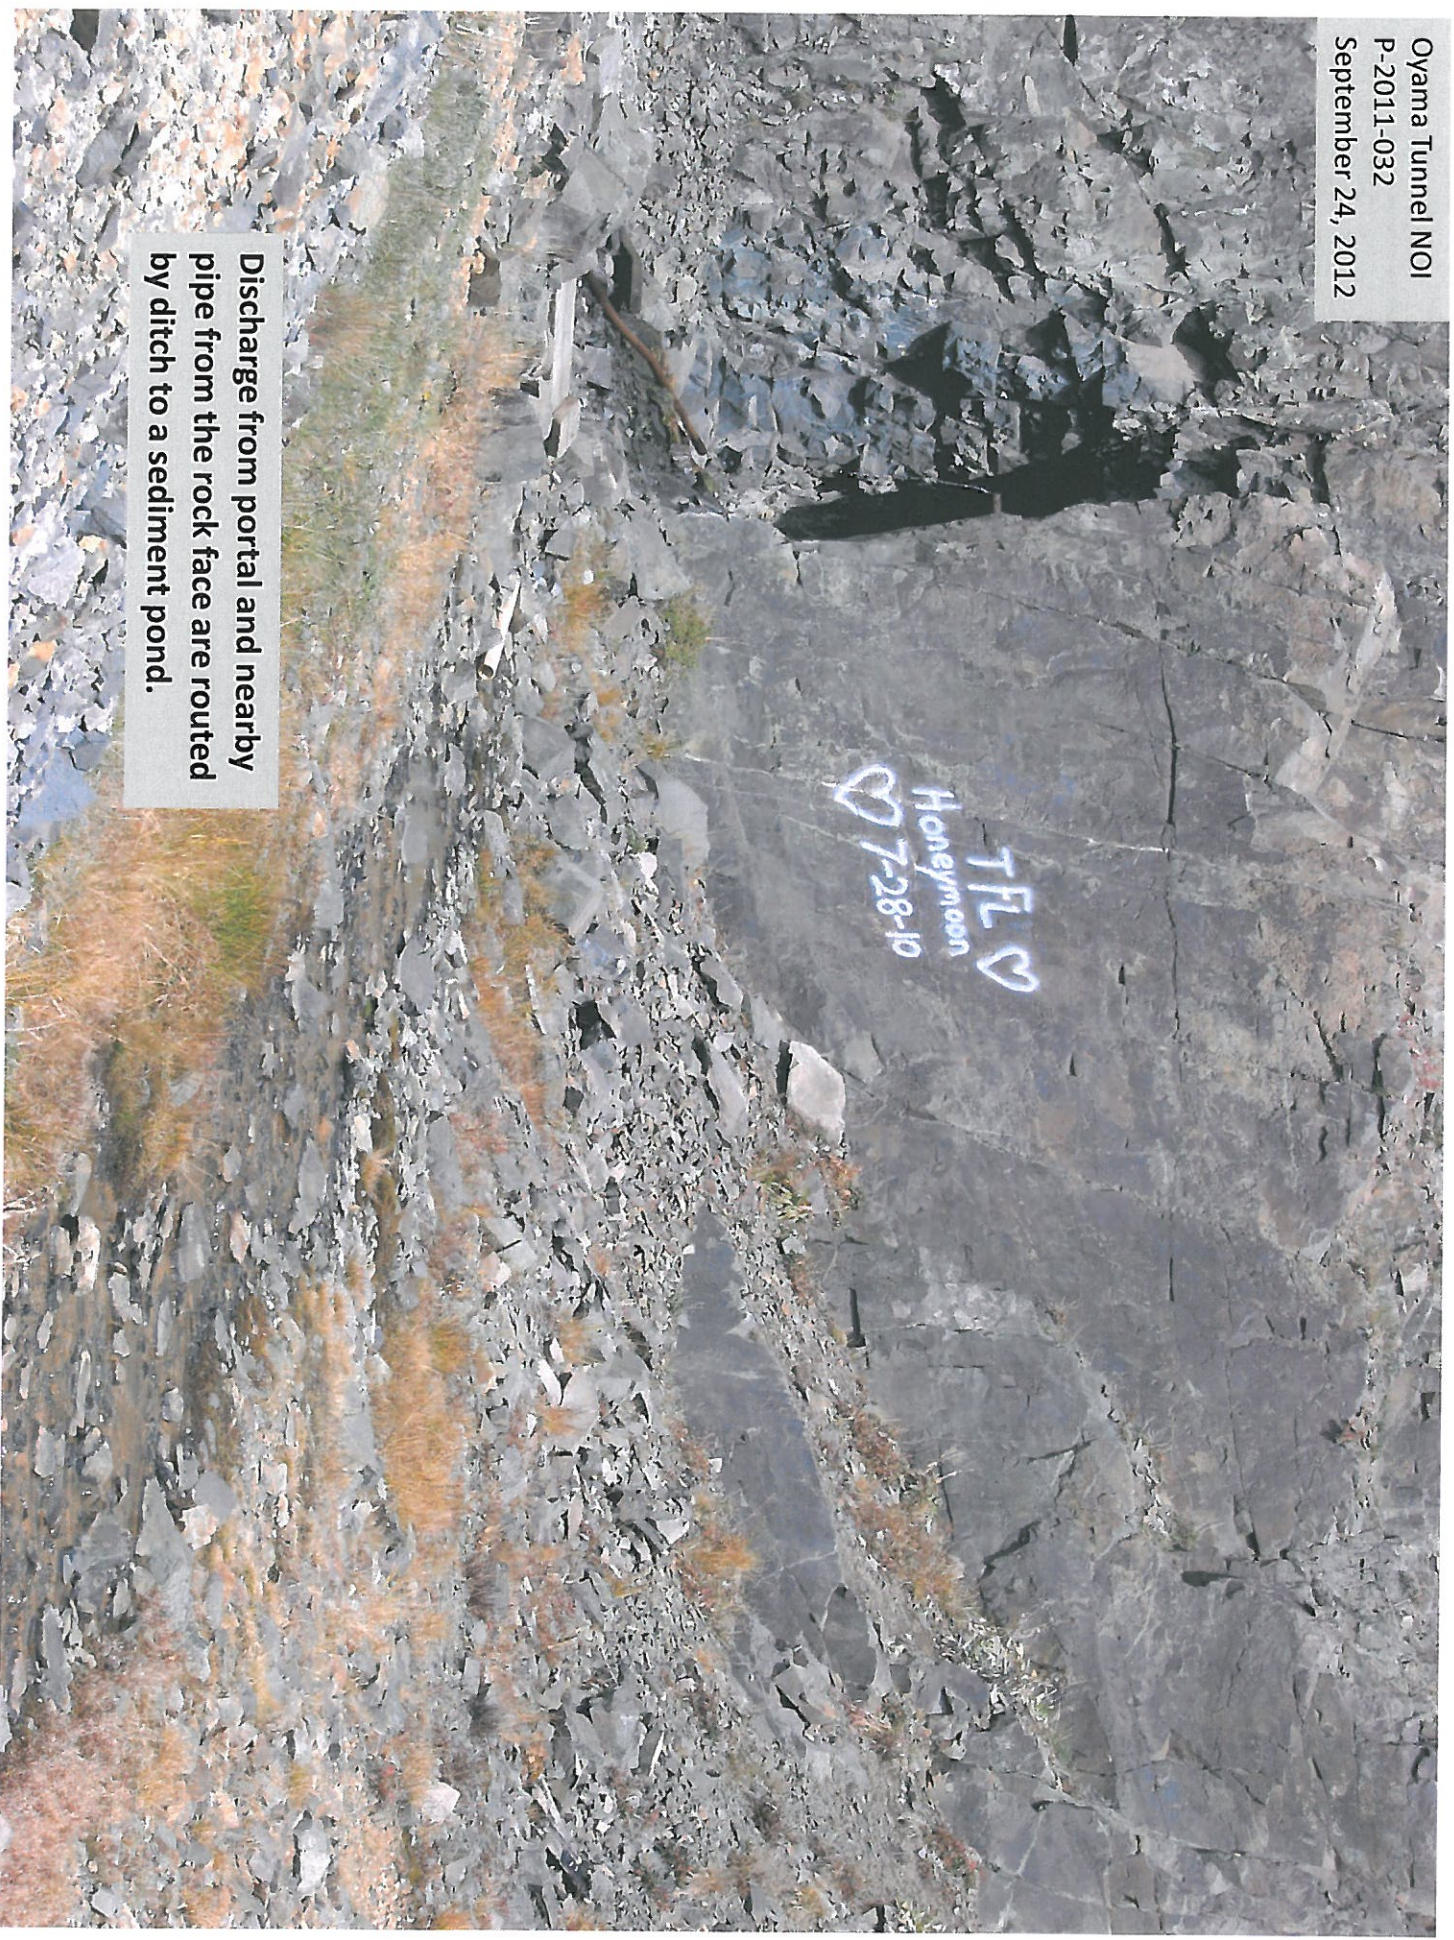
Discharge from portal and nearby
pipe from the rock face are routed
by ditch to a sediment pond.
