COLORADO DIVISION OF RECLAMATION, MINING AND SAFETY COAL PROGRAM INSPECTION REPORT

Permit Number: C-2009-087 Mine Name: Peabody Sage Creek Mine Operator: Peabody Sage Creek Mining LLC Operator Address: Mr B. Scott Cowman P.O. Box 250 36600 Routt County Road 27 Hayden, CO 81639	County: Routt Operation Type: Underground Permit Status: Active Ownership: Federal
Operator Representative Present: Scott Cowman	
Operator Representative Signature: (Field Issuance Only)

Inspection Start Date: October 3, 2012 Inspection Start Time: 08:00 Inspection End Date: October 3, 2012 Inspection End Time: 14:30	Inspection Type: Coal Partial Inspection Inspection Reason: OSM Special Focus Weather: Clear
Joint Inspection Agency: OSM	Joint Inspection Contacts:
Post Inspection Agency: None	Post Inspection Contacts:
Inspector(s): Jason D. Musick	Inspector's Signature:

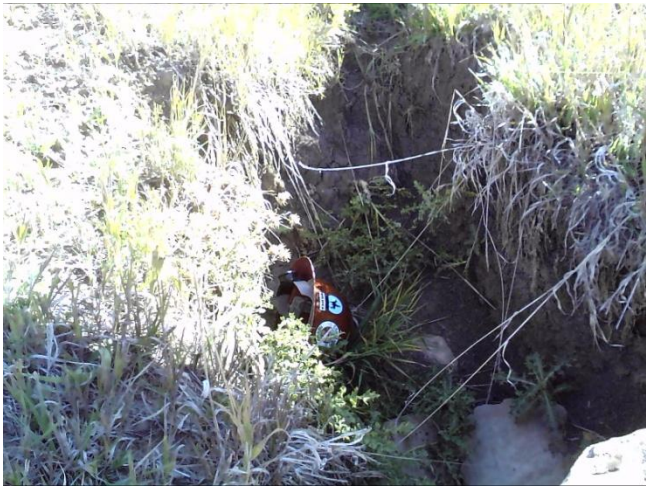
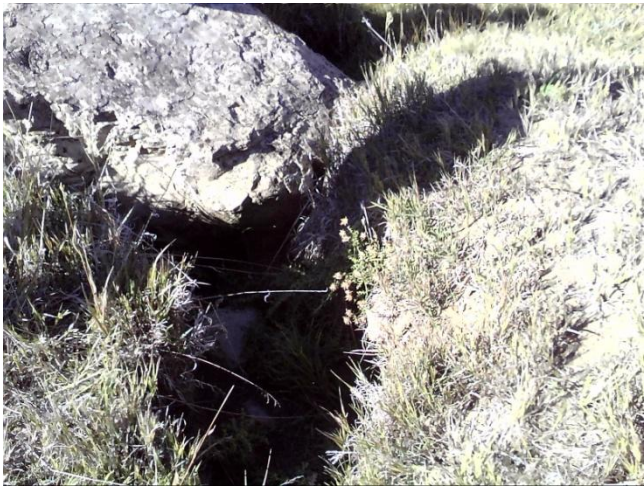
Pond 004 Emergency Spillway Erosion Feature

- A small erosion feature was identified at the toe of the emergency spillway. This down cutting will need to be addressed and rip-rap installed as designed.

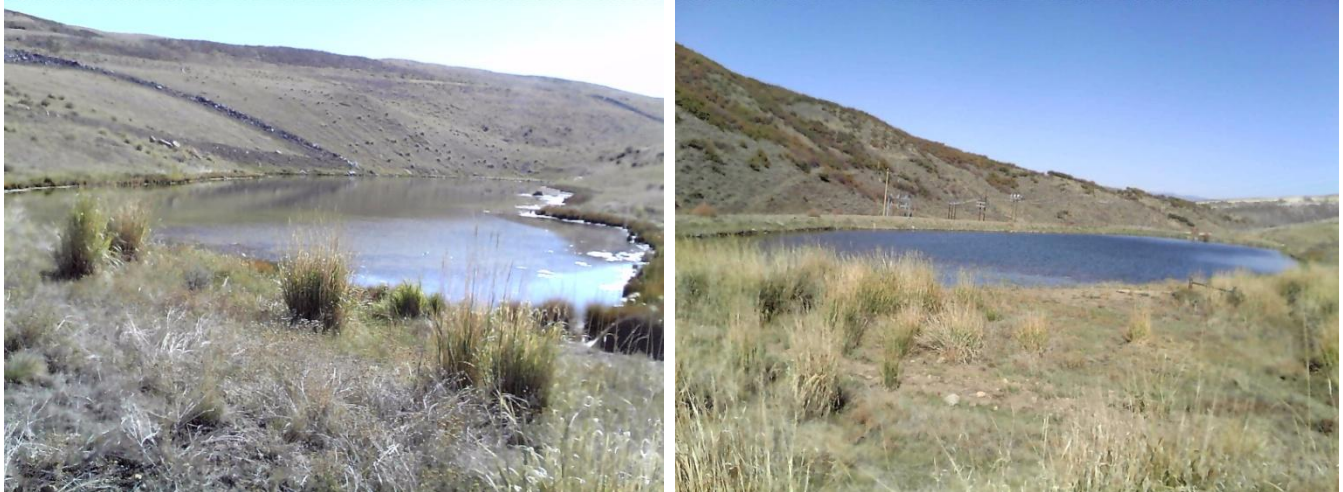
The Pecoco Pond is a permanent impoundment originally permitted under C-1980-005 and contained water at the time of the inspection. The Pecoco utilizes a corrugated steel pipe primary spillway and vegetation lined emergency spillway. The discharge at the time of the inspection was approximately $\frac{1}{4}$ full through the 24" primary spillway. The emergency spillway appeared stable with no signs of water flow. The pond embankments appeared stable and well vegetated at the time of the inspection. The discharge from the Pecoco Pond enters the Upper Sump and is impounded before discharging to Pond 002.

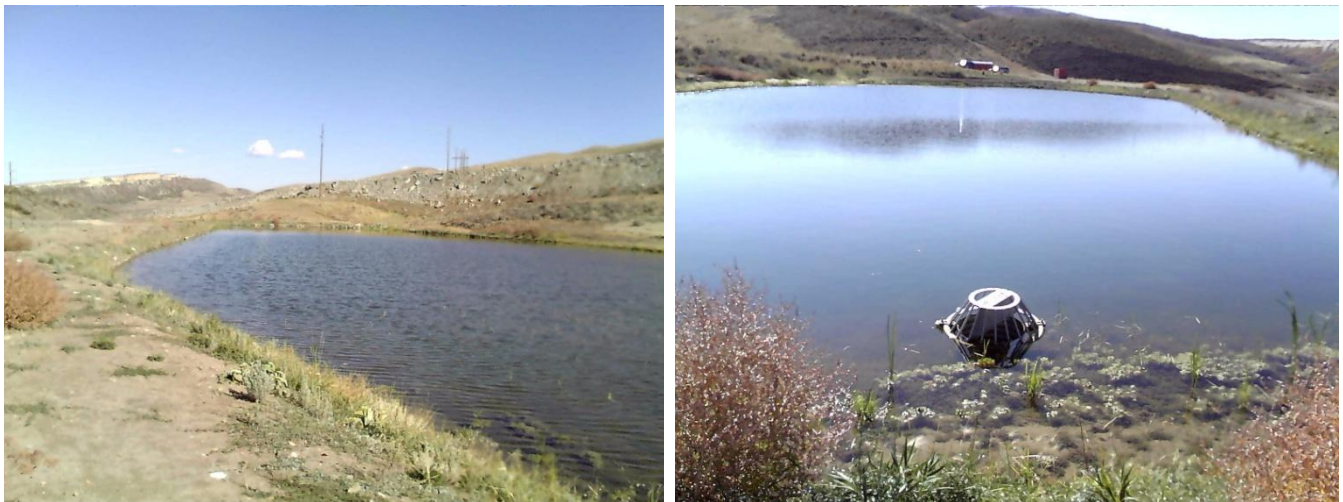
The Upper Sump impoundment is a recently constructed impoundment as part of the Peabody Sage Creek Mine drainage and sediment control plan. The Upper Sump contained water at the time of the inspection. The Upper Sump utilizes a corrugated steel pipe primary spillway with a 90 Degree Riser Pipe and a trash rack and a rock lined emergency spillway. The discharge at the time of the inspection was approximately $\frac{1}{4}$ full through the 24" primary spillway. The emergency spillway appeared stable with no signs of water flow. The pond embankments appeared stable and with good initial vegetation growth along the pond side of the embankment at the time of the inspection. The following maintenance items were noted:

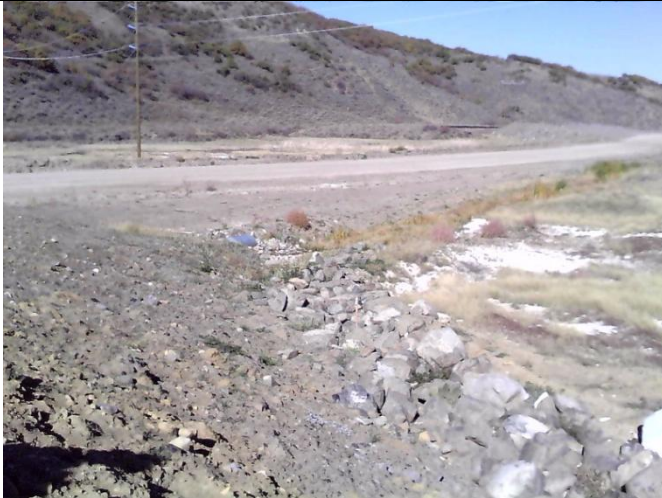
Upper Sump Emergency Spillway

- Weed management will be needed in the area in and around the emergency spillway. Heavy thistle growth was observed and should be cleared.

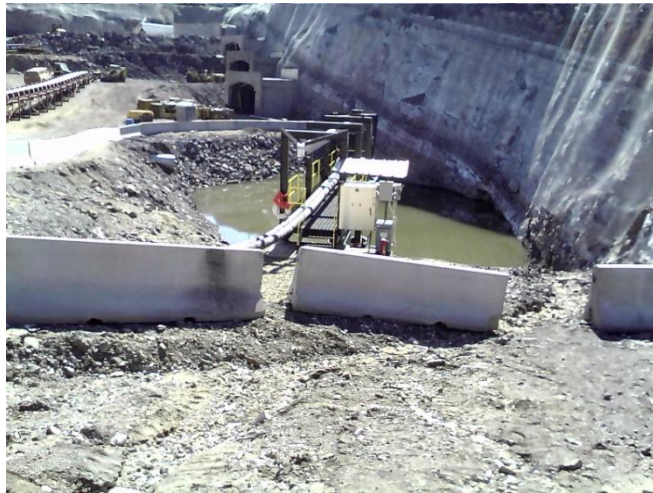
The Portal Area Sump #1 and #2 are recently constructed non-discharging impoundments that receive run-off from only the mine portal excavation area. Run-off is impounded in the #1 pond and then flows to the #2 pond and is then pumped out.. The Portal Sump #2 contained water at the time of the inspection. The Portal Sumps utilizes a 36" corrugated steel pipe between the two sumps. These are incised sumps and do not have constructed embankments.

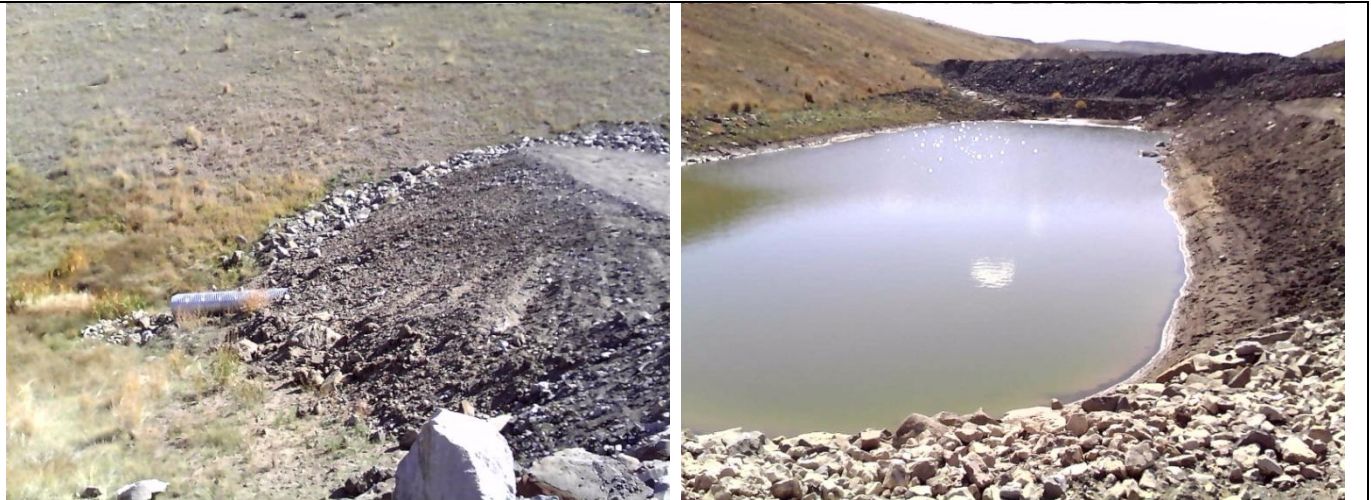
The Lower Sump impoundment is a recently constructed impoundment as part of the Peabody Sage Creek Mine drainage and sediment control plan. The Lower Sump contained water at the time of the inspection. The Lower Sump utilizes a corrugated steel pipe primary spillway with a 90 Degree Riser Pipe and a trash rack and a rock lined emergency spillway. No discharge was observed through the 36" primary spillway. The emergency spillway was stable with no signs of water flow. The pond embankments appeared stable and with no vegetation growth at the time of the inspection. The embankment will require seeding.

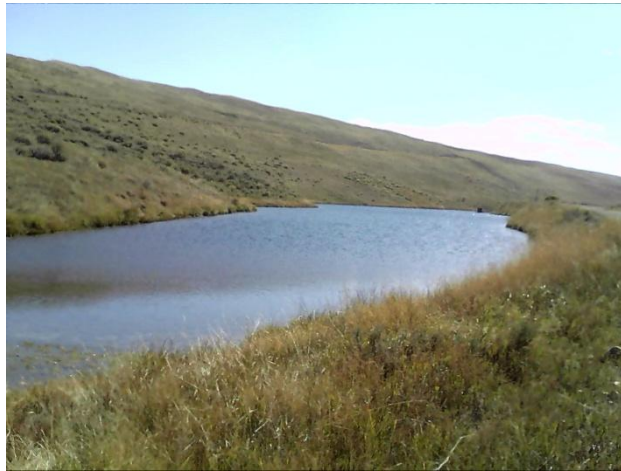
Pond 002 is a permanent impoundment originally permitted under C-1980-005 and contained water at the time of the inspection. Pond 002 utilizes a combination trapezoidal primary and emergency spillway. There was water discharging at the time of the inspection. The water level gage on the flume was unreadable; however, the mechanical meter was in place and functioning at the time of the inspection. No problems were noted.
