**COLORADO DIVISION OF RECLAMATION, MINING AND SAFETY  
COAL PROGRAM INSPECTION REPORT**

<b>Permit Number:</b> C-1980-005 <b>Mine Name:</b> Seneca II Mine <b>Operator:</b> Seneca Coal Company, LLC <b>Operator Address:</b> Mr Roy Karo P.O. Box 670 Hayden, CO 81639	<b>County:</b> Routt <b>Operation Type:</b> Surface <b>Permit Status:</b> Active <b>Ownership:</b> Private  <b>Operator Representative Present:</b>  Scott Cowman
<b>Operator Representative Signature: (Field Issuance Only)</b>

<b>Inspection Start Date:</b> October 3, 2012 <b>Inspection Start Time:</b> 08:00 <b>Inspection End Date:</b> October 3, 2012 <b>Inspection End Time:</b> 14:00		<b>Inspection Type:</b> Coal Partial Inspection <b>Inspection Reason:</b> OSM Special Focus <b>Weather:</b> Clear	
<b>Joint Inspection Agency:</b>  OSM		<b>Joint Inspection Contacts:</b>	
<b>Post Inspection Agency:</b>  None		<b>Post Inspection Contacts:</b>	
<b>Inspector(s):</b>  Jason D. Musick	<b>Inspector's Signature:</b>

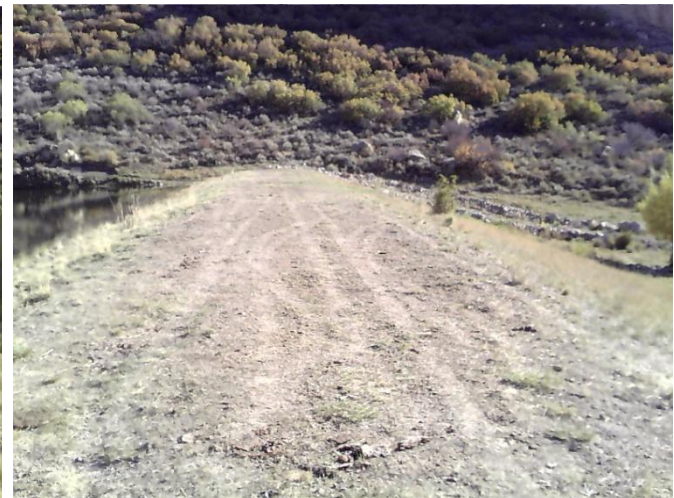
The pond embankments appeared to be well vegetated and stable with no signs of erosion or damage at the time of the inspection.

Pond 008 Embankment

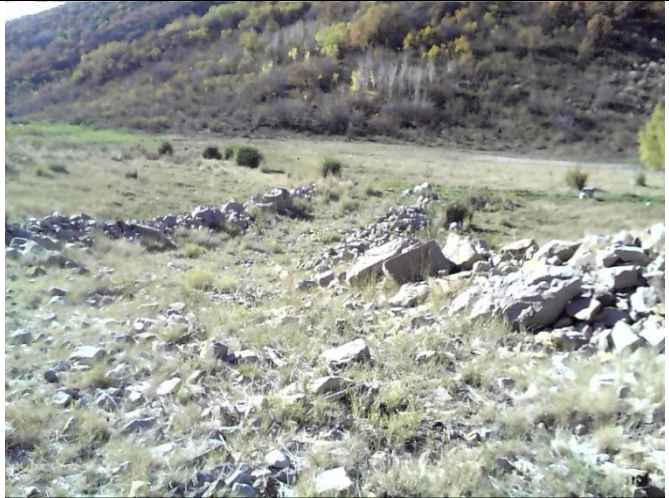
Drainage Control 4.05.1, 4.05.2, 4.05.3; Siltation Structures 4.05.5, 4.05.6; Discharge Structures 4.05.7, 4.05.10; Diversions 4.05.4; Effluent Limits 4.05.2; Ground Water Monitoring 4.05.13; Surface Water Monitoring 4.05.13; Drainage – Acid and Toxic Materials 4.05.8; Impoundments 4.05.6, 4.05.9; Stream Buffer Zones 4.05.18: Pond 008 is a permanent impoundment and was holding clear water at the time of the inspection. Pond 008 utilizes an 8" smooth plastic pipe primary spillway and a rock lined emergency spillway. Approximately >.1 cfs was discharging through the 12' flume at the time of the inspection and the spillway appeared to be functioning as permitted. The emergency spillway appeared to be stable with no problems noted at the time of the inspection.

Pond 008 Emergency Spillway
