**COLORADO DIVISION OF RECLAMATION, MINING AND SAFETY  
COAL PROGRAM INSPECTION REPORT**

<b>Permit Number:</b> C-1981-037 <b>Mine Name:</b> GEC Strip Mine <b>Operator:</b> GEC Minerals <b>Operator Address:</b> Dr W Corley 2605 Constellation Drive Colorado Springs, CO 80906	<b>County:</b> Fremont <b>Operation Type:</b> Surface <b>Permit Status:</b> Revoked <b>Ownership:</b> Private
	<b>Operator Representative Present:</b>  NA
<b>Operator Representative Signature:</b> (Field Issuance Only)

<b>Inspection Start Date:</b> August 24, 2012 <b>Inspection Start Time:</b> 16:00 <b>Inspection End Date:</b> August 24, 2012 <b>Inspection End Time:</b> 17:30	<b>Inspection Type:</b> Coal Complete Inspection <b>Inspection Reason:</b> Normal I&E Program <b>Weather:</b> Raining
<b>Joint Inspection Agency:</b>  None	<b>Joint Inspection Contacts:</b>
<b>Post Inspection Agency:</b>  None	<b>Post Inspection Contacts:</b>
<b>Inspector(s):</b>  Janet H. Binns	<b>Inspector's Signature:</b>   <b>Signature Date:</b>  9/6/2012

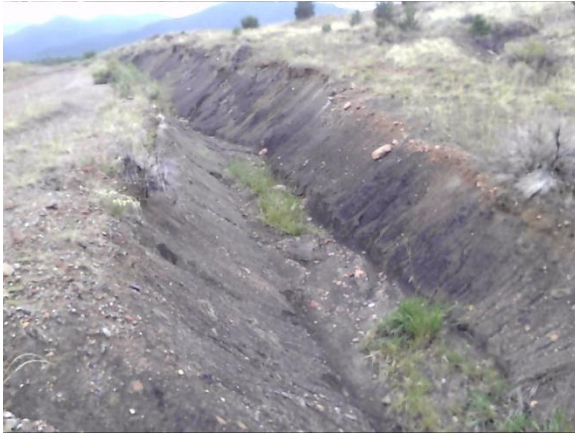
The inspector walked the north road side ditch To discern the source of the sediment. Some of the recent sediment appeared to have been washed down from the undisturbed area and historic reclaimed disturbances located west FCR92.

Photo 1: road ditch on W side of FCR92  
Note sediment in bottom.

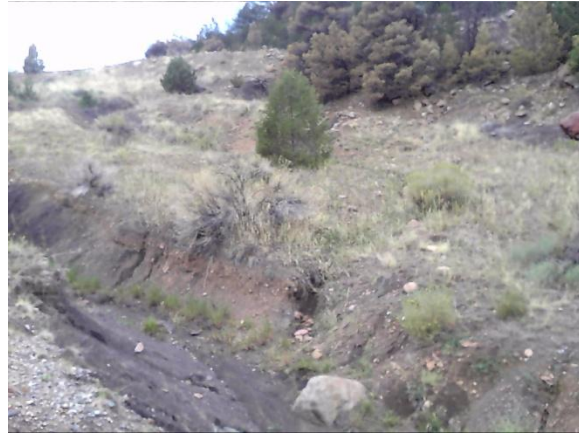
Photo 2: FCR92 west ditch, inflow from slope  
West of FCR92.

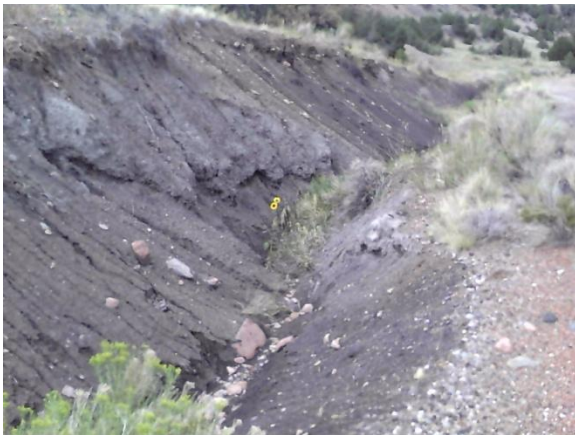
A road cut alongside the west side of FCR92 also exhibits recent rilling. It appears that this bank is one of the sources of the sediment deposited near the gate. This cut bank on the road is located north of the neighboring Southfield permit boundary. There is very little sediment in the ditch to the south of this cut bank.

Photo 3: Cut bank that appears to be contributing  
Additional sediment along west side of FCR92

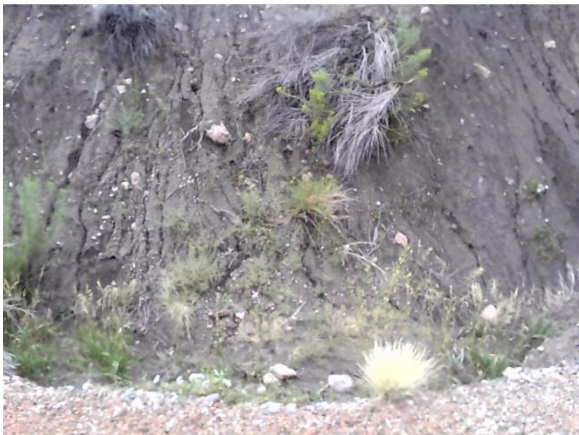
Photo 4: Cut bank west of FCR92

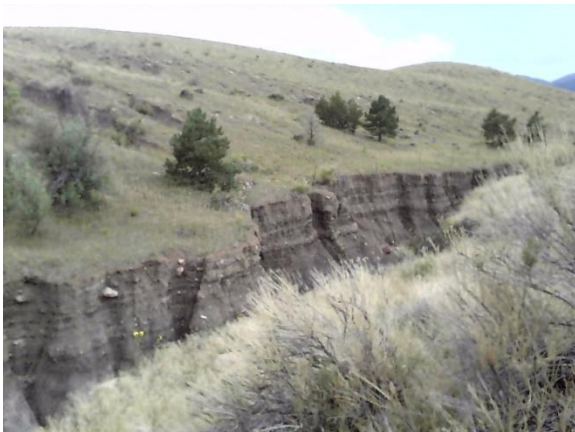
Gullies on Chens Hill still have plants growing in the bottom of the gullies. There is evidence of some additional sediment deposition in the ditch at the bottom (west side) of the slope from the larger gullies on the west side of Chens Hill.

Photo 5: west side of Chen's hill

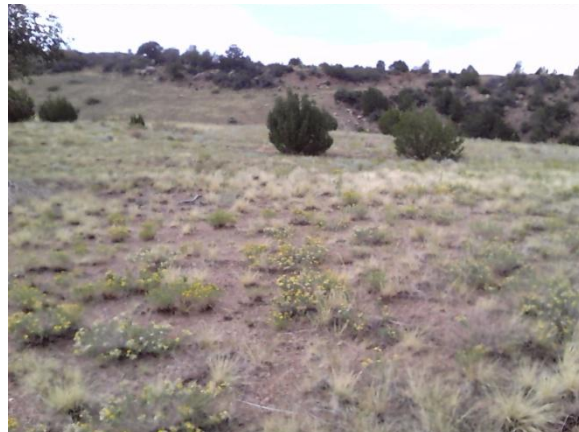
Photo 6: slope west of FCR92.
