**COLORADO DIVISION OF RECLAMATION, MINING AND SAFETY
COAL PROGRAM INSPECTION REPORT**

Permit Number: C-1994-082 Mine Name: Yoast Mine Operator: Seneca Coal Company, LLC Operator Address: Mr. Roy Karo 27796 Routt County Road 53 P.O. Box 670 Hayden, CO 81639	County: Routt Operation Type: Surface Permit Status: Permanent Cessation Ownership: Federal
	Operator Representative Present: None
Operator Representative Signature: (Field Issuance Only)

Inspection Start Date: October 2, 2012 Inspection Start Time: 07:30 Inspection End Date: October 3, 2012 Inspection End Time: 15:30	Inspection Type: Coal Complete Inspection Inspection Reason: Normal I&E Program Weather: Clear
Joint Inspection Agency: None	Joint Inspection Contacts:
Post Inspection Agency: None	Post Inspection Contacts:
Inspector(s): Jared L. Ebert Susan L. Burgmaier	Inspector's Signature:

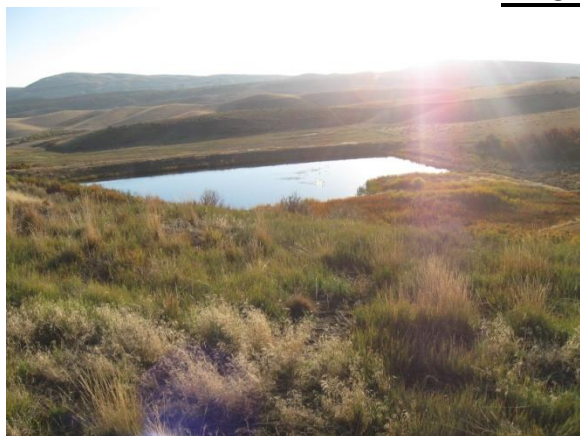
Pond 010 was holding water but was not discharging. The pond embankment was stable and vegetated. The flume was in place and functional.

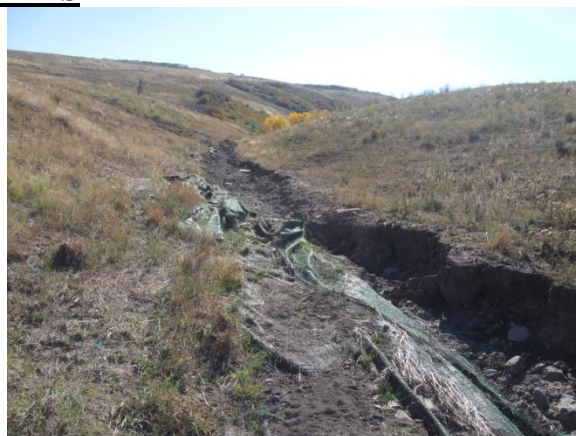
Channel erosion

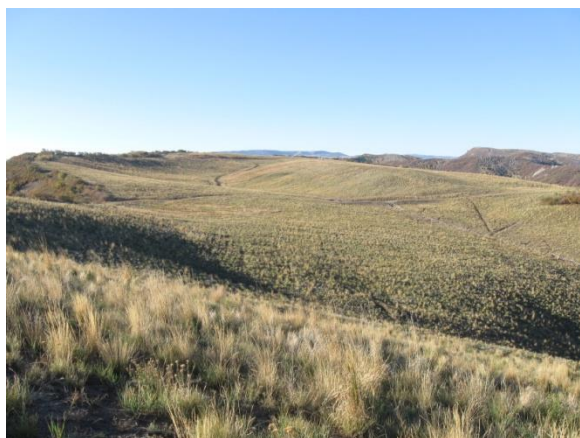
South Pit Area

The revegetated areas of the south pit area were observed. It appears the dominant vegetation in this area is sage and alfalfa. Overall, it appears the perennial vegetation is establishing well.

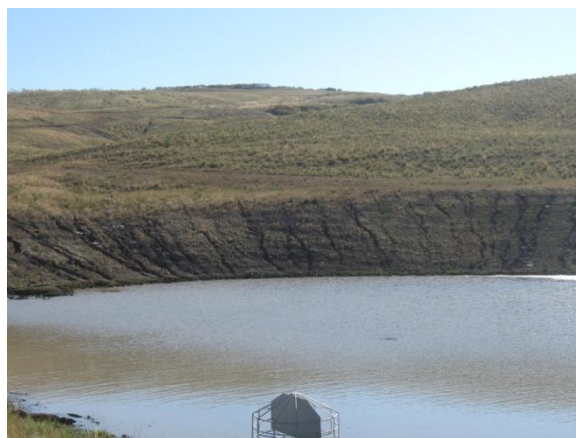
Pond 12a is holding water but is not discharging. It appears this pond needs to have built up sediment removed to restore the ponds capacity. The pond embankment appears stable, however many rills and small gullies were observed on the pond slopes that will need to be monitored.

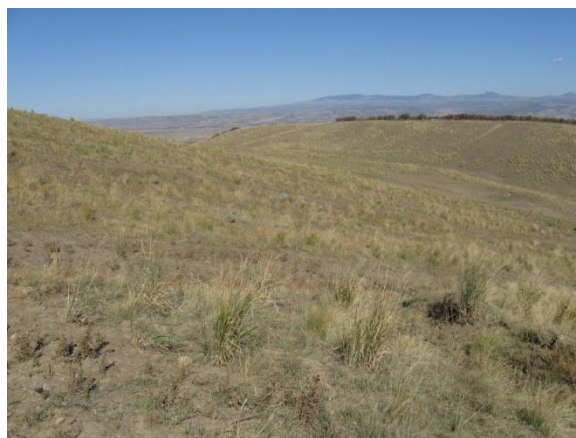
North pit reclamation

Both the north slope and the south slope was walked in the north pit area. The vegetation appears to be well established in this area. Several bare spots were observed at the top of the north slope. Shrubs have been planted on a small portion of the southern slope that were not enclosed. These shrubs have been heavily browsed by wildlife and primarily annual weeds have established in this area.

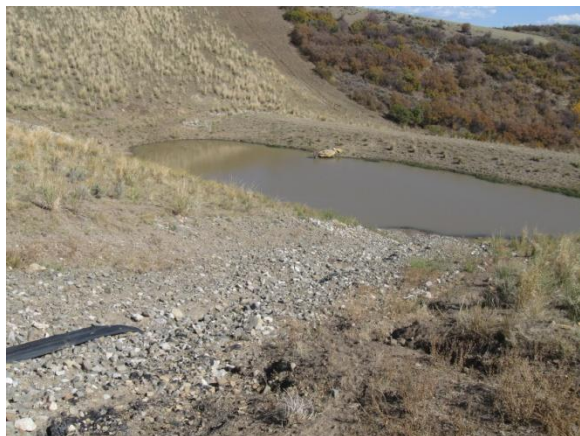
Pond 011a was holding water and discharging. The pond embankment was stable and vegetated. The spillway was clear of debris and functional. The drainage leading into this pond appears to be eroded and incised in places and will need to be repaired.

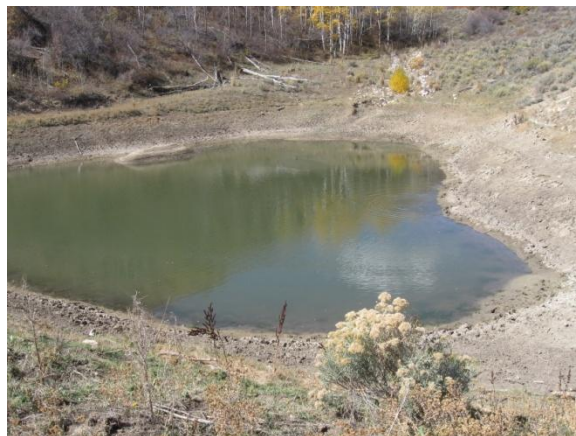
Pond 011 was holding water but was not discharging. The pond embankment was stable and vegetated. The flume was in place and functional.
