COLORADO DIVISION OF RECLAMATION, MINING AND SAFETY COAL PROGRAM INSPECTION REPORT

Permit Number: C-1980-001 Mine Name: Edna Strip Mine Operator: Chevron Mining, Inc. Operator Address: Mr. James A Tarazoff 116 Inverness Drive East, Suite 207 Englewood, CO 80112	County: Routt Operation Type: Surface Permit Status: Permanent Cessation Ownership: Federal
Operator Representative Present:	
Operator Representative Signature: (Field Issuance Only)

Inspection Start Date: October 9, 2012 Inspection Start Time: 13:10 Inspection End Date: Inspection End Time:	Inspection Type: Coal Partial Inspection Inspection Reason: Normal I&E Program Weather: Clear
Joint Inspection Agency: None	Joint Inspection Contacts:
Post Inspection Agency: None	Post Inspection Contacts:
Inspector(s): Robert D. Zuber	Inspector's Signature:

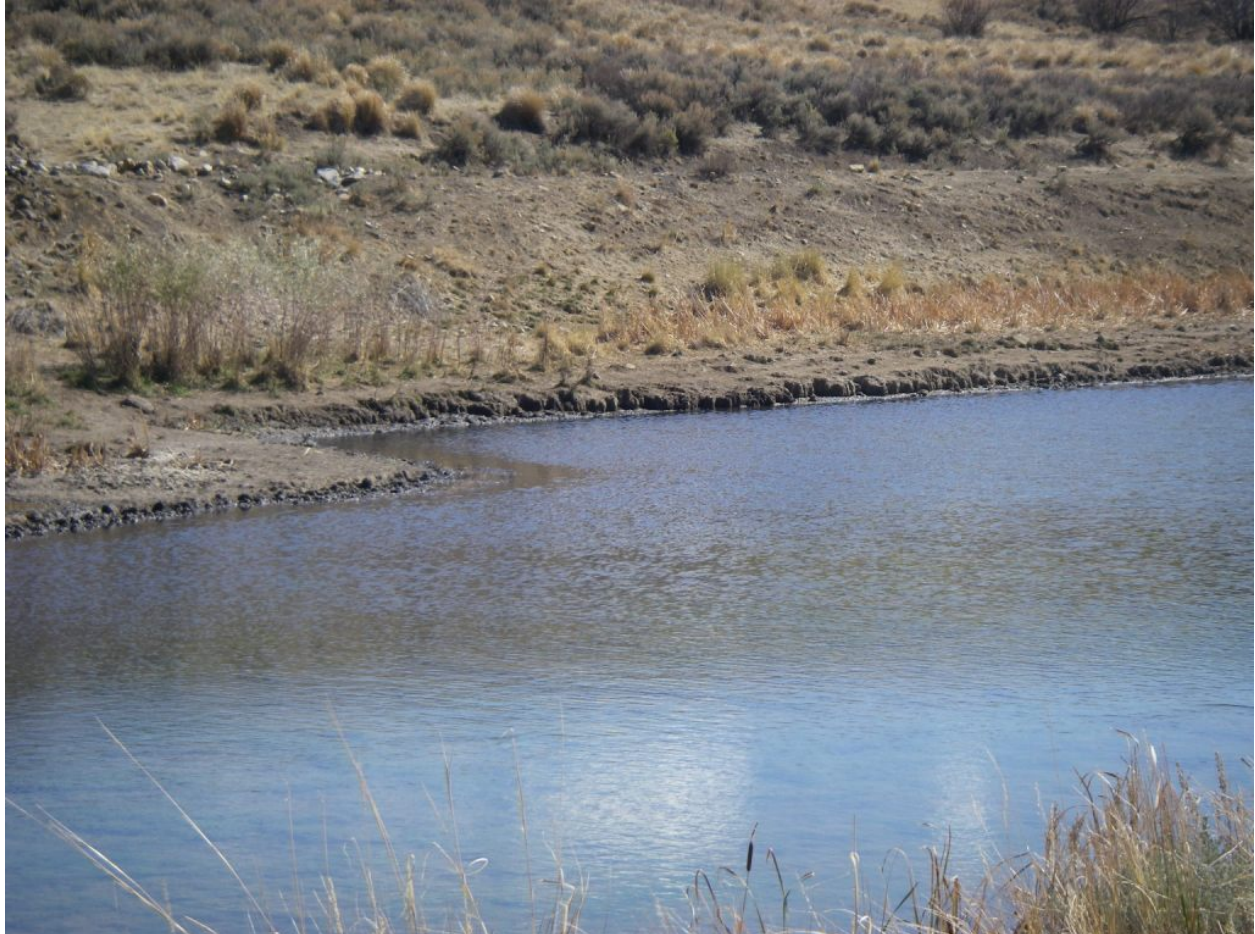
- The east bank of the Moffat Pond has been damaged, apparently by sheep.

Moffat Pond – damaged bank on east side of pond

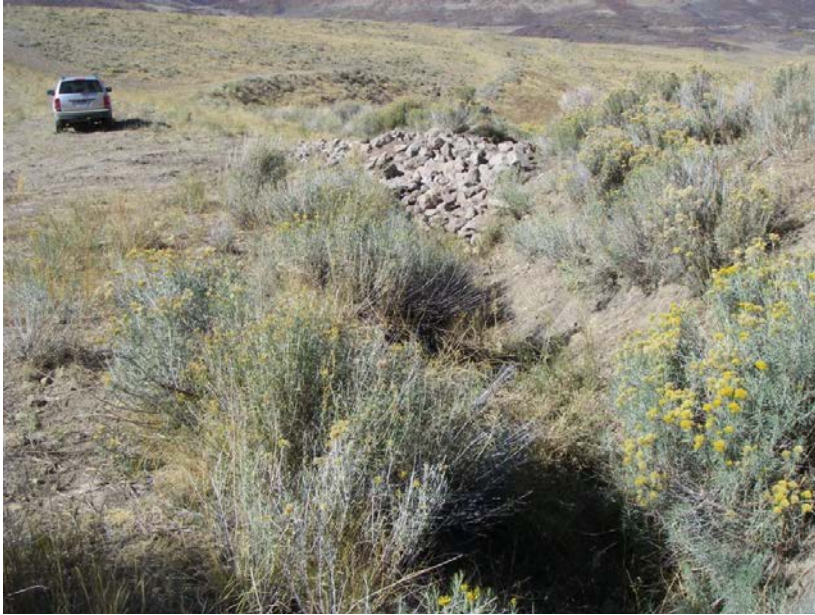
To address the gullies where the West Ridge Road crosses the West Ridge drainage (identified in September inspection report), work has been performed. A berm built out of soil and riprap has been constructed to direct the runoff away from the larger gully (east side of drainage) and into the primary ditch that continues to the west side of the drainage. This ditch is along an apparent old road and is the upper end of the ditch where the second gully was observed during the September inspection. The gullies themselves have not been repaired.

West Ridge Road – repair of roadside ditch above West Ridge drainage

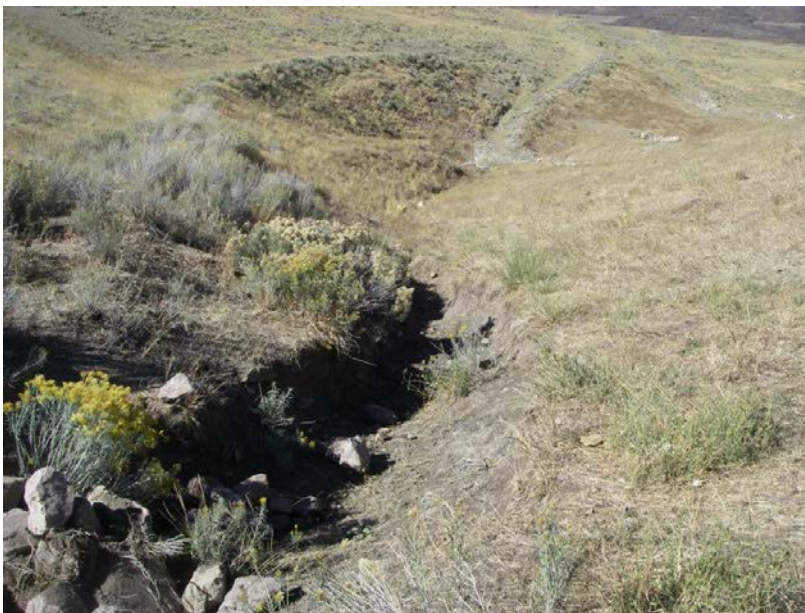
The area of the smaller gully is on a large bend where the ditch/gully turns almost full circle with a radius of approximately 20 feet. This area should be watched, at the least. It may need to be enlarged and or armored to prevent further erosion.

Gully below West Ridge Road – has not yet been repaired

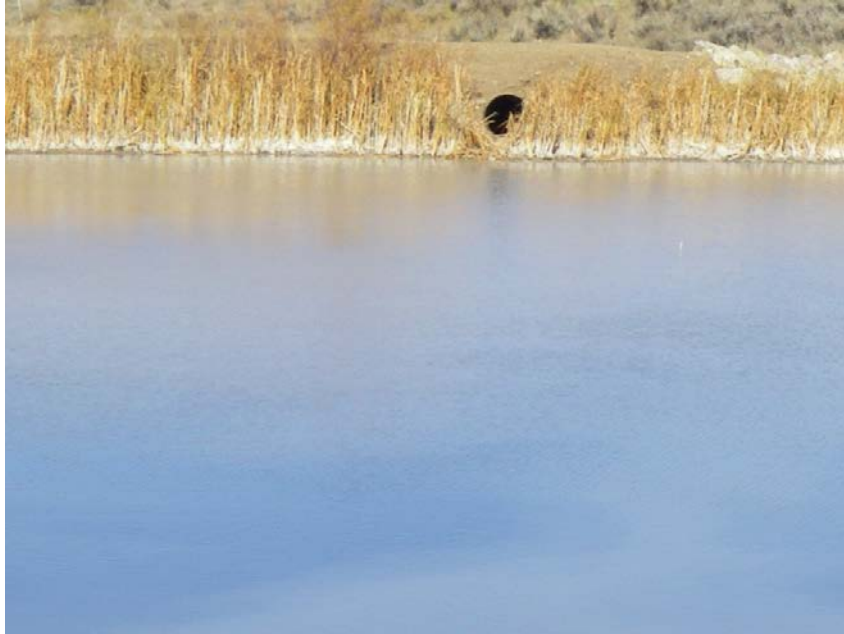
The pipe in the primary spillway at the West Ridge Pond has been replaced. The new one is a 42-inch corrugated plastic pipe, and the water elevation was 1-2 feet below the invert. There is no silt fence, wattle or other sediment control BMP below the construction area, but there is no evidence of sediment from the construction area down the channel that receives discharge. Also, there is little chance of sediment being transported off site due to the large amount of vegetation in the channel. Furthermore, there is another pond between the embankment of West Ridge Pond and Trout Creek, and this other pond would easily capture any sediment that is eroded from the area where the pipe was replaced. Equipment accessed the pond from the northeast.

West Ridge Pond – new pipe in primary spillway

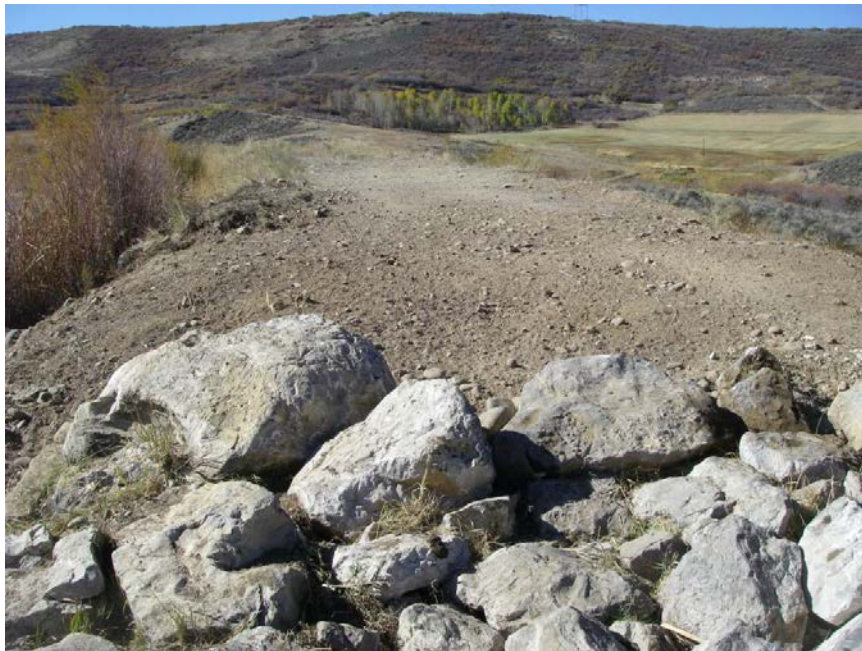
West Ridge Pond construction area

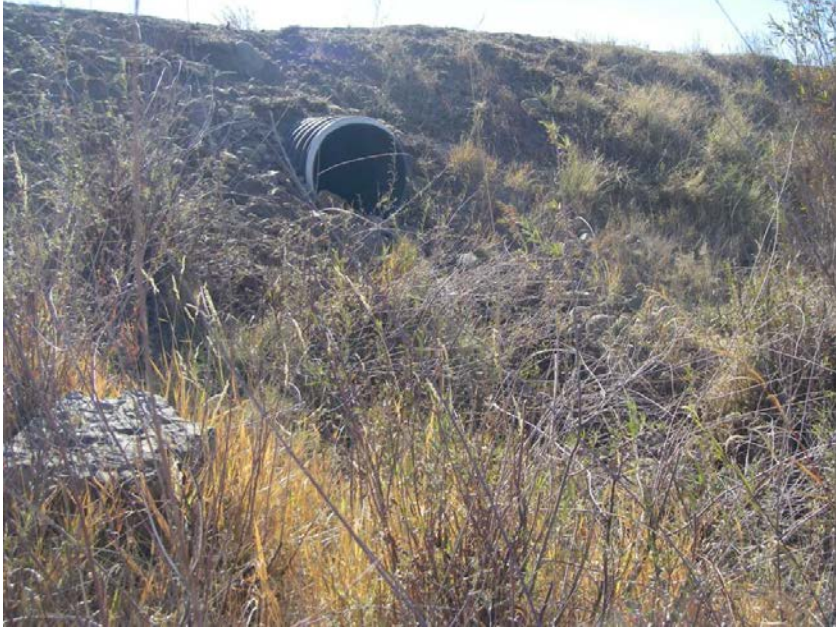
West Ridge Pond – new pipe in primary spillway (corrugated plastic, 42” dia)

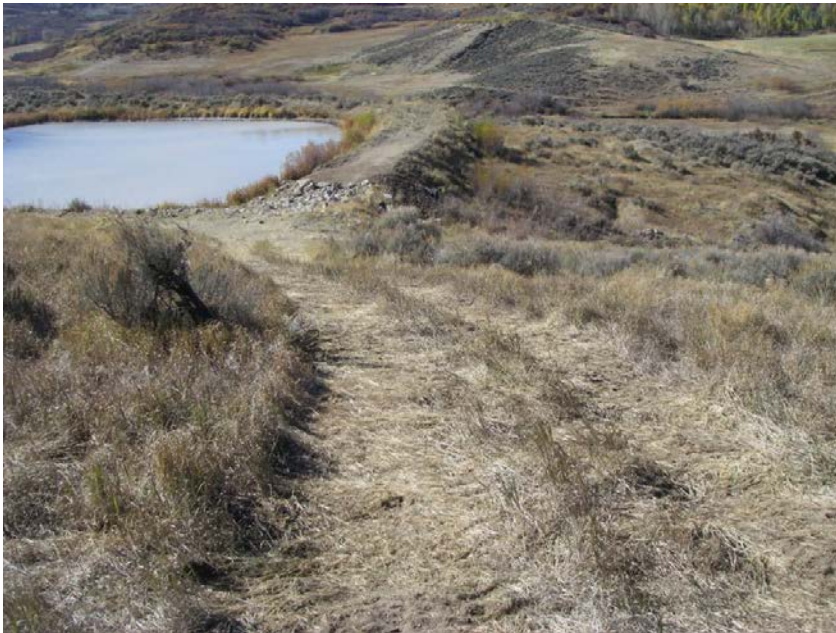
West Ridge Pond – access to primary spillway construction
