COLORADO DIVISION OF RECLAMATION, MINING AND SAFETY COAL PROGRAM INSPECTION REPORT

| Permit Number: C-1981-019 Mine Name: Colowyo Coal Mine Operator: Colowyo Coal Company L.P. Operator Address: Mr. Tony Tennyson 5731 State Highway 13 Meeker, CO 81641 | County: Moffat, Rio Blanco Operation Type: Surface Permit Status: Active Ownership: Federal |

| Inspection Start Date: October 10, 2012 Inspection Start Time: 07:45 Inspection End Date: Inspection End Time: | Inspection Type: Coal Partial Inspection Inspection Reason: Normal I&E Program Weather: Clear |

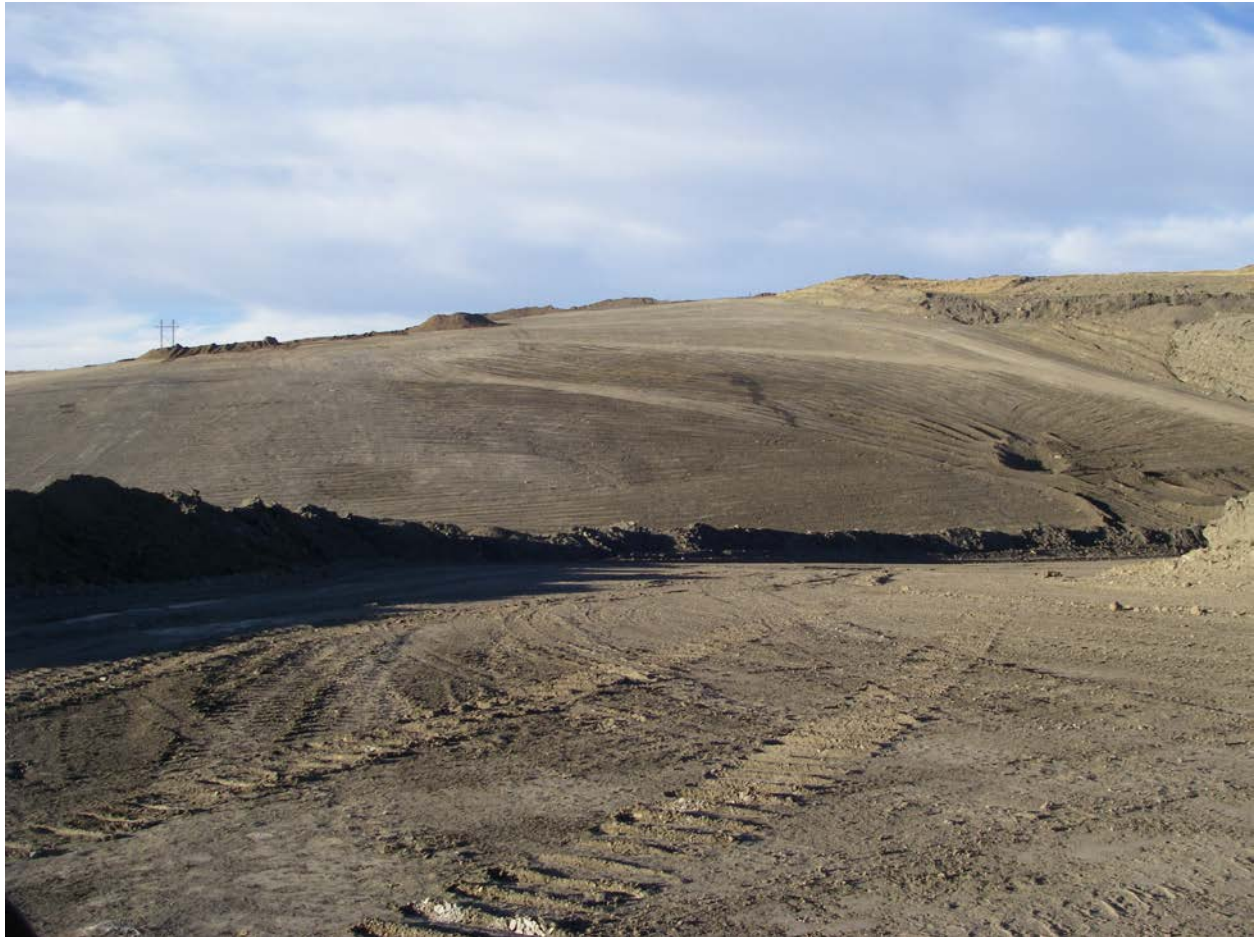
In the East Pit (EP056 and EP051), equipment was completing the grading of the north facing slope.

East Pit Reclamation (hole was filled by dozer minutes after photo was taken)

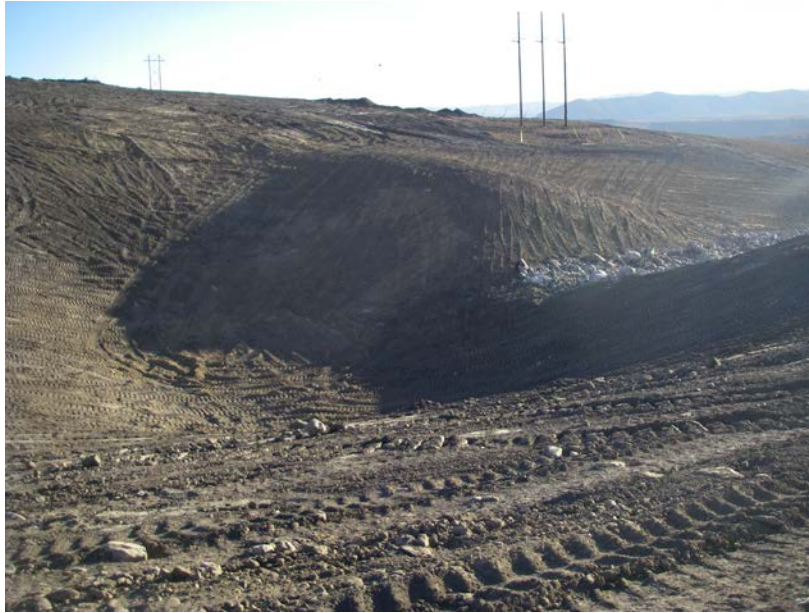
The EP2 Pond has been excavated, and rocks will be added in the near future per Tony Tennyson. The channel below the pond has been constructed.

EP2 Pond – after excavation and before final rock placement

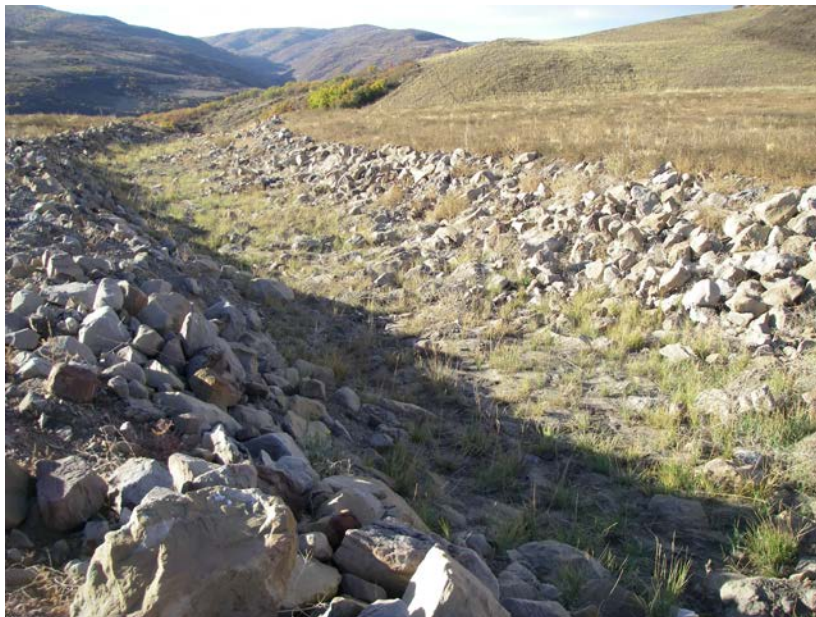
The reach of the NTEP Ditch below NTEP1 Pond was inspected as part of the follow-up for SL-06. The reach in question contains significant riprap (D50 of approximately 12 inches) in some locations and is vegetated in areas where the riprap is sparse. Below the reach that was targeted for inspection the riprap coverage is very good.

NTEP Ditch – area where additional rock may be needed (pending review of SEDCAD)

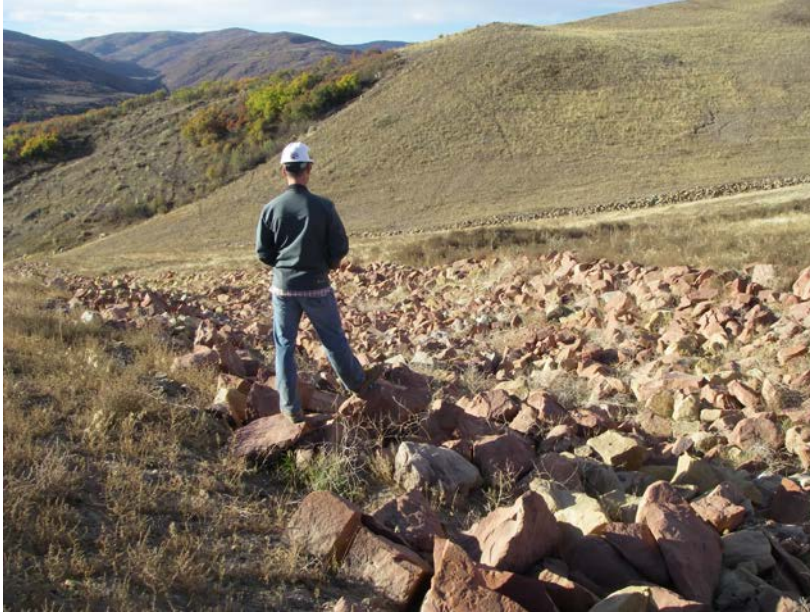
NTEP Ditch – area where riprap coverage is good (below previous photo)

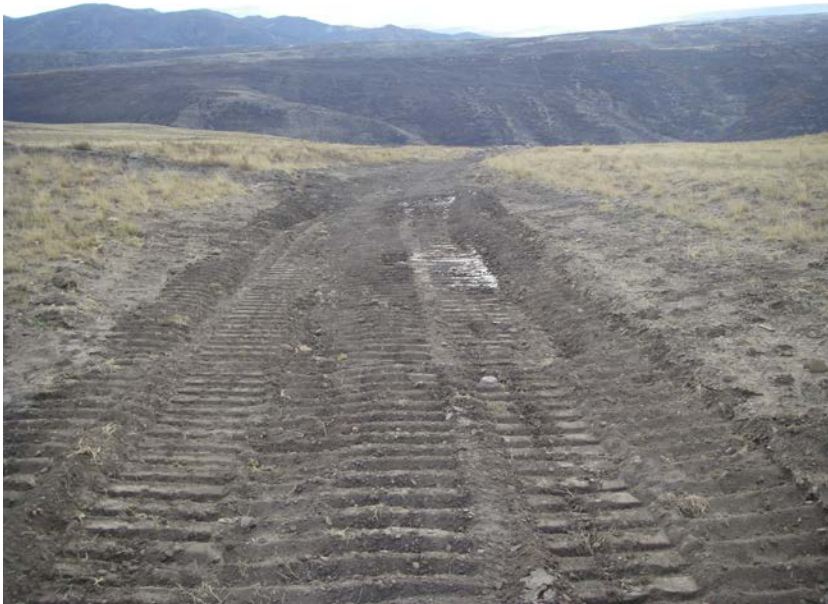
ditch was graded and erosion matting and straw booms (aka wattles) were placed in the channel. Generally dimensions: 12-foot bottom, flat slopes, and a depth of 3 feet. Seeding is planned for this autumn, and some vegetation is already growing. The 15 booms are approximately 30 feet long and 10 feet apart; they require maintenance as some of them were not staked down in some areas. The channel still contains large boulders and should be continually observed for erosion problems.

Prospect Ditch – recently graded reach, will be seeded in near future

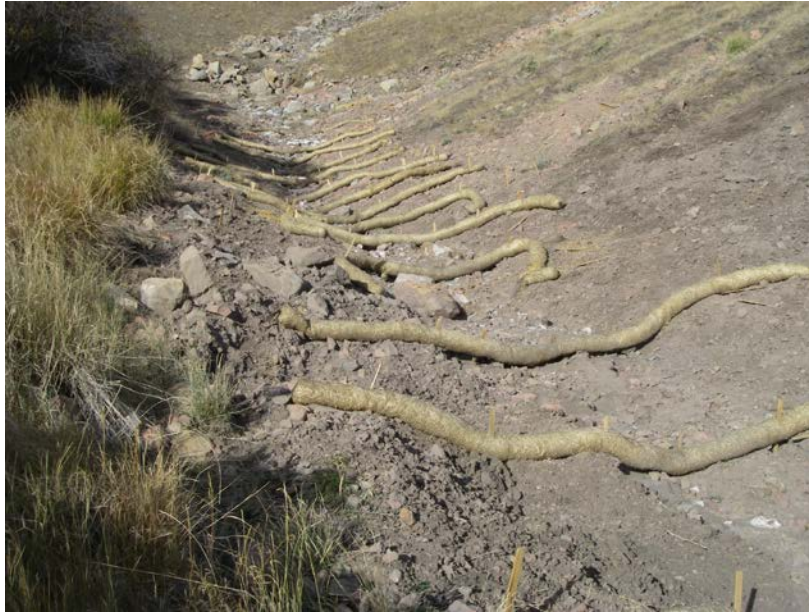
The recent maintenance in Prospect Ditch was closely inspected and no significant problems were observed. The

Prospect Ditch – reach where recent maintenance has been performed

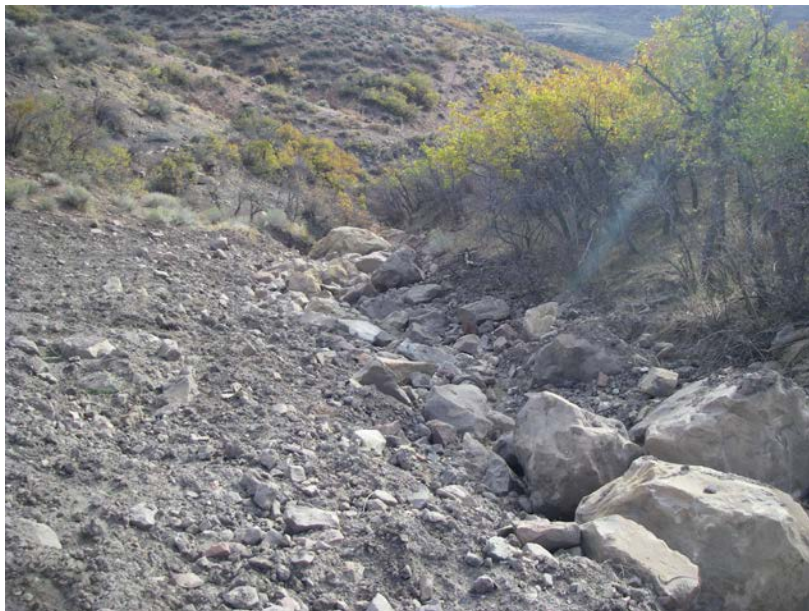
Prospect Ditch – large boulders where recent maintenance has been performed

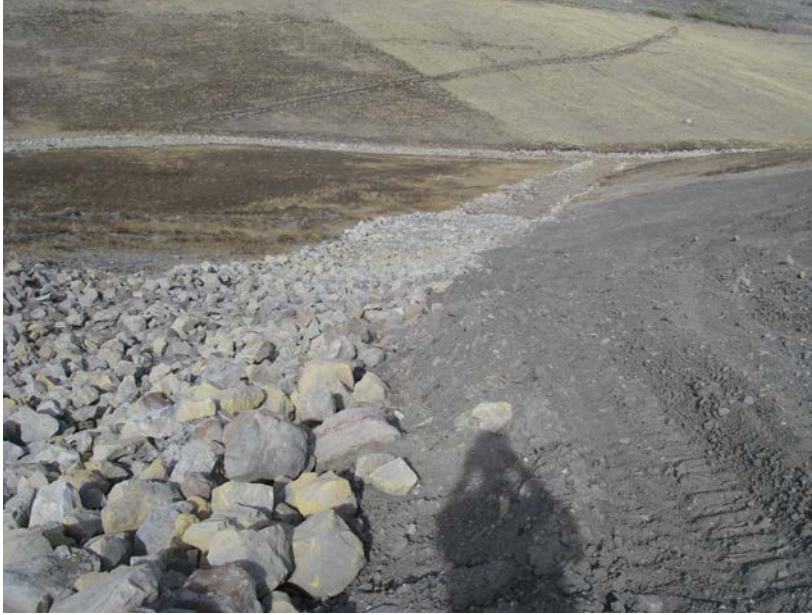
Taylor Ditch was inspected as part of the follow-up for SL-06. At the upper end of the ditch, riprap looks good as the rock has been broken and spread across the channel. No maintenance was performed near the bottom of the channel; per Tony Tennyson, the SEDCAD for this reach has been altered.

Taylor Ditch – reach where recent maintenance has been performed

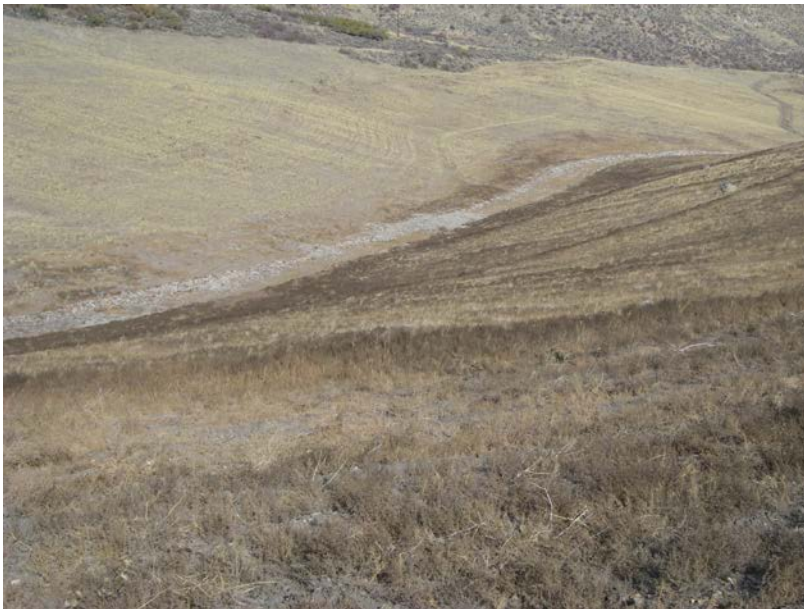
Taylor Tributary Ditch was inspected as part of the follow-up for SL-06 and appears to be stable. The channel contains riprap and well established vegetation.

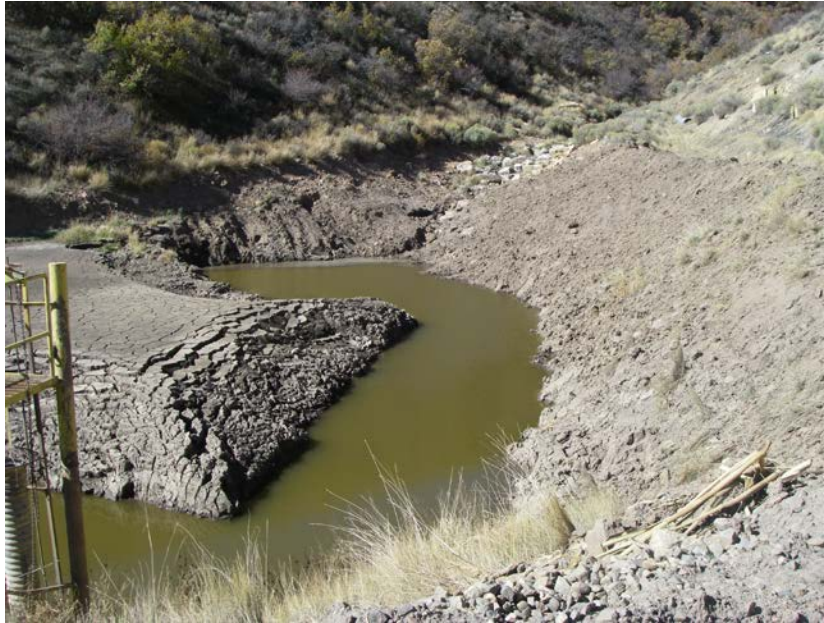
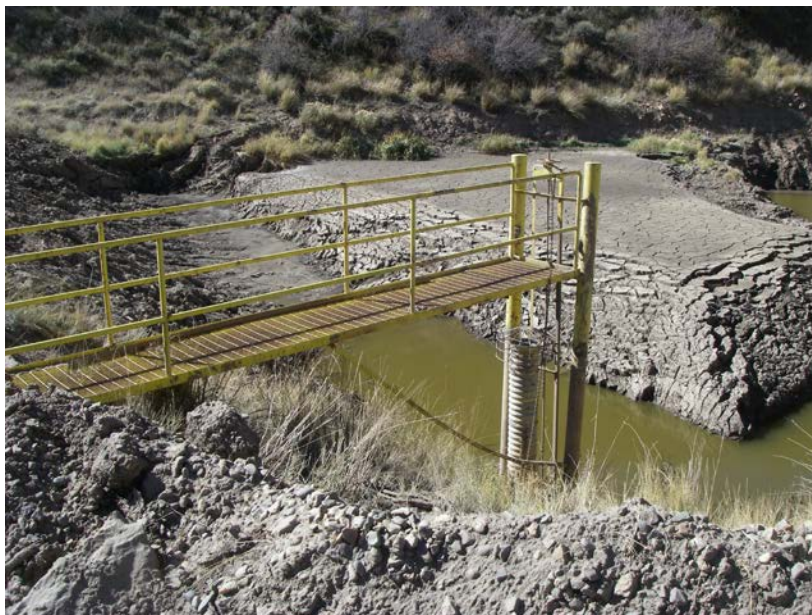
Prospect Pond – recent cleaning of pond (more may be needed)

- Below the flume at Stoker Siding, cattails have been removed.
- Prospect Pond requires more cleaning and should be surveyed. The embankment needs to be seeded (this is planned for the autumn of 2012).
