**COLORADO DIVISION OF RECLAMATION, MINING AND SAFETY**  
**MINERALS PROGRAM INSPECTION REPORT**  
**PHONE: (303) 866-3567**

| <b>MINE NAME:</b><br>SM-18 Mine | <b>MINE/PROSPECTING ID#:</b><br>M-1978-116 | <b>MINERAL:</b><br>Uranium and vanadium | <b>COUNTY:</b><br>Montrose |
| <b>INSPECTION TYPE:</b><br>Monitoring | <b>INSPECTOR(S):</b><br>Dustin Czapla, Russ Means | <b>INSP. DATE:</b><br>October 2, 2012 | <b>INSP. TIME:</b><br>09:00 |

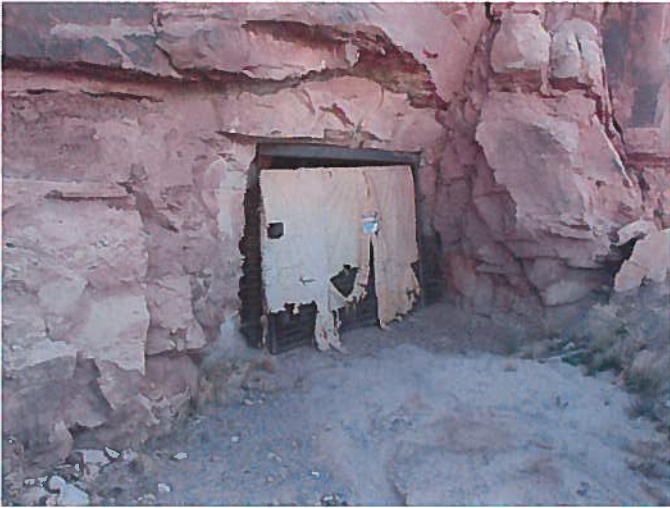
Figure 1: Wright Portal.

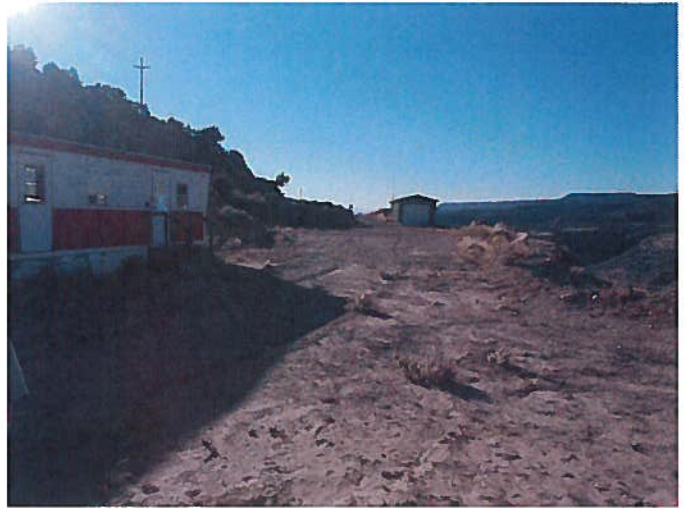
The south portion of the affected area consists of the Wright Portal, an operations area, sediment control structures, and ore and waste pile areas. There is an office building, compressor building, and fuel storage located in this area. The fuel tank was empty during this inspection.

Figure 2: Operation area located above the Wright Portal. Office building in the foreground, compressor building in the distance.

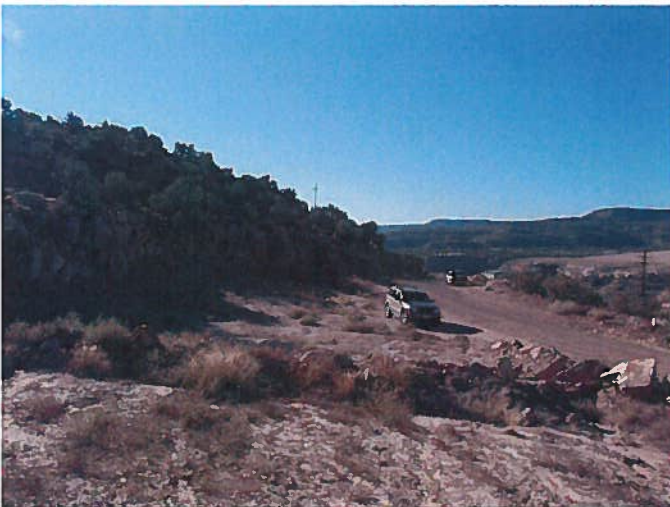
Figure 3: View, facing southeast, toward the proposed ore stockpile area.

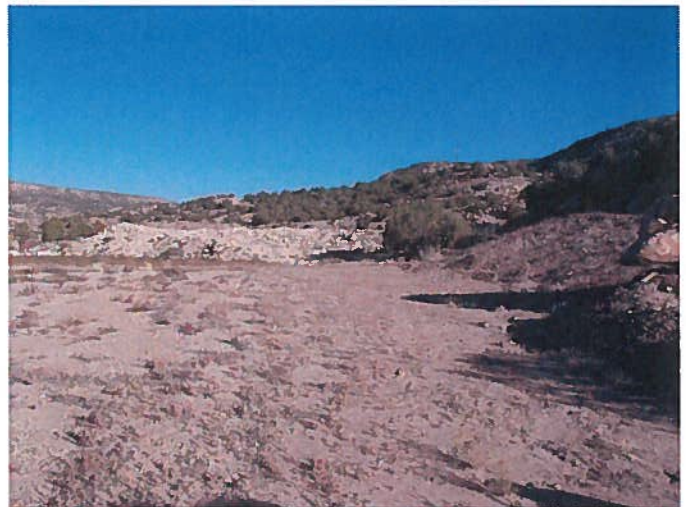
Figure 4: View, facing northwest, toward the waste dump area.

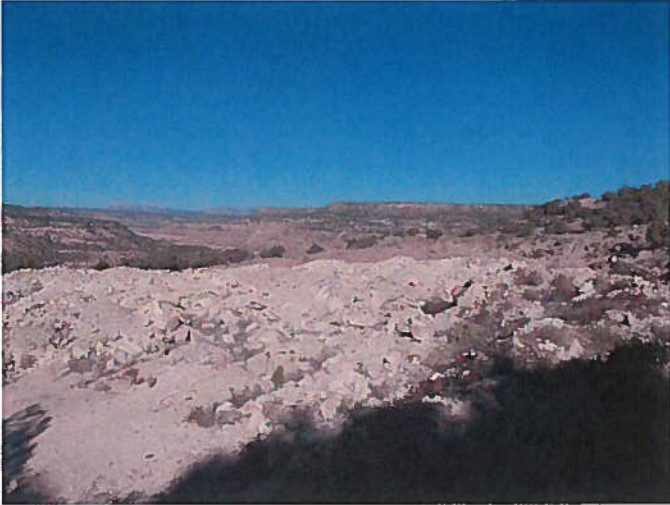
Figure 5: Waste dump area north of the ore stockpile area.

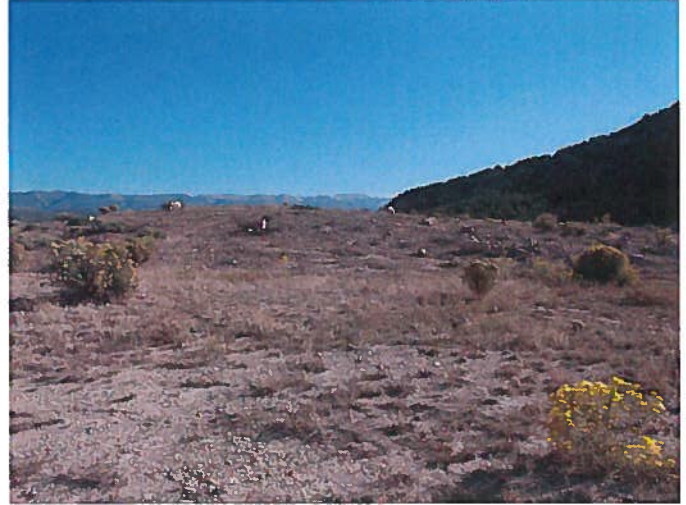
The north portion of the affected area, on the north side of Spring Creek Mesa, consists of the old reclaimed portal and mine area. Reclamation grading has been completed in this area and vegetation is becoming well established. A mine building is located in this area that is to remain as part of the approved reclamation plan. All reclaimed slopes in this area appeared stable.

Figure 6: Reclaimed waste pile area on the north side of Spring Creek Mesa.

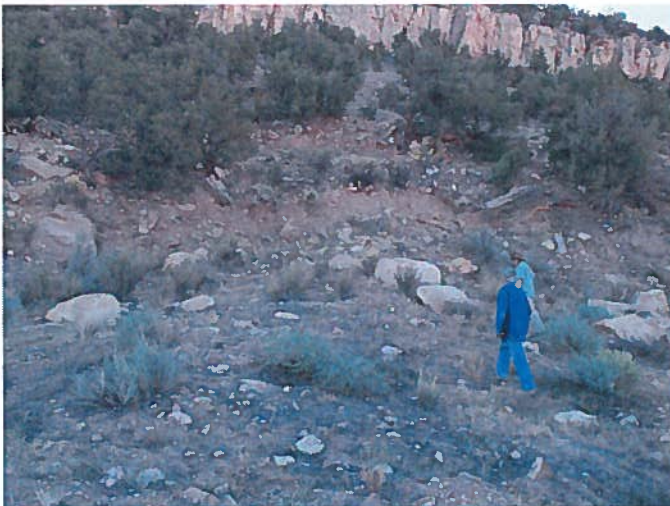
Figure 7: Reclaimed portal area on the north side of Spring Creek Mesa.

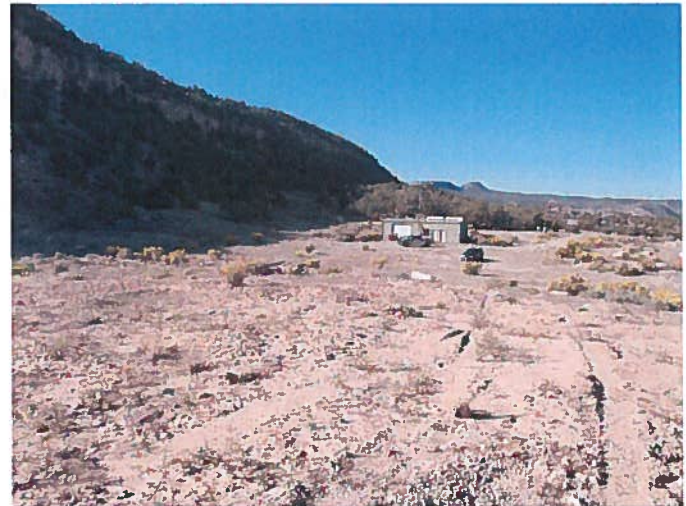
Figure 8: View from reclaimed waste pile area on the north side of Spring Creek Mesa, toward the existing mine building.
