COLORADO DIVISION OF RECLAMATION, MINING AND SAFETY MINERALS PROGRAM INSPECTION REPORT

MINE NAME: CM-25 Mine	MINE/PROSPECTING ID#: M-1977-307	MINERAL: Uranium and vanadium	COUNTY: Montrose
INSPECTION TYPE: Monitoring	INSPECTOR(S): Dustin Czapla, Russ Means	INSP. DATE: October 2, 2012	INSP. TIME: 10:00
OPERATOR: Cotter Corporation	OPERATOR REPRESENTATIVE: Glen Williams	TYPE OF OPERATION: 110d - Designated Limited Impact

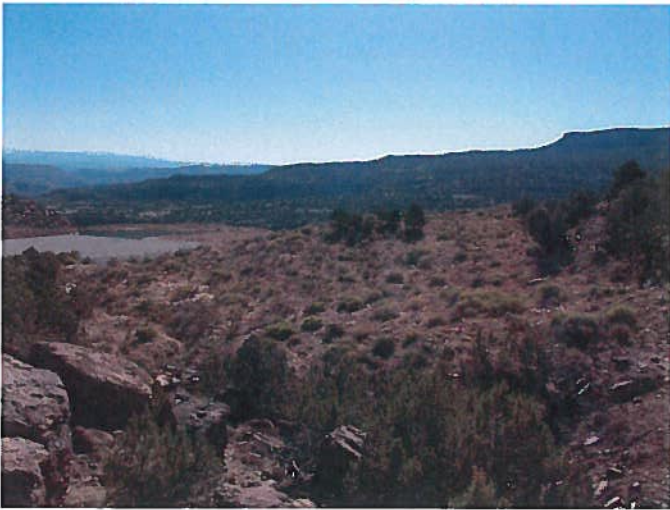
Figure 1: Looking south across affected area.

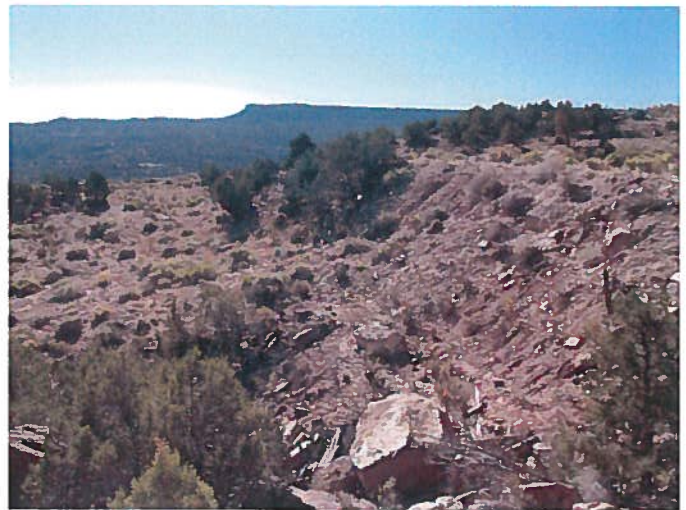
Figure 2: Looking south across affected area.

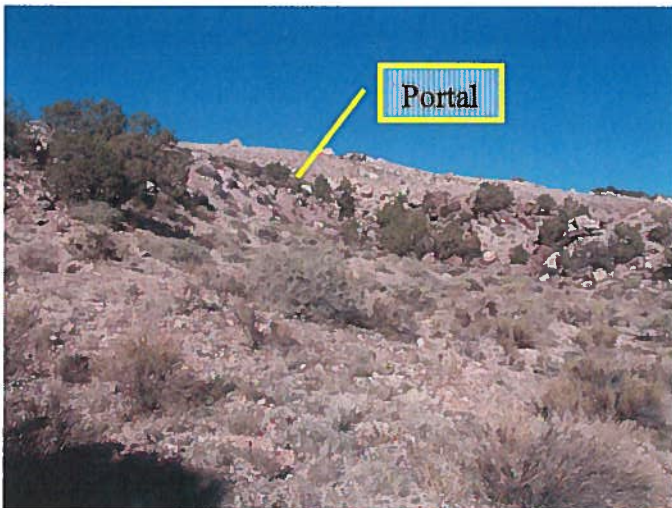
Figure 3: View, facing north, towards the reclaimed portal area.

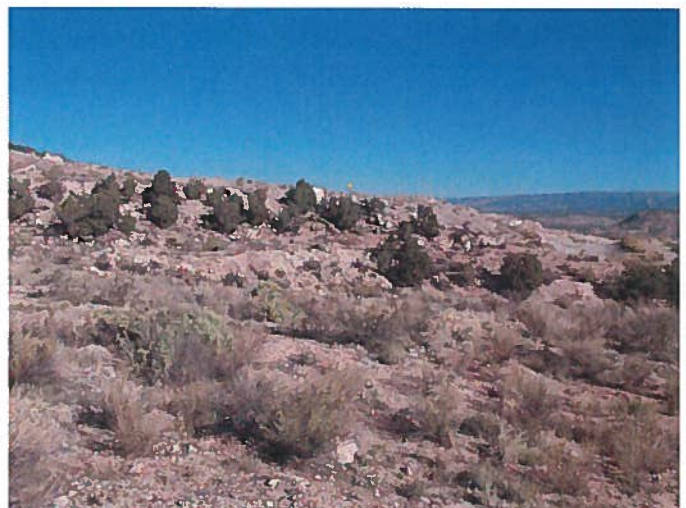
Figure 4: Looking north across the affected area.
