COLORADO DIVISION OF RECLAMATION, MINING AND SAFETY
MINERALS PROGRAM INSPECTION REPORT
PHONE: (303) 866-3567

MINE NAME: C-LP-21 Mine	MINE/PROSPECTING ID#: M-1977-305	MINERAL: Uranium and vanadium	COUNTY: Montrose
INSPECTION TYPE: Monitoring	INSPECTOR(S): Dustin Czapla, Russ Means	INSP. DATE: October 2, 2012	INSP. TIME: 11:00
OPERATOR: Cotter Corporation	OPERATOR REPRESENTATIVE: Glen Williams	TYPE OF OPERATION: 112d-1 - Designated Mining Operation

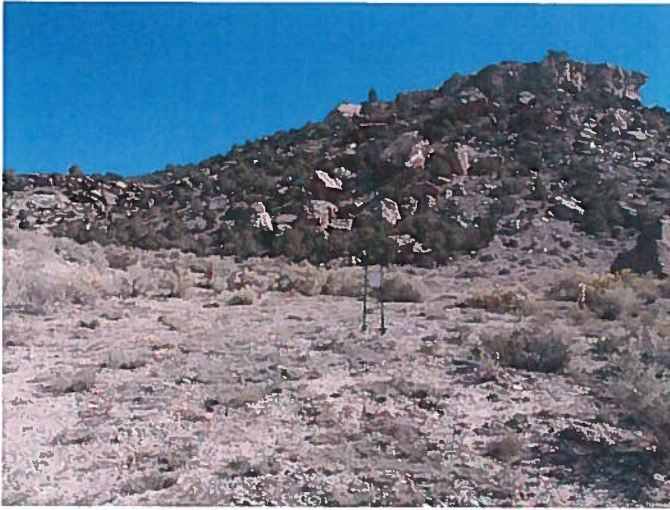
Figure 1: View, facing east, toward the reclaimed portal.

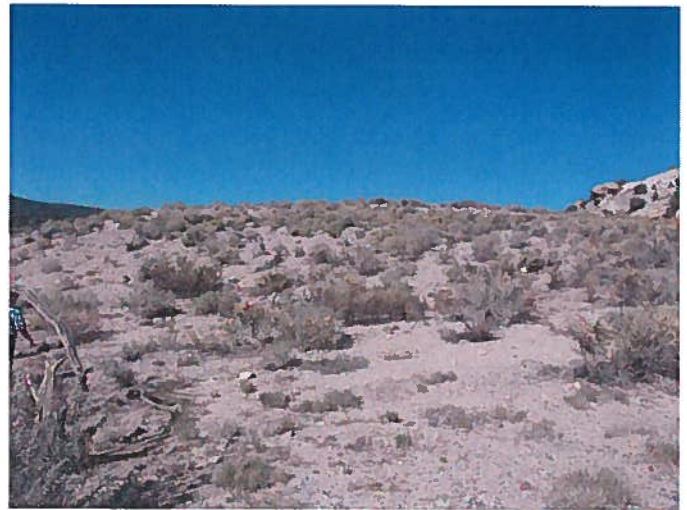
All reclaimed slopes at the site appeared stable. The waste rock pile had been pocked and seeded. Vegetation was well established over the reclaimed areas.

Figure 2: View of the reclaimed waste rock pile.
