**COLORADO DIVISION OF RECLAMATION, MINING AND SAFETY
MINERALS PROGRAM INSPECTION REPORT
PHONE: (303) 866-3567**

MINE NAME: JD-9 Mine	MINE/PROSPECTING ID#: M-1977-306	MINERAL: Uranium and vanadium	COUNTY: Montrose
INSPECTION TYPE: Monitoring	INSPECTOR(S): Dustin M. Czapla	INSP. DATE: October 2, 2012	INSP. TIME: 12:00
OPERATOR: Cotter Corporation	OPERATOR REPRESENTATIVE: Glen Williams	TYPE OF OPERATION: 112d-1 - Designated Mining Operation

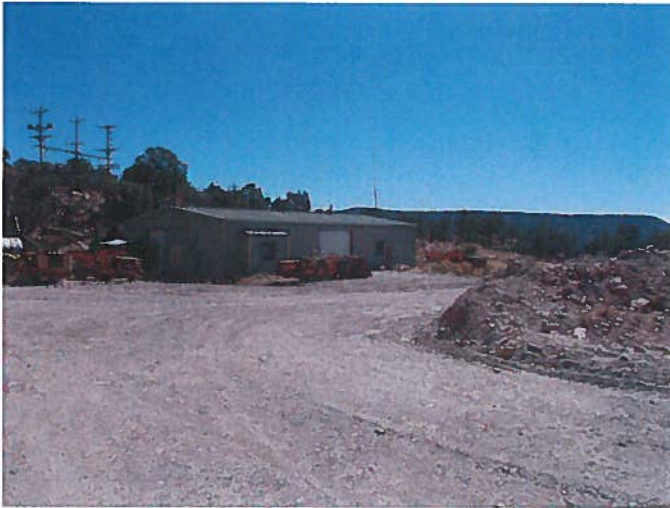
Only the Bull Canyon area was visited during this inspection. There is a mine building located on the main mine bench area. Several pieces of dilapidated equipment and refuse were observed around the building.

Figure 1: Building located on mine bench in Bull Canyon area.

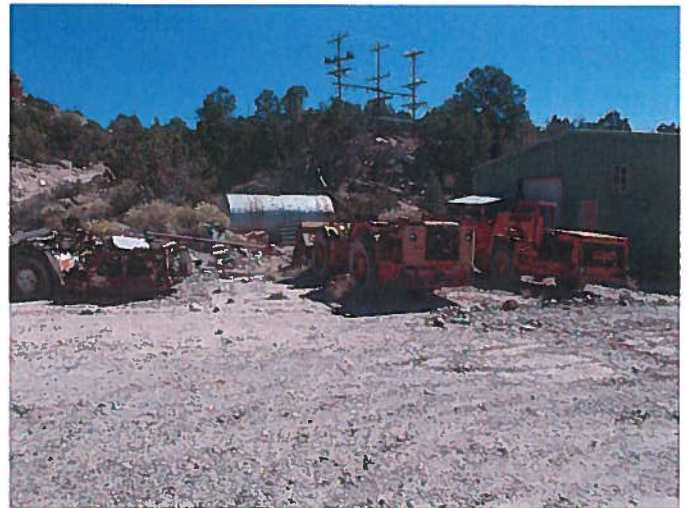
Figure 2: Dilapidated equipment and refuse located around building.

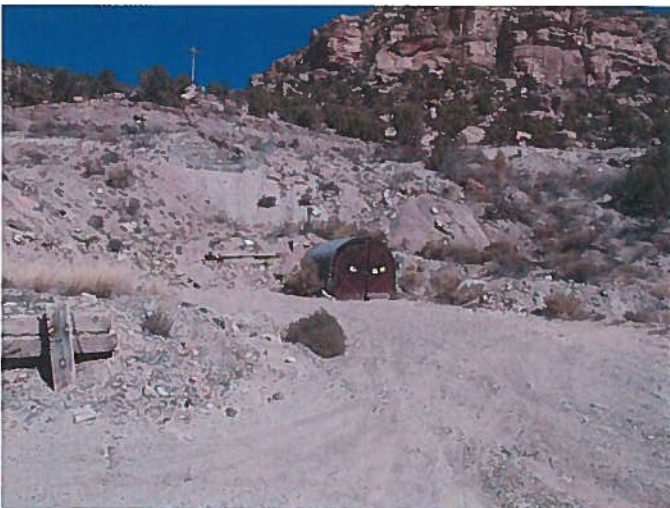
The portal in this area collapsed years ago and has not yet been reopened.

Figure 3: Collapsed JD-9 portal.

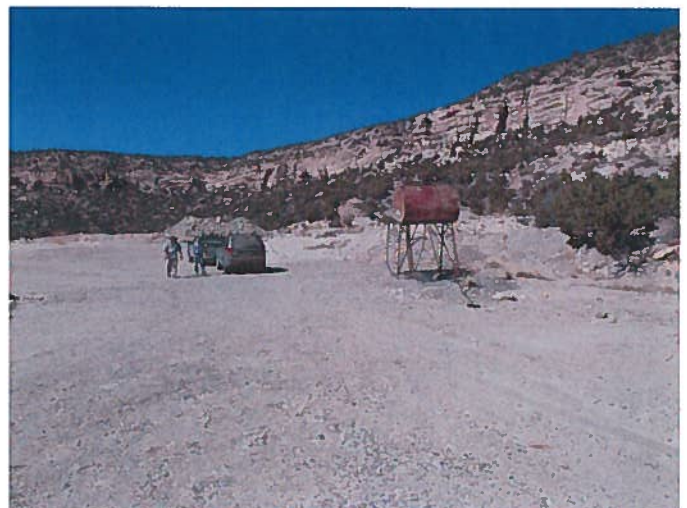
An empty fuel tank was observed on the mine bench. This tank was placed in a lined containment area, but with insufficient volume to contain 110% of the tanks capacity. Should this fuel tank be used in the future, the containment area must be enlarged.

Figure 4: Fuel storage on mine bench.

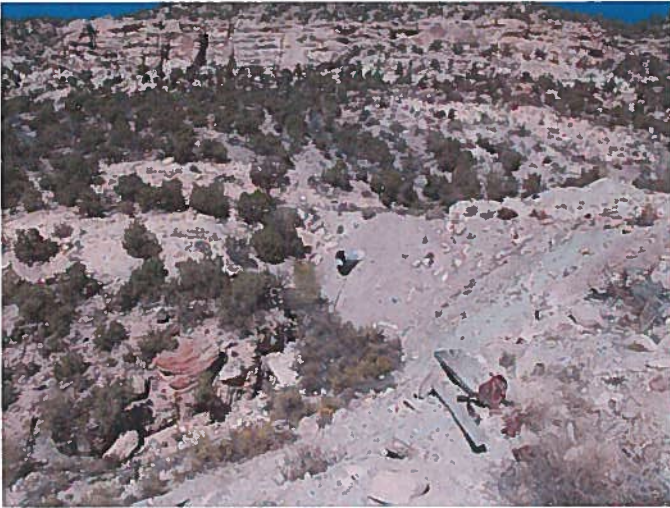
Figure 5: View of drainage on the west side of the mine bench.

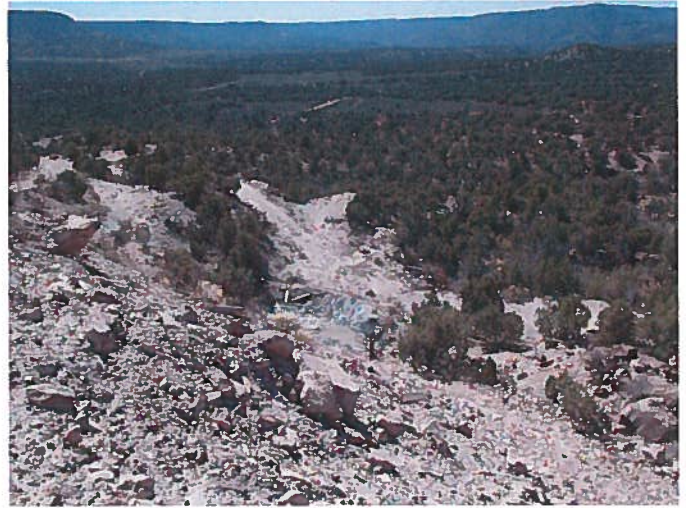
Figure 6: View of drainage on the west side of the mine bench.
