**COLORADO DIVISION OF RECLAMATION, MINING AND SAFETY  
MINERALS PROGRAM INSPECTION REPORT  
PHONE: (303) 866-3567**

<b>MINE NAME:</b> C-JD-8	<b>MINE/PROSPECTING ID#:</b> M-1984-014	<b>MINERAL:</b> Uranium and vanadium	<b>COUNTY:</b> Montrose
<b>INSPECTION TYPE:</b> Monitoring	<b>INSPECTOR(S):</b> Dustin Czapla, Russ Means	<b>INSP. DATE:</b> October 2, 2012	<b>INSP. TIME:</b> 12:30
<b>OPERATOR:</b> Cotter Corporation	<b>OPERATOR REPRESENTATIVE:</b> Glen Williams	<b>TYPE OF OPERATION:</b> 112d-1 - Designated Mining Operation

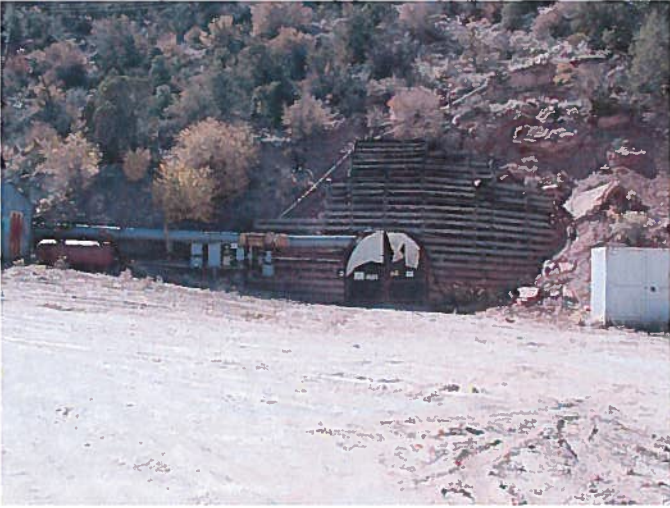
Figure 1: JD-8 portal.

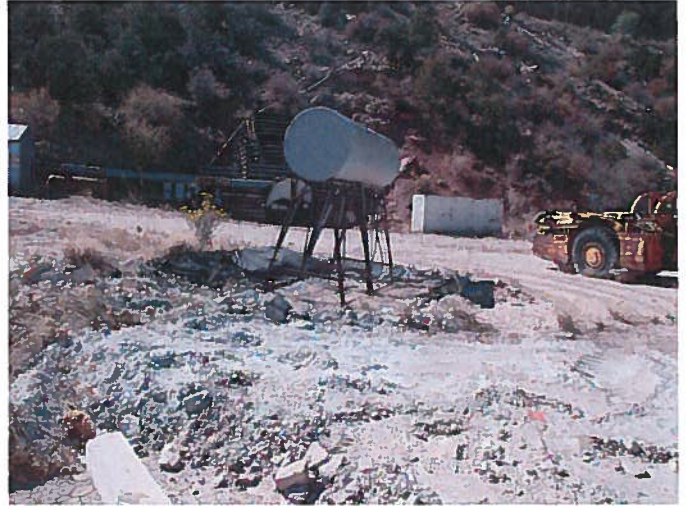
An office building, compressor building and ventilation system was in place on the main mine bench. Mining equipment was located at the site. An empty fuel tank was observed on the mine bench. This tank was placed in a lined containment area, but with insufficient volume to contain 110% of the tank's capacity. Should this fuel tank be used in the future, the containment area must be enlarged.

Figure 2: Fuel storage on site. Tank was empty during inspection. Containment will need be enlarged should fuel tank be used in future.

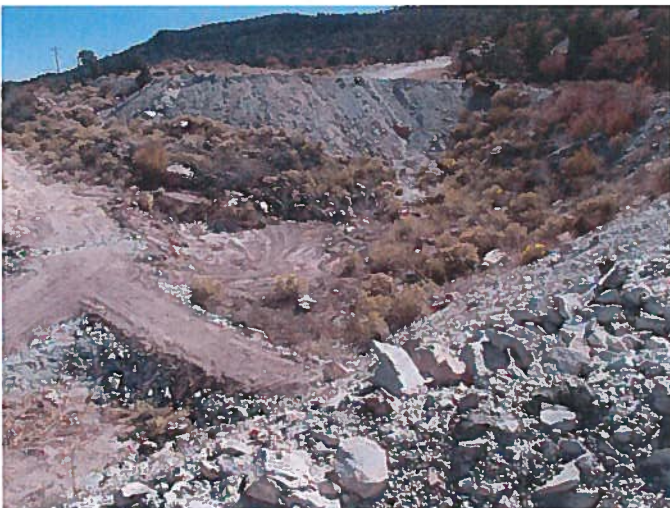
Upgrades to the site's storm water control system had been completed.

Figure 3: Stormwater retention pond constructed on northeast side of mine bench.

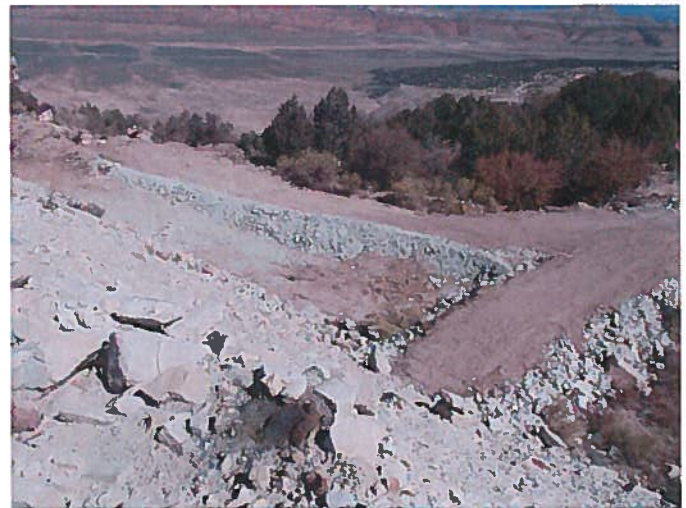
Figure 4: Stormwater retention pond constructed on northwest side of mine bench.
