COLORADO DIVISION OF RECLAMATION, MINING AND SAFETY
MINERALS PROGRAM INSPECTION REPORT
PHONE: (303) 866-3567

MINE NAME: JD-6 Mine	MINE/PROSPECTING ID#: M-1977-310	MINERAL: Uranium and vanadium	COUNTY: Montrose
INSPECTION TYPE: Monitoring	INSPECTOR(S): Dustin Czapla, Russ Means	INSP. DATE: October 2, 2012	INSP. TIME: 13:50
OPERATOR: Cotter Corporation	OPERATOR REPRESENTATIVE: Glen Williams	TYPE OF OPERATION: 110d - Designated Limited Impact

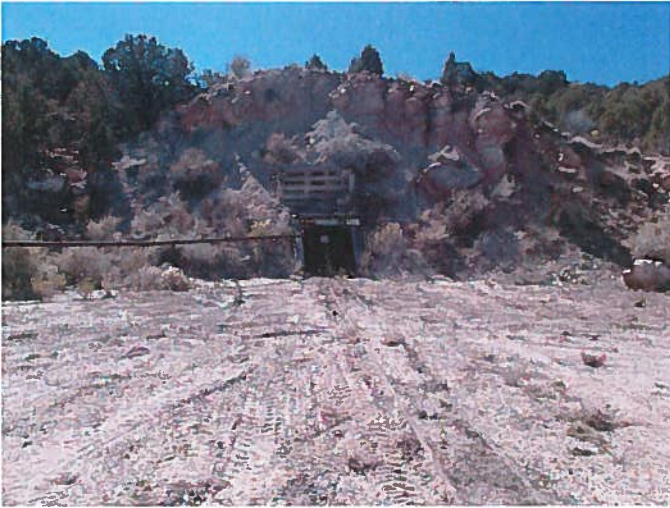
Figure 1: Access portal located on the upper mine bench.

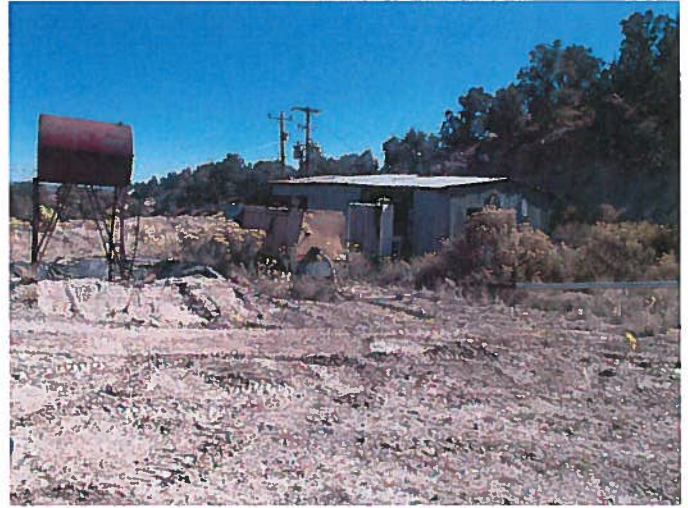
Figure 2: Generator shed located on the upper mine bench.

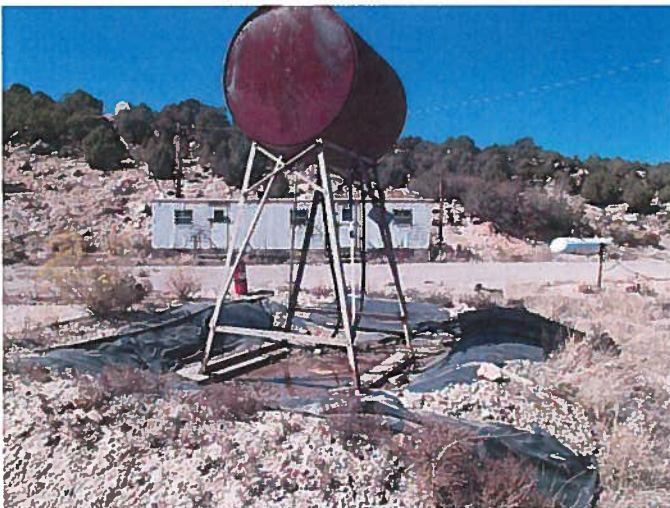
Figure 3: Fuel storage and mine building located on the upper mine bench.

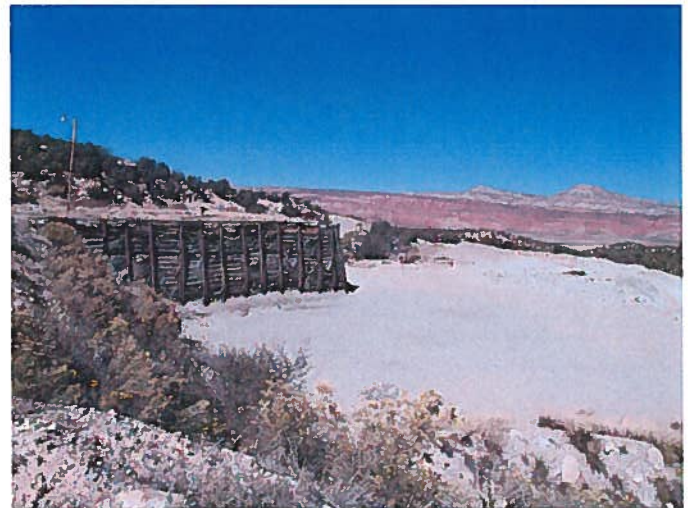
Figure 4: View of dump area from the upper mine bench.

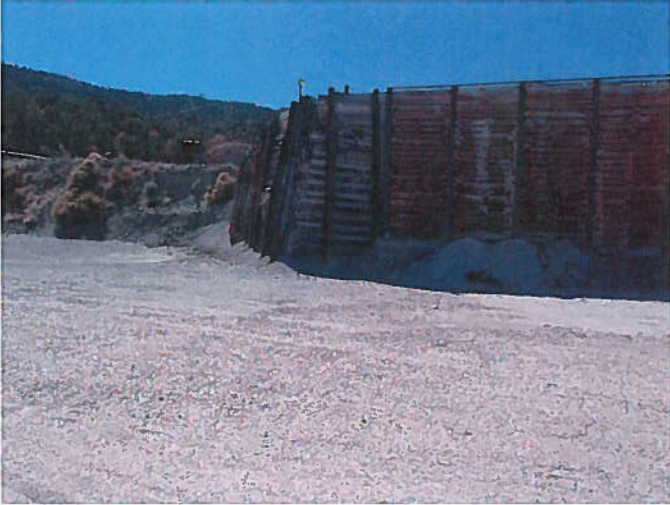
On the upper mine bench, there is a secured portal, generator shed, mine office building and other associated mining equipment. A fuel storage area is located on this bench. A retaining wall has been constructed along the north side of the mine bench, just above the dump area. The wall appeared stable during this inspection. The dump area bench has been graded flat. A berm has been placed around the perimeter of the bench in order to control stormwater. The slopes of the waste dump bench appeared to have been established at the materials angle of repose. Some evidence of erosion due to runoff was observed on the slopes of this bench. A stormwater retention pond was located at base of the northwest slope of the dump bench.

Figure 5: Retention wall constructed on the dump area bench, below the mine area bench.

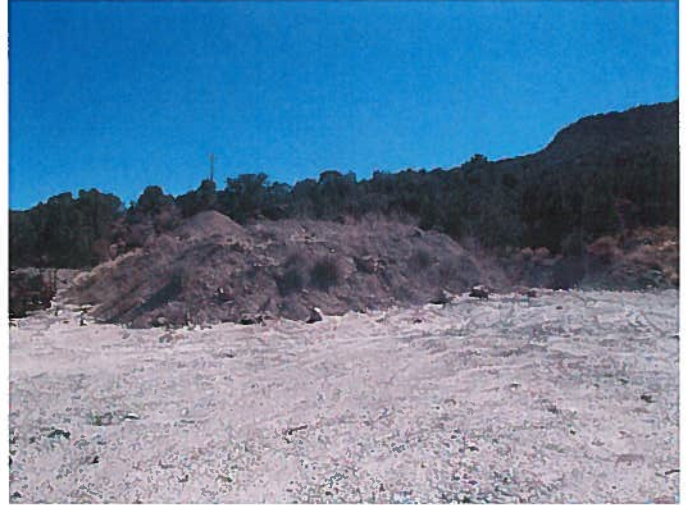
Figure 6: Topsoil stockpile located at the east end of the dump area bench.

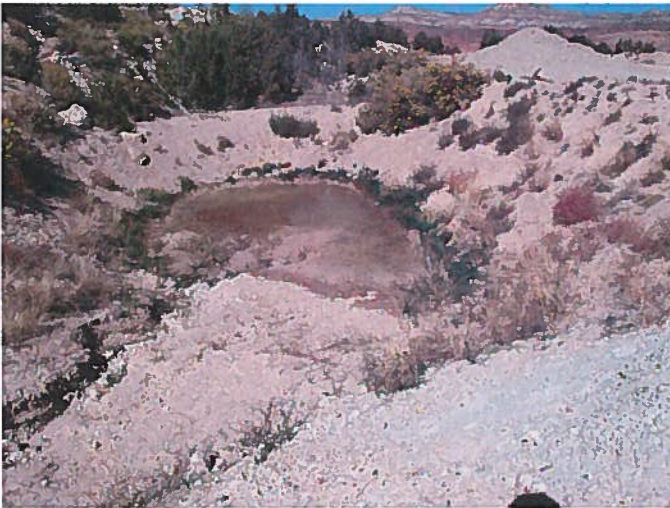
Figure 7: Stormwater retention pond at the base of the dump area bench.

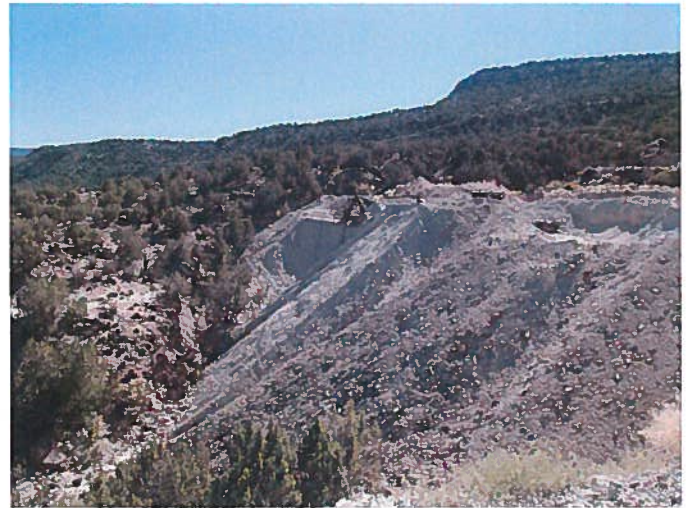
Figure 8: North slope of the dump area.
