**COLORADO DIVISION OF RECLAMATION, MINING AND SAFETY
MINERALS PROGRAM INSPECTION REPORT
PHONE: (303) 866-3567**

MINE NAME: JD-7 Pit	MINE/PROSPECTING ID#: M-1979-094-HR	MINERAL: Uranium and vanadium	COUNTY: Montrose
INSPECTION TYPE: Monitoring	INSPECTOR(S): Dustin Czapla, Russ Means	INSP. DATE: October 2, 2012	INSP. TIME: 14:30
OPERATOR: Cotter Corporation	OPERATOR REPRESENTATIVE: Glen Williams	TYPE OF OPERATION: 112d-3 - Designated Mining Operation

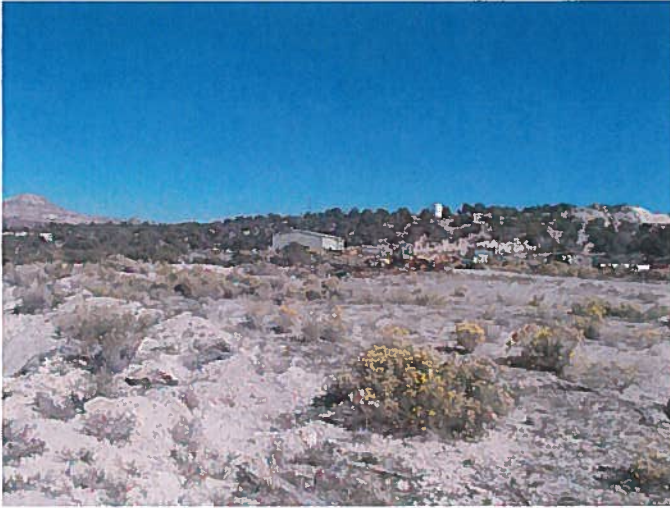
Various mine equipment and debris was noted around the area of the mine office/shop located near the JD-7 Underground portal. Settling ponds are located just west of the office area. Should the site become operational again, the integrity of the pond liners shall be addressed. Fuel storage was not noted at the site.

Figure 1: Area around mine office/shop and JD-7 Underground portal.

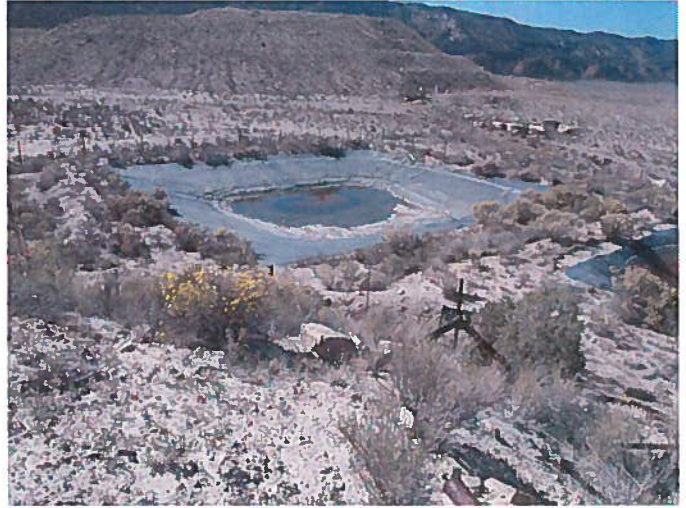
Figure 2: Upper settling pond located just west of the office/shop area.

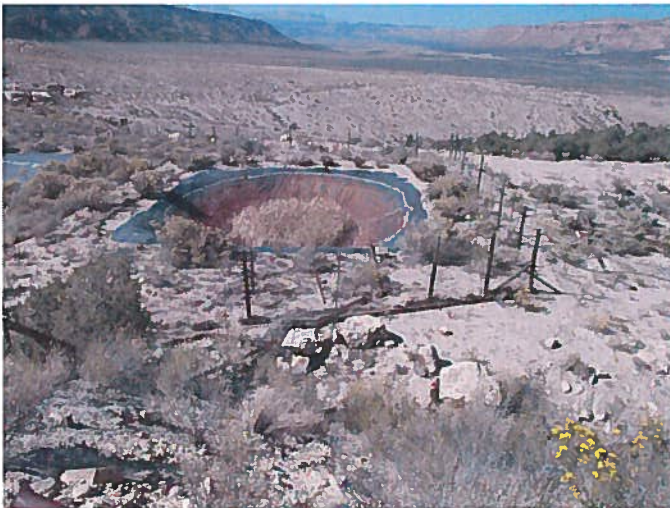
Figure 3: Middle settling pond located just west of the office/shop area.

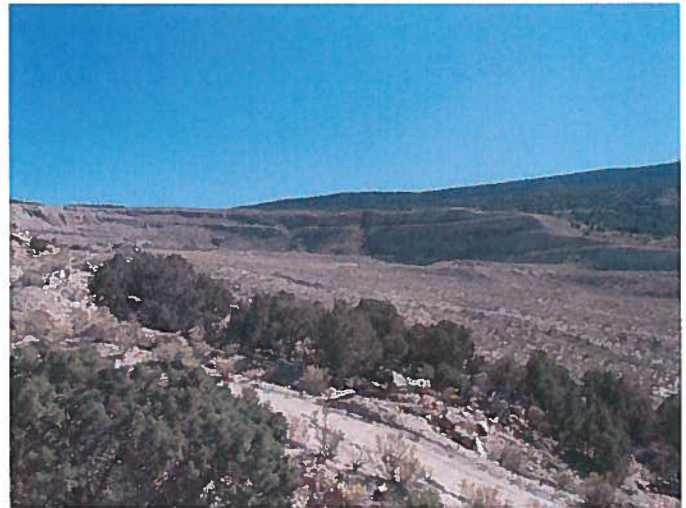
The pit floor and dump area to the west appeared to be well vegetated and stable. A benched highwall, with overall slopes approximately 1H:1V, was located on the east side of the pit. No major stability issues were noted during this inspection. Slopes at the west end of the dump area have been reclamation graded and vegetated.

Figure 4: View towards pit and highwall, from the northwest.
