## COLORADO DIVISION OF RECLAMATION, MINING AND SAFETY COAL PROGRAM INSPECTION REPORT

| <b>Permit Number:</b> C-1981-010<br><b>Mine Name:</b> Trapper Mine<br><b>Operator:</b> Trapper Mining, Inc.<br><b>Operator Address:</b><br>Mr Forrest V Luke<br>P.O. Box 187<br>Craig, CO 81626 | <b>County:</b> Moffat<br><b>Operation Type:</b> Surface<br><b>Permit Status:</b> Active<br><b>Ownership:</b> Federal |

| <b>Inspection Start Date:</b> October 2, 2012<br><b>Inspection Start Time:</b> 14:00<br><b>Inspection End Date:</b> October 2, 2012<br><b>Inspection End Time:</b> 14:30 | | <b>Inspection Type:</b> Aerial Inspection<br><b>Inspection Reason:</b> Normal I&E Program<br><b>Weather:</b> Clear | |

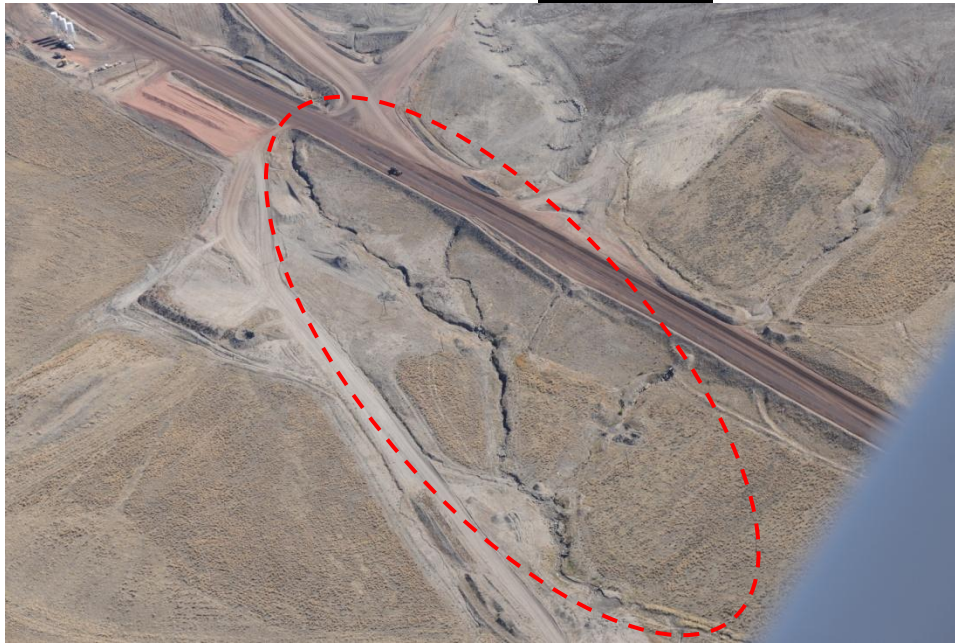
The East Pyeatt re-established drainage north of the life of mine road appears eroded and incised in these photographs. The Division is working with Trapper on future stabilization plans for this drainage and others at the site.

East Pyeatt re-established drainage north of life of mine road near Parcels A-B-98 and A-B-96. Channel appears incised.

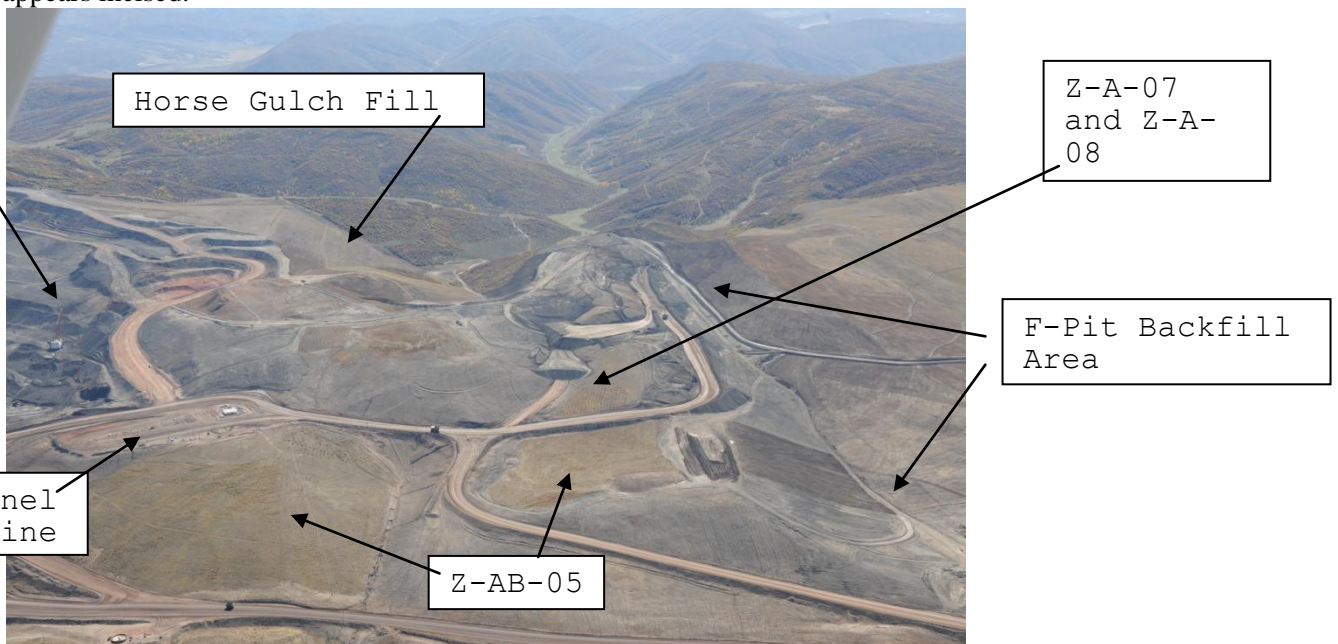
From north looking south.

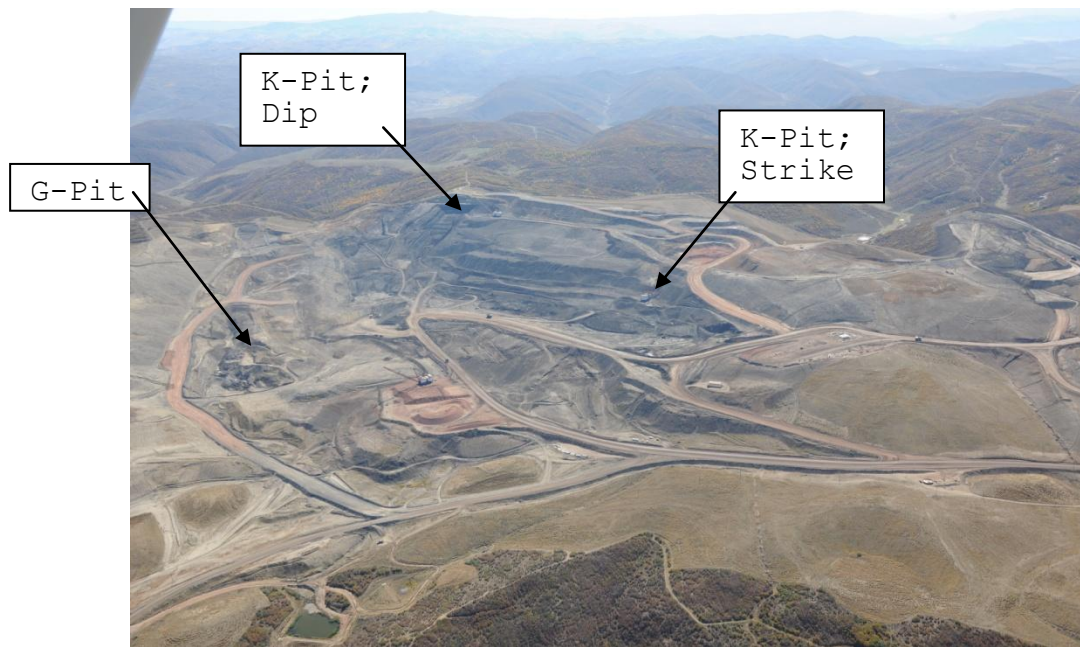
From north looking south.

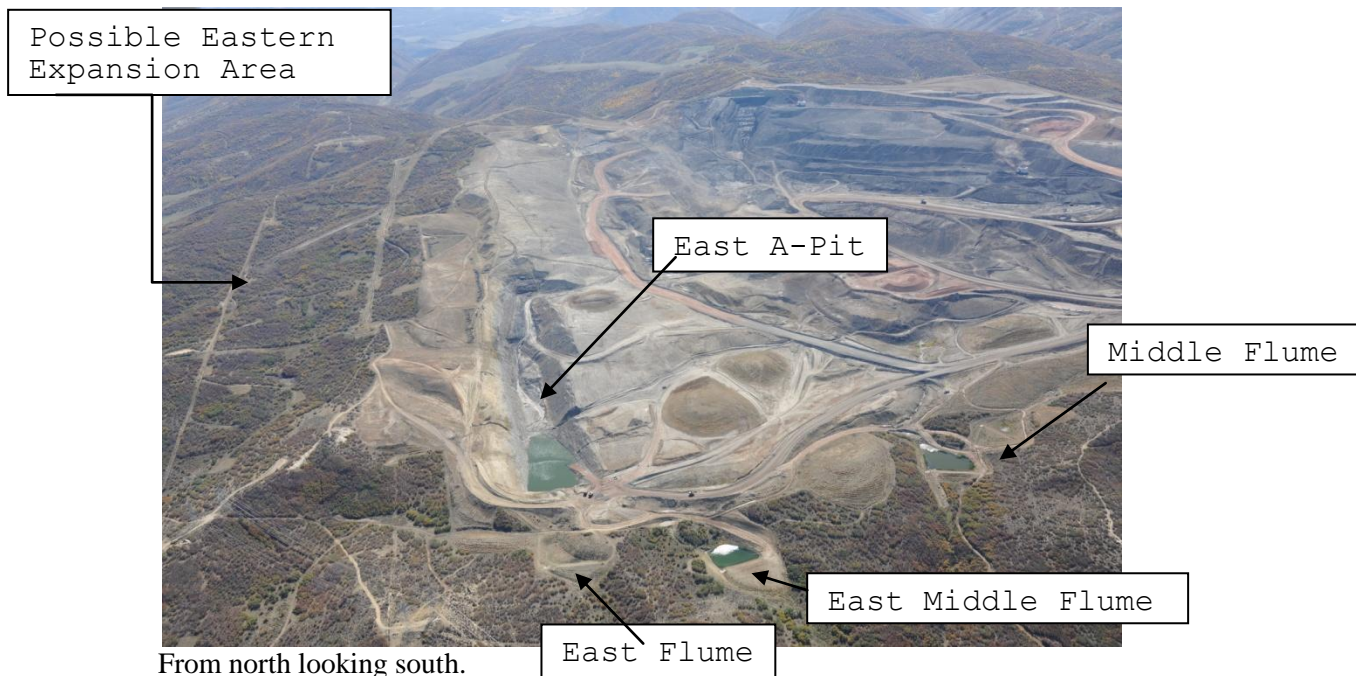
From north looking south.

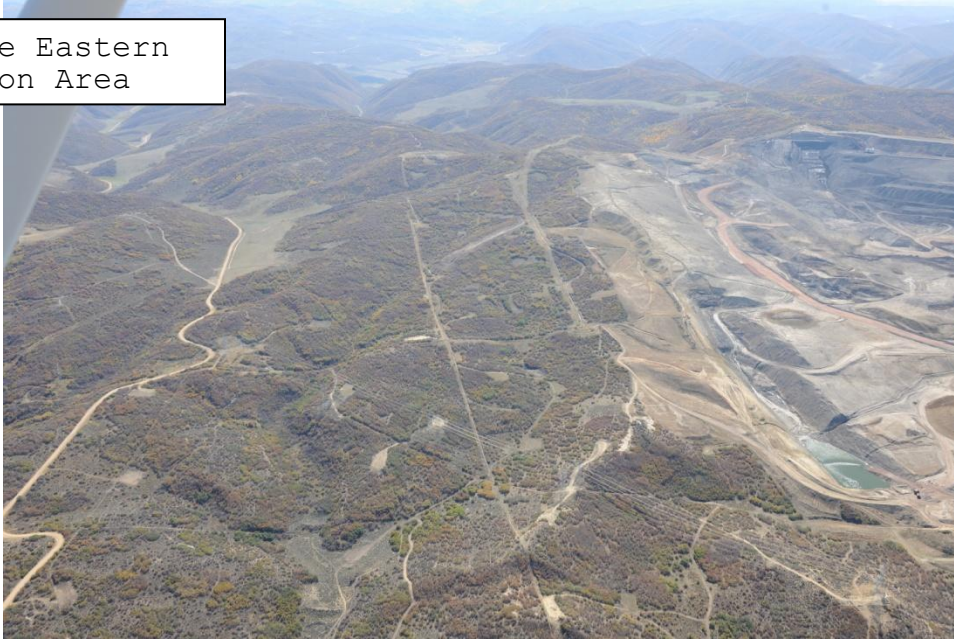
Possible Eastern  
Expansion Area

From north looking south

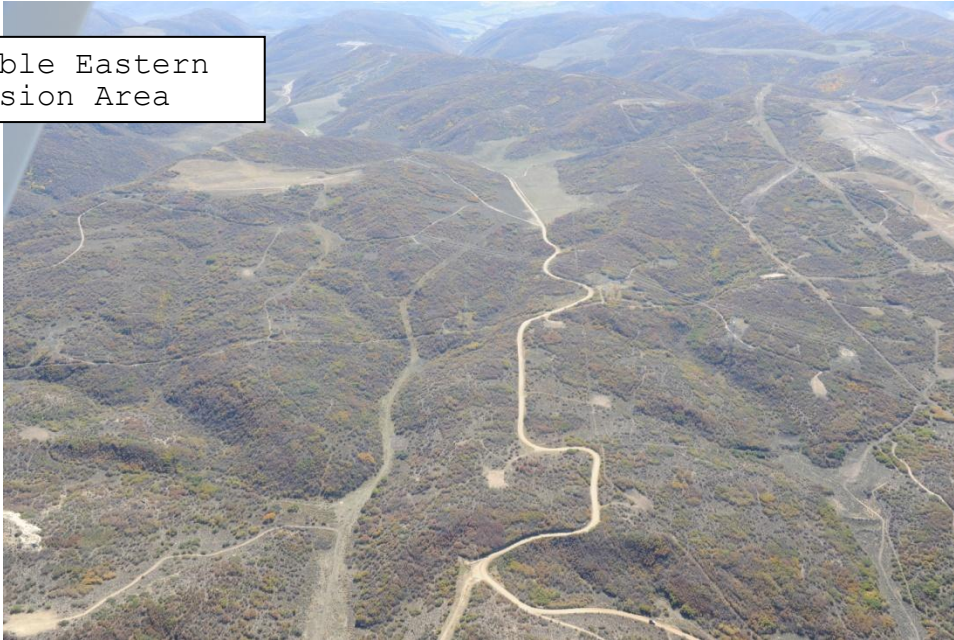
Possible Eastern  
Expansion Area

From north looking south
