**COLORADO DIVISION OF RECLAMATION, MINING AND SAFETY  
MINERALS PROGRAM INSPECTION REPORT  
PHONE: (303) 866-3567**

<b>MINE NAME:</b> Ike No 1 Mine	<b>MINE/PROSPECTING ID#:</b> M-1977-451	<b>MINERAL:</b> Uranium and vanadium	<b>COUNTY:</b> San Miguel
<b>INSPECTION TYPE:</b> Monitoring	<b>INSPECTOR(S):</b> Dustin Czapla, Russ Means	<b>INSP. DATE:</b> October 3, 2012	<b>INSP. TIME:</b> 10:30
<b>OPERATOR:</b> Cotter Corporation	<b>OPERATOR REPRESENTATIVE:</b> Glen Williams	<b>TYPE OF OPERATION:</b> 112d-1 - Designated Mining Operation

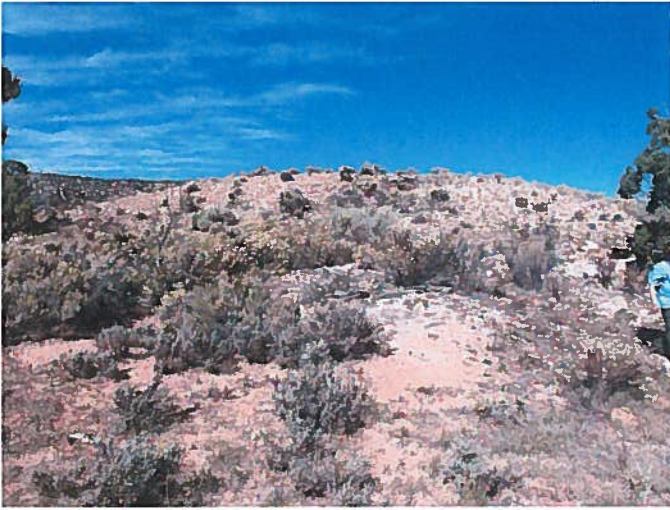
The Ike Mine area has been reclaimed. The portal has been backfilled and site grading has been completed. All slopes appeared stable and vegetation was well established.

Figure 1: Reclaimed Ike Mine Portal area.

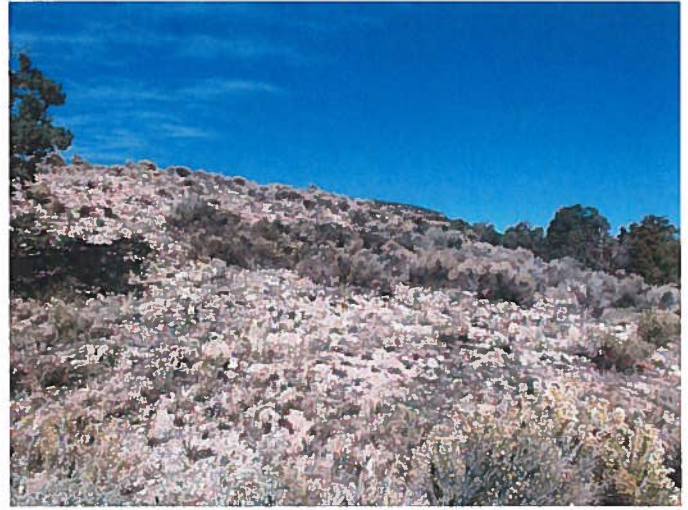
Figure 2: Reclaimed Ike Mine Portal area.

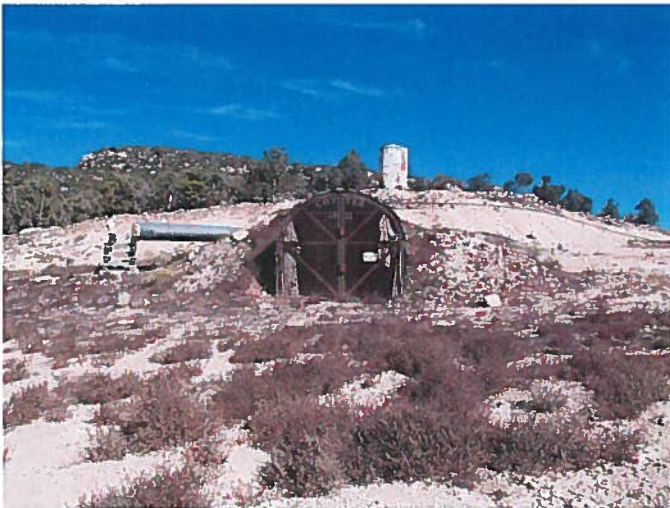
The SR-11 portal was secured by a locked steel gate. A mine office building and water tank were located on site. No other structures or equipment were observed. The area has been stripped of growth medium and cleared for mine operations. The cleared areas contained a significant amount of Russian thistle. Other native vegetation was becoming established as well. Stormwater runoff is directed to and retained by a sediment pond located in the southeast corner of the site. The system appeared to be effective.

Figure 3: SR-11 Portal.

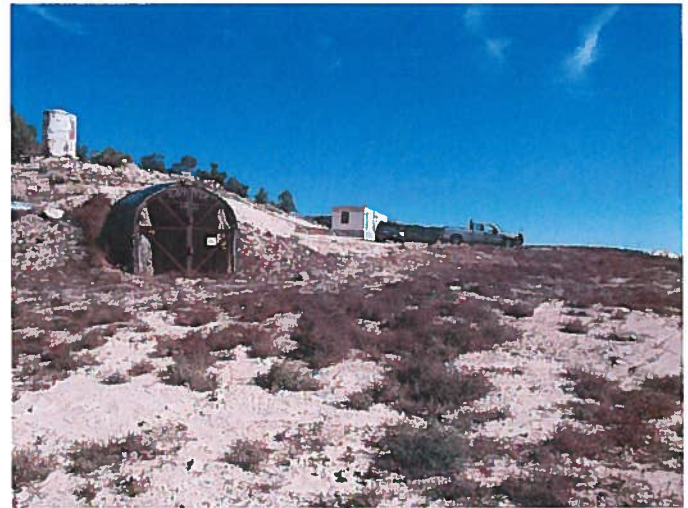
Figure 4: SR-11 Portal and operations area.

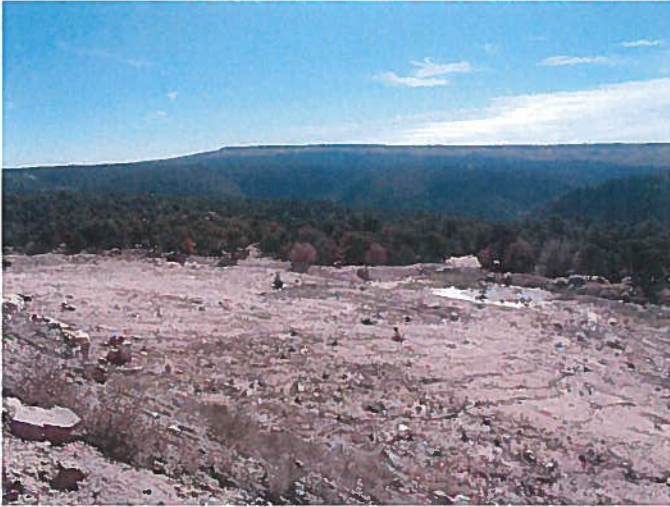
Figure 5: View from the SR-11 mine bench, facing east toward the sediment pond.

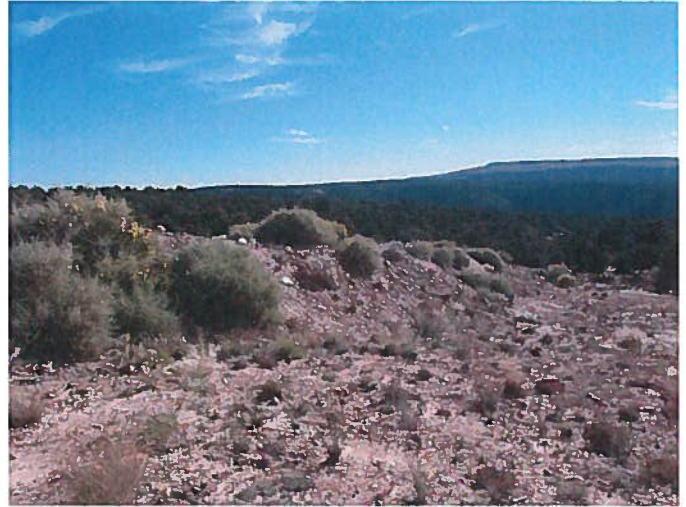
Figure 6: Growth medium stockpiled at the east end of the SR-11 area.

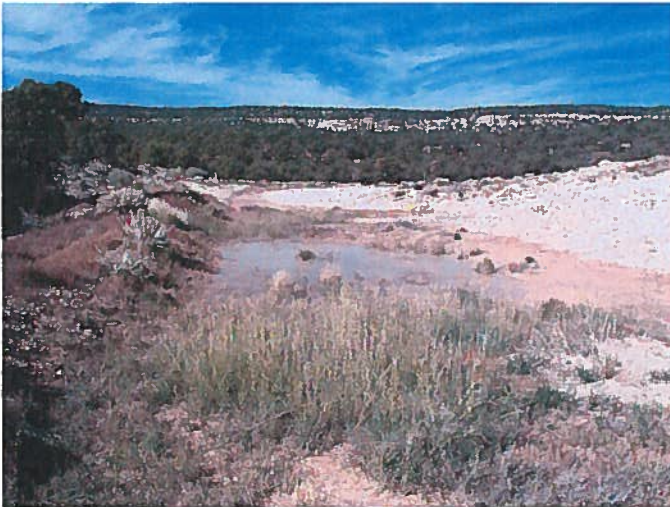
Figure 7: Facing west, from the east side of the sediment pond.
