COLORADO DIVISION OF RECLAMATION, MINING AND SAFETY
MINERALS PROGRAM INSPECTION REPORT
PHONE: (303) 866-3567

MINE NAME: SR-13A Mine	MINE/PROSPECTING ID#: M-1977-311	MINERAL: Uranium and vanadium	COUNTY: San Miguel
INSPECTION TYPE: Monitoring	INSPECTOR(S): Dustin M. Czapla	INSP. DATE: October 3, 2012	INSP. TIME: 12:00
OPERATOR: Cotter Corporation	OPERATOR REPRESENTATIVE: Glen Williams	TYPE OF OPERATION: 110d - Designated Limited Impact

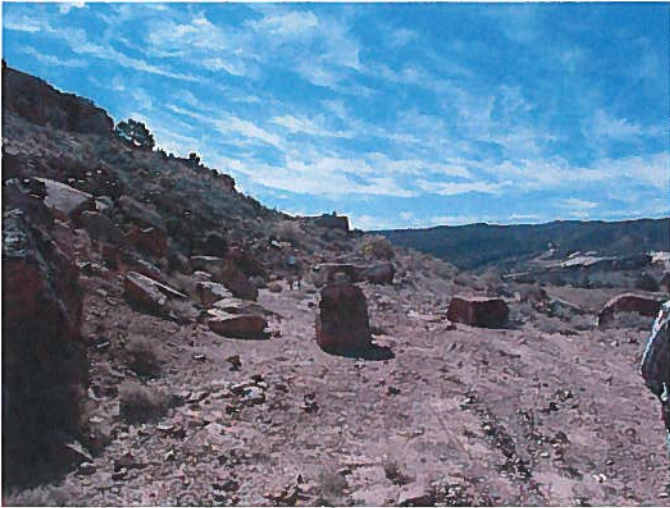
Figure 1: Facing south from access road.

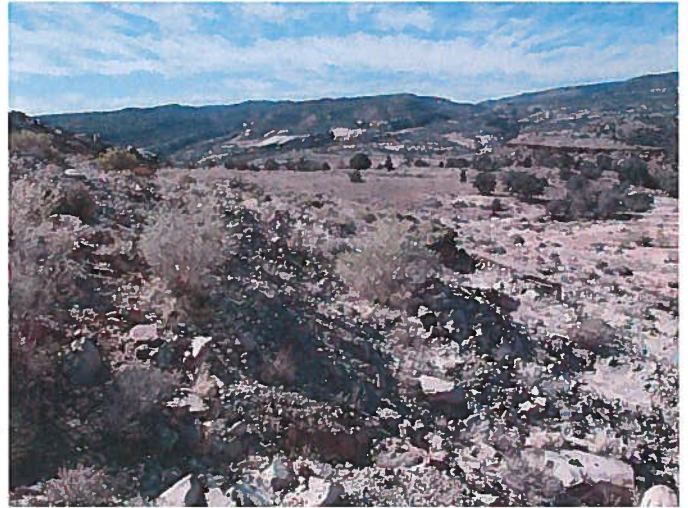
Much of the site has been adequately reclaimed. The access road has been ripped and seeded. Reclaimed slopes at the site have been pocked and seeded, and appeared stable. The remaining portal was secured with a steel gate. The fractured sandstone overlying the mudrock above the portal appeared highly unstable. Cables have been used to secure the rock. The reclaimed slopes are very rocky with little growth medium available, but vegetation is beginning to establish itself.

Figure 2: View of reclaimed slopes, facing south.

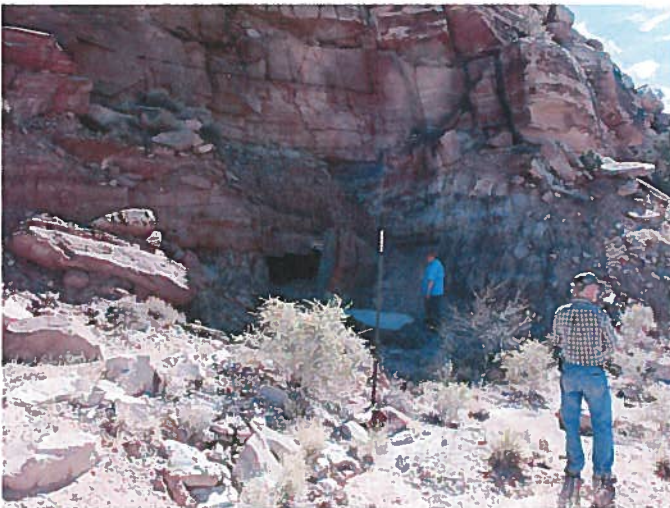
Figure 3: Portal entrance.

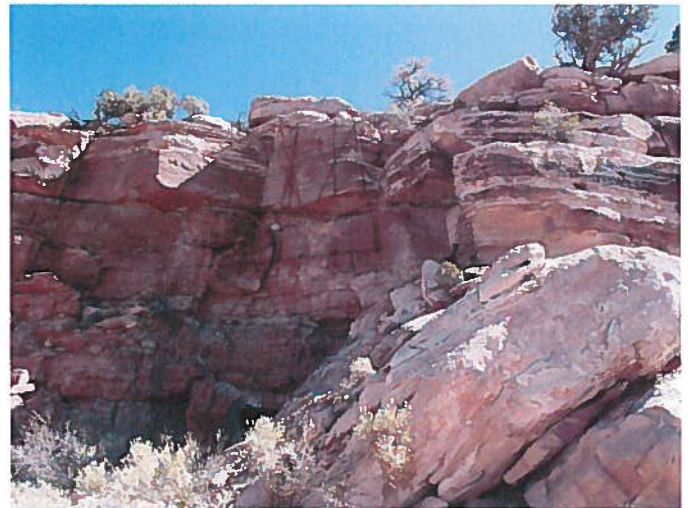
Figure 4: Portal entrance.

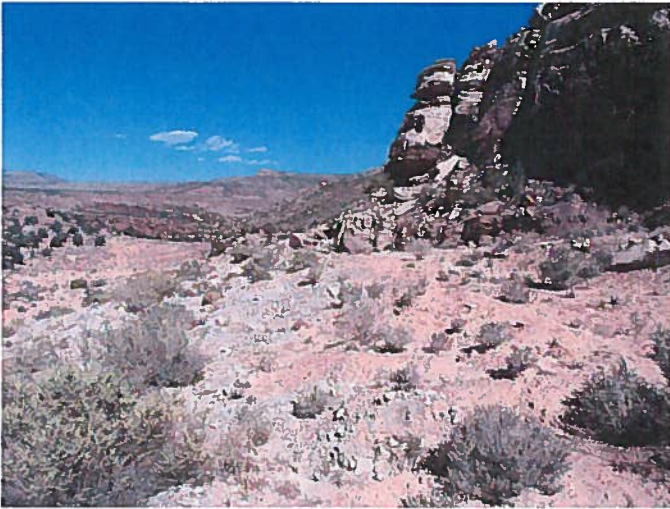
Figure 5: Reclaimed slopes, facing north from near portal.

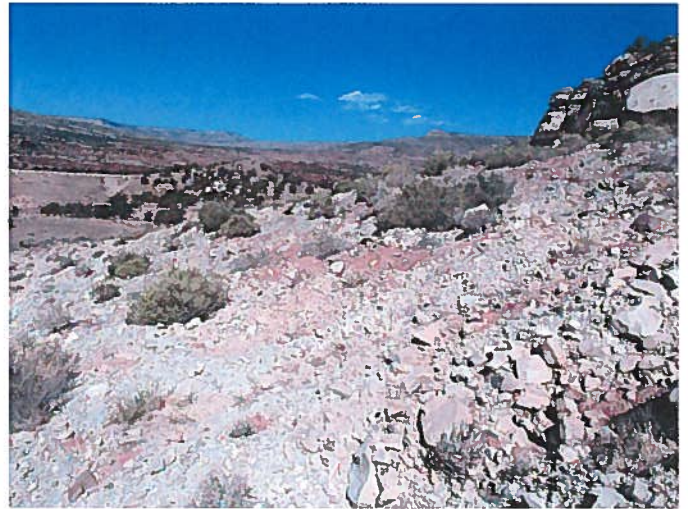
Figure 6: Reclaimed slopes, facing north from near portal.
