**COLORADO DIVISION OF RECLAMATION, MINING AND SAFETY
COAL PROGRAM INSPECTION REPORT**

Permit Number: C-1982-057 Mine Name: Seneca II-W Mine Operator: Seneca Coal Company, LLC Operator Address: Mr. Roy Karo 37796 Routt County Road 53 P.O. Box 670 Hayden, CO 81639	County: Routt Operation Type: Surface Permit Status: Permanent Cessation Ownership: Federal
	Operator Representative Present: None-Aerial
Operator Representative Signature: (Field Issuance Only)

Inspection Start Date: October 2, 2012 Inspection Start Time: 14:00 Inspection End Date: October 2, 2012 Inspection End Time: 14:30	Inspection Type: Aerial Inspection Inspection Reason: Normal I&E Program Weather: Clear
Joint Inspection Agency: None	Joint Inspection Contacts:
Post Inspection Agency: None	Post Inspection Contacts:
Inspector(s): Jared L. Ebert Harry B. Ranney	Inspector's Signature:

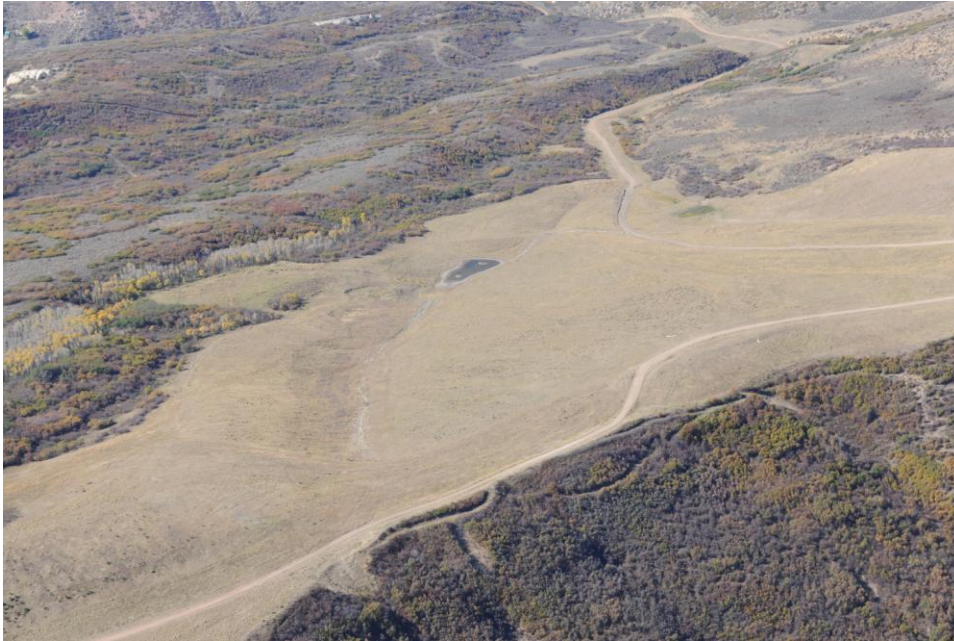
North Area, stock tank T-18 and T-20

Stock tanks T-5, T-18, T-20, T-26 and T-27 were holding water. Ponds 006, 016, 017 were holding water. The stock tanks and ponds appeared stable.

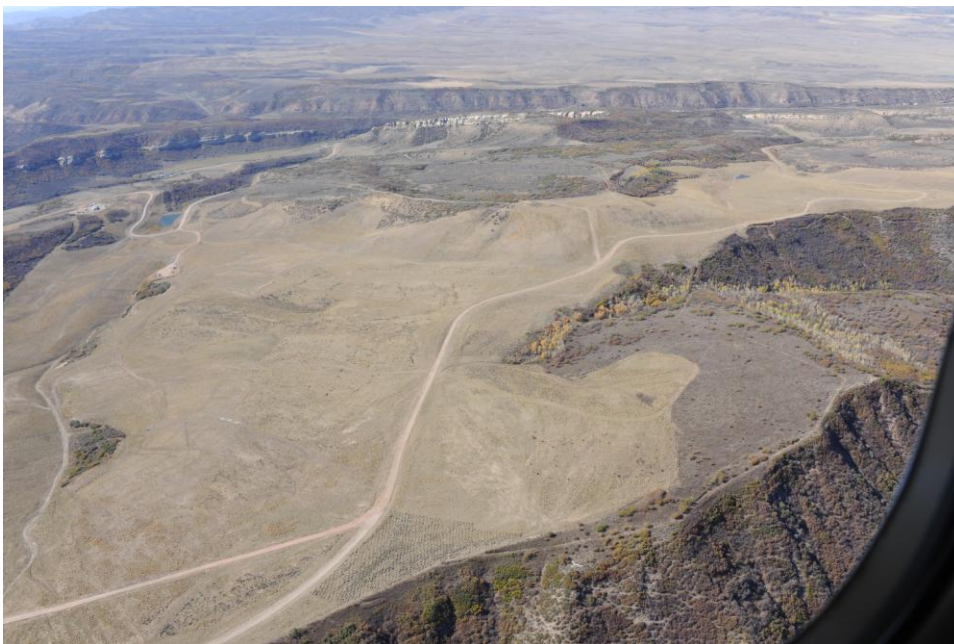
North Area, Pond 006 and shop at top left corner.

The shop area was observed and no problems were noted.

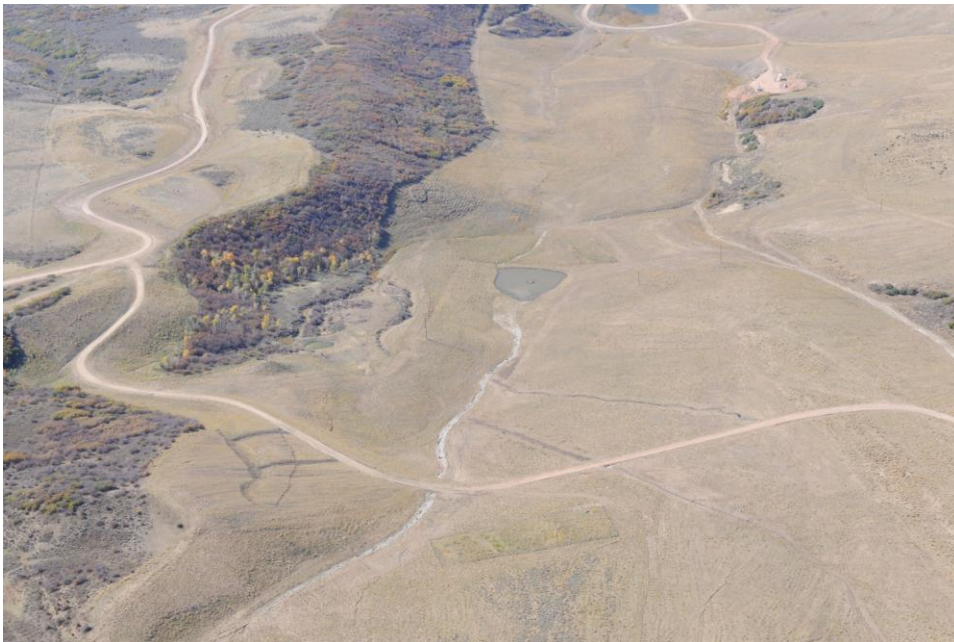
Pit Ramp Slide and Stock Tank T-5

The pit ramp slide was observed and it does not appear the slide has moved significantly and no problems were noted. The pond 016A slide appears to have been graded and rock mulch has been applied to the slide area.

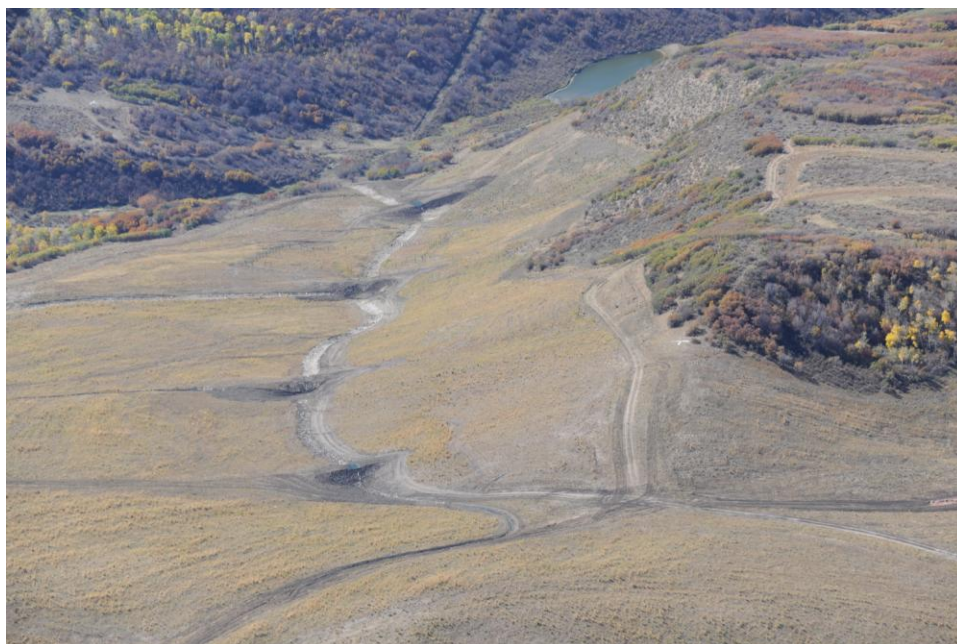
Several surge tanks have been installed along the PM 1 drainage.

Pond 017; Drainage PM-1
Surge Tanks

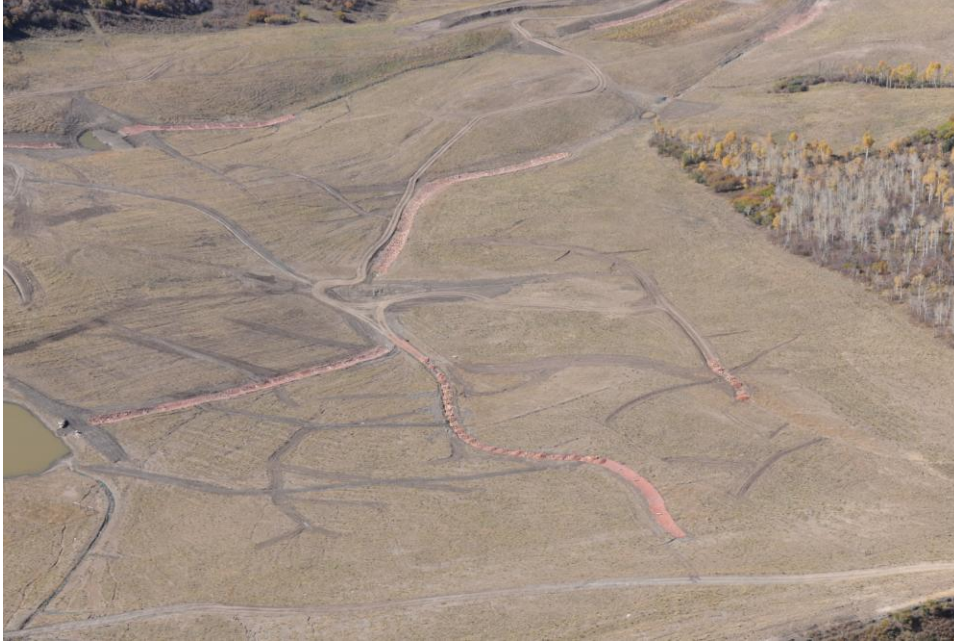
It appears repair work has recently been conducted along the PM-2 drainage and its upper branches. Many check dams have been installed and the drainages appear to be lined with rock.

Stock tank T-26 bottom left corner, looking toward Pond 016. Repair work in PM-2 drainage.
