## Royal Gorge Field Office Minerals Inspection/Site Visit

<b>Date</b>	05/18/12
<b>Time Period Onsite</b>	2:15 pm –2:45 pm
<b>Project Name</b>	Foster Scott Placer Operation
<b>Project Location</b>	Cripple Creek
<b>Project Classification</b>	Locatable
<b>Inspection Purpose</b>	Inspect Plan of Operations Activity
<b>Attendees</b>	Stephanie Carter (BLM)
	Amy Titterington (BLM)

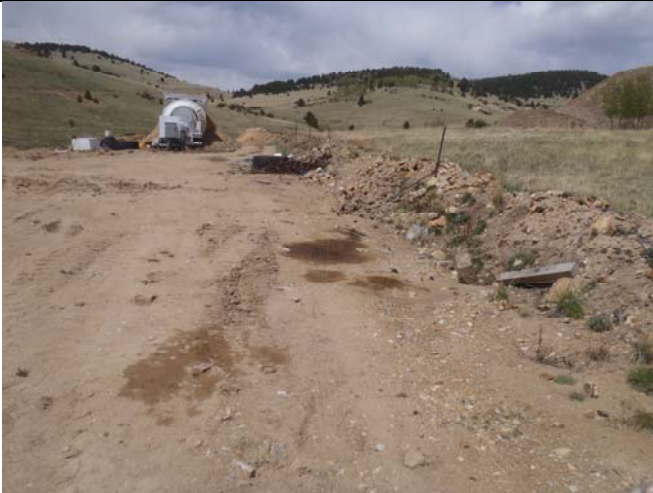
Photo 1: Oil staining.

- Oil staining is common throughout the site. Contaminated soils need to be remediated.
- Generator is leaking. No spill pan is present.
- The operator has no water rights and uses city water for processing.

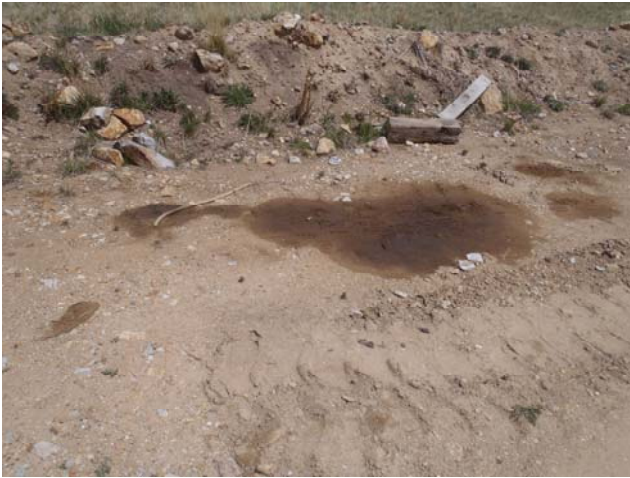
Photo 2: Oil staining close up.

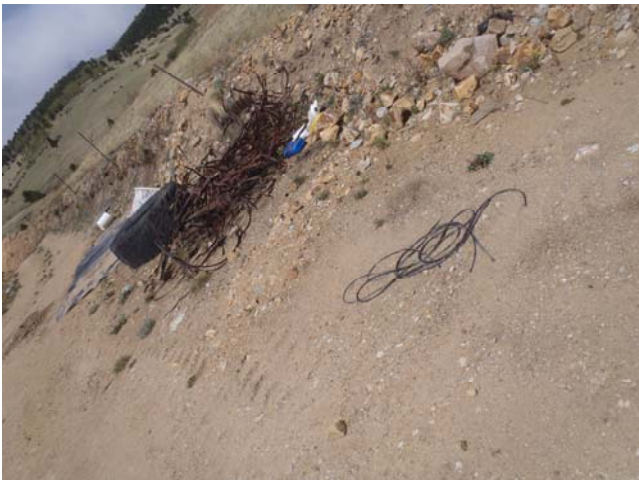
Photo 3: Trash pile near southern entrance.

- The operator was notified of the inspection via voicemail, but did not attend.
- Chemicals (mostly appear to be POL products) and oil drums are improperly stored, and have leaked. Additionally, tires and other trash are abundant throughout the site. I need to inform CDRMS, who needs to alert the operator that storage practices need to change, and he needs to clean-up the spills.

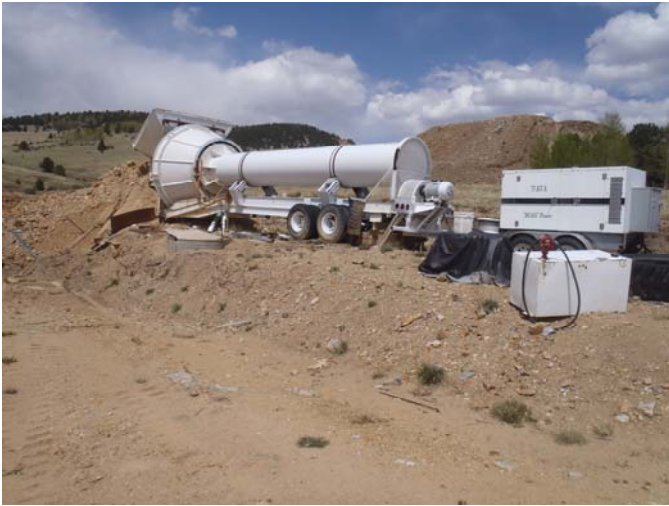
Photo 4: Sluice (spiral), looking north.

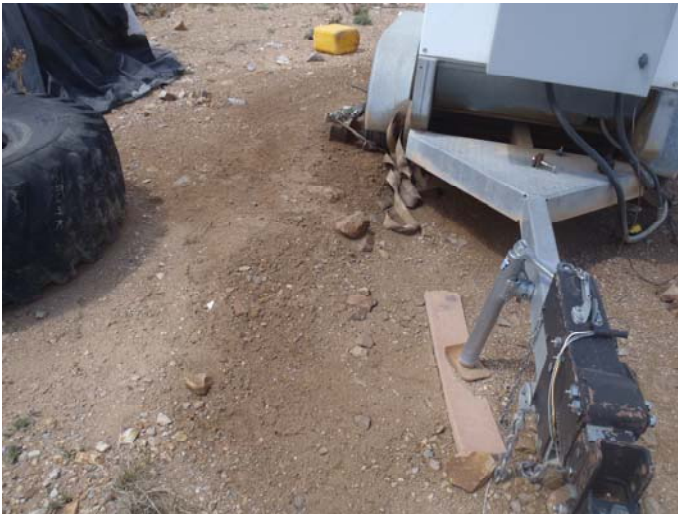
Photo 5: Trash near generator.  
Generator is leaking oil. Multiple  
containers found nearby, improperly  
stored.

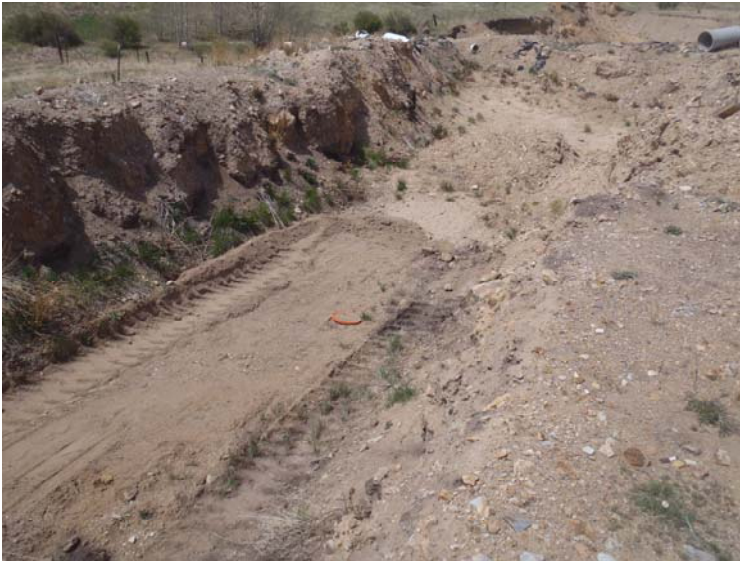
Photo 6: Detention Pond on west side.  
Trash common – liner, culverts. Recent activity.

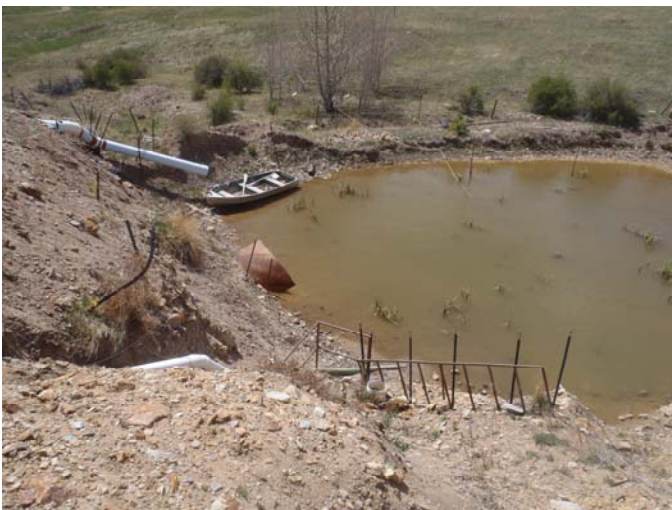
- Two ponds are present. The lower one is used as storage for city water. The upper one is groundwater infiltration. This water is being pumped out, bypasses the lower pond and goes straight to a settling pond and then to a drainage. The pump was not running upon arrival to the site.

Photo 7: Southern pond.

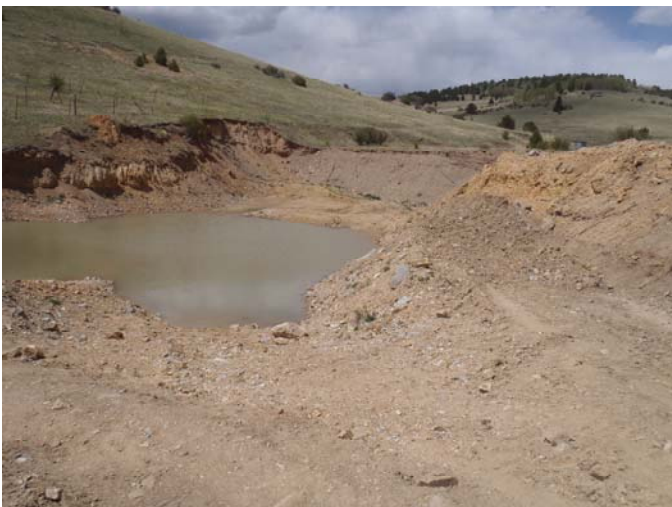
Photo 8: Northern pond. No change in conditions.

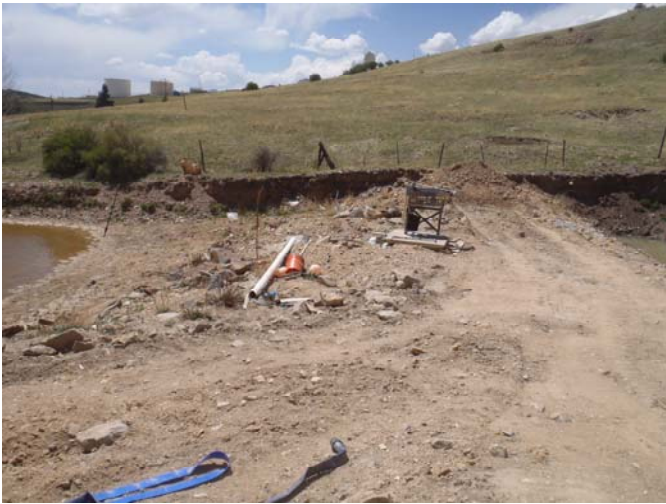
Photo 9: Trash found near northern end of southern pond.

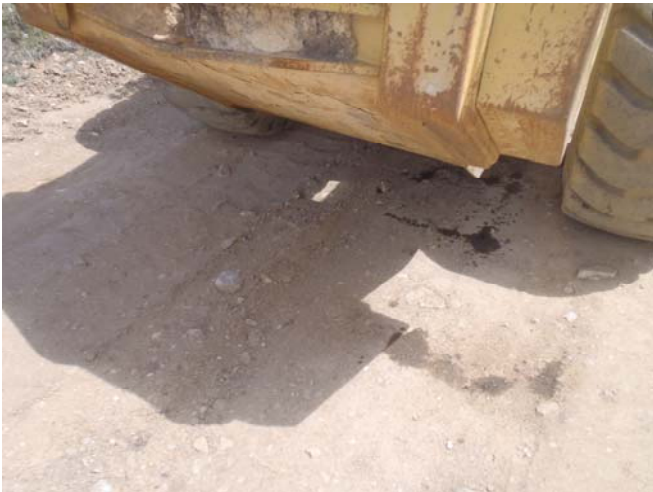
Photo 10: Leaking equipment.

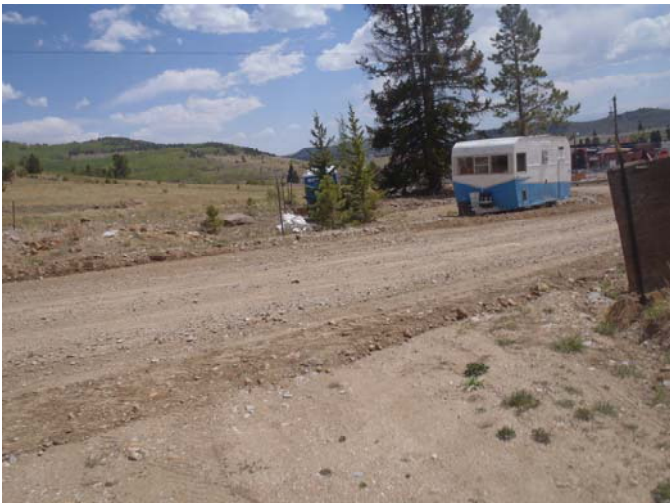
- Does the operator have a NPDES permit?
- Port-o-potty and trailer located across the street from the entrance to the operations. Trailer is filled with gas cans and other supplies. Potential HAZMAT issue.

Photo 11: Storage trailer, across road. Holds improperly stored gas cans and other possible chemicals.

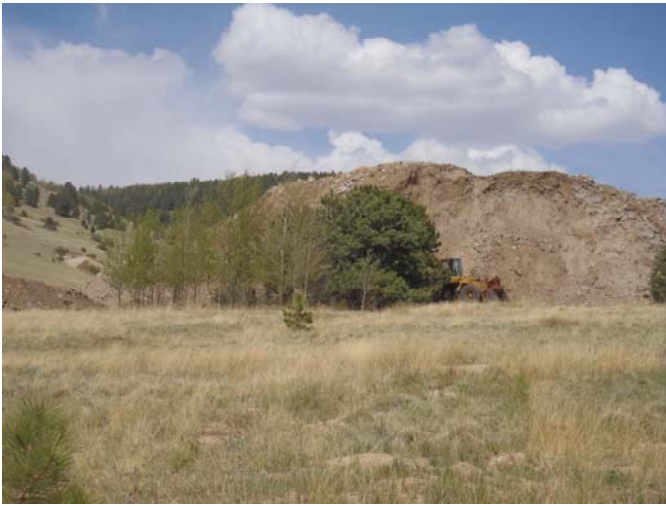
- Note – Approximately 200' northeast of the sluice, and outside the operations boundary, is a very large dump pile that CDRMS said they saw coming from the construction of the new casino downgradient of this area. Need to check on land status associated with this pile.

Photo 12: Trespass to north. Need to check land status. Dozer is new.
