COLORADO DIVISION OF RECLAMATION, MINING AND SAFETY COAL PROGRAM INSPECTION REPORT

Permit Number: C-1981-014 Mine Name: Southfield Mine Operator: Energy Fuels Coal, Inc. Operator Address: Mr George Patterson P.O. Box 459 Florence, CO 81226	County: Fremont Operation Type: Underground Permit Status: Permanent Cessation Ownership: Private
	Operator Representative Present: None
Operator Representative Signature: (Field Issuance Only)

Inspection Start Date: October 11, 2012 Inspection Start Time: 10:45 Inspection End Date: October 12, 2012 Inspection End Time: 10:30	Inspection Type: Coal Partial Inspection Inspection Reason: Normal I&E Program Weather: Clear
Joint Inspection Agency: None	Joint Inspection Contacts:
Post Inspection Agency: None	Post Inspection Contacts:
Inspector(s): Janet H. Binns Jason D. Musick	Inspector's Signature:

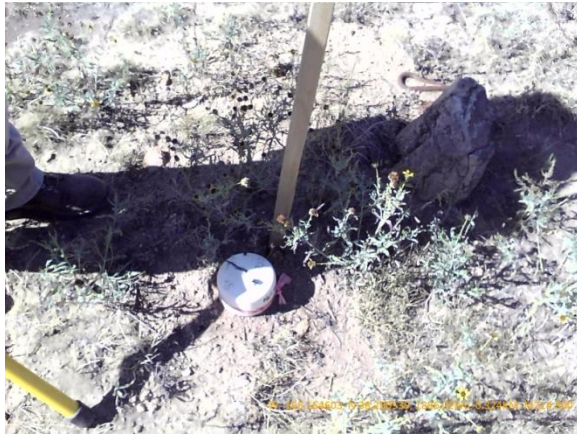
SF87-07

SF-87-07: remains opened and a 4" diameter PCVC casing with a cap remain in place. This hole was permitted with MR-11 and was originally drilled under exploration permit CX1988-154-19. Southfield will need to seal this borehole in accordance with Rule 4.07.3.

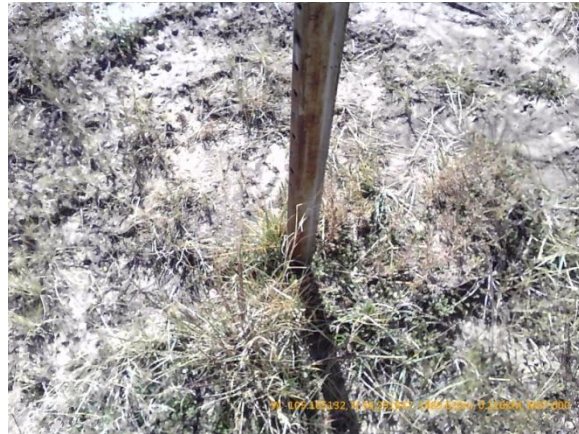
C-63-01

C5601 and C6301 were located and found to be sealed, reclaimed and marked with steel posts.

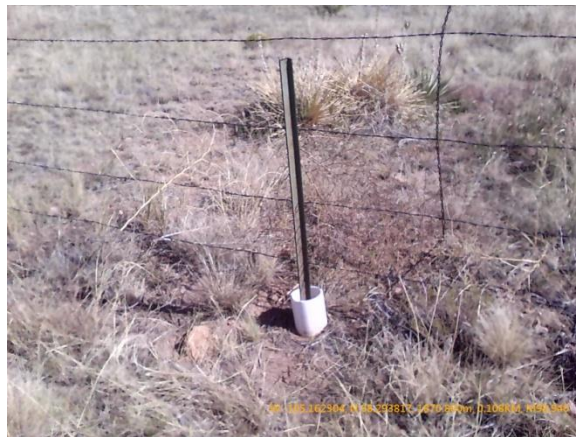
C56-02

C5602 and C6302 were located along the property line fence. Each location was sealed, reclaimed, and marked with a steel post along the fence line.

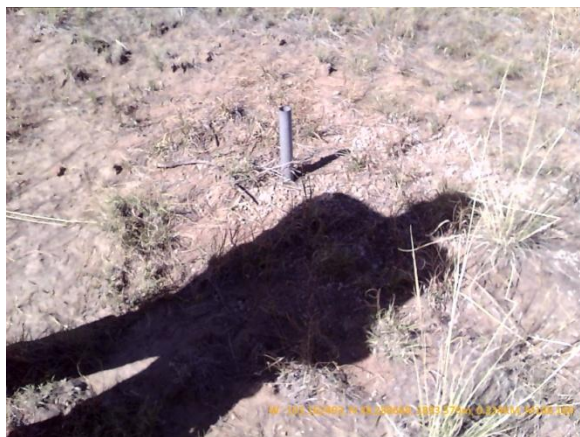
CC-21 was located, sealed, reclaimed and marked with a 1 1/2" aluminum post.

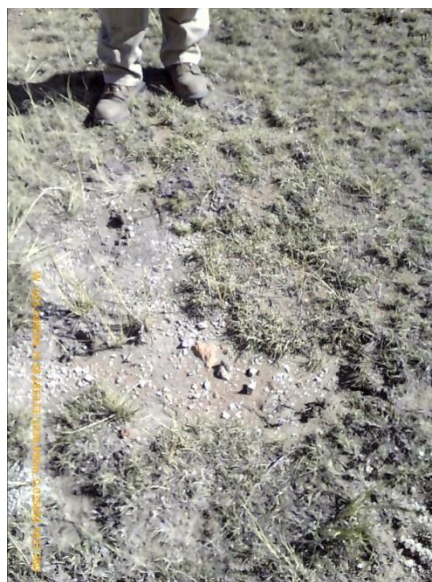
SR-63

SR63 was located and found evidence of cuttings on the surface, sealed and reclaimed. No marker.

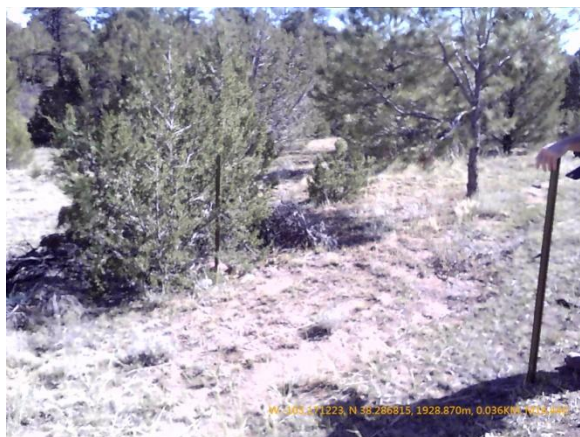
LS14142 location we found 3 posts. Area appeared reclaimed with no open holes.

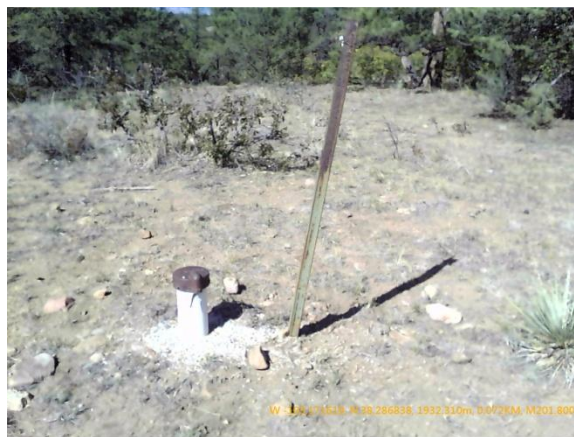
SF87-09 remains open. A 4" pvc casing is present, and is capped. This hole was previously permitted as CC54A and was converted to SF87-09 with MR-11. Southfield will need to seal this borehole in accordance with Rule 4.07.3.

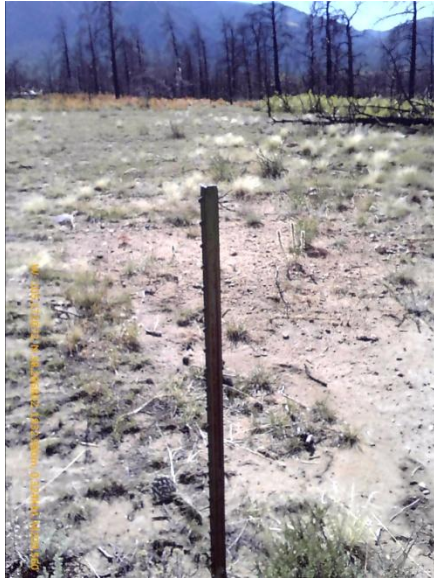
CC-54 is sealed, reclaimed and marked with a steel post, and located adjacent to SF87-09.

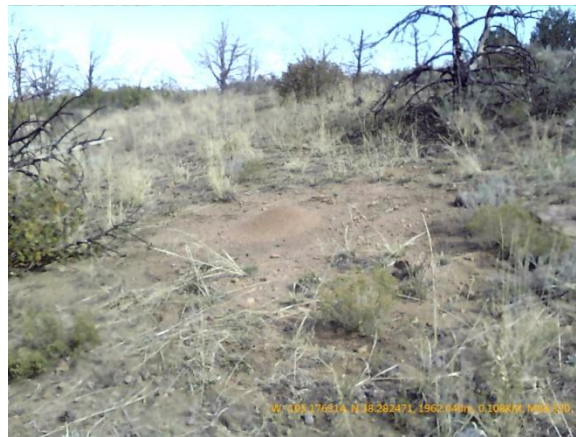
SF85-02

SF85-02. We were unable to locate a marker, open hole or casing. The area looked like a reclaimed access road with a good stand of reclaimed grass species. This hole was originally permitted under MR7 (1985). It appears that this well was not drilled, as only 6 of the permitted 11 holes were drilled.

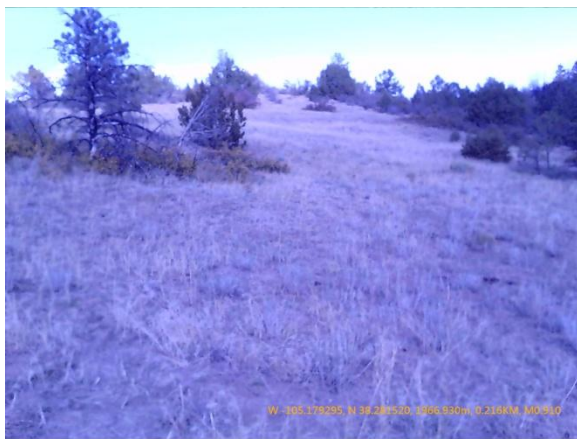
SR-62A

SF64, SR62 and SR62A, there were no signs of disturbance, holes, reclamation, casing or markers for any of these three holes.

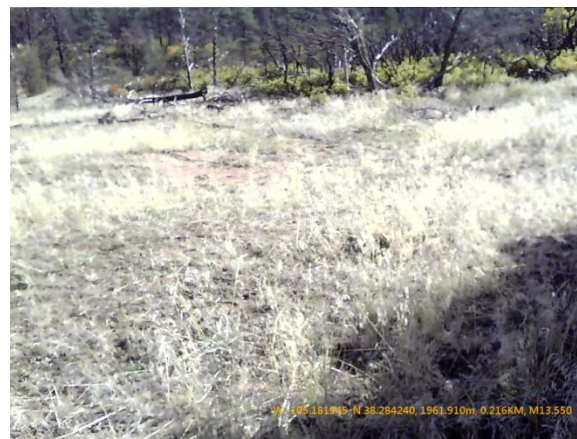
SF85-03

SF85-03: Area was reclaimed, a steel post was lying on the ground in the area, and partially buried black plastic was noted at this location. The Division has a drill hole abandonment report for this hole, dated 1/10/1986, Mitchell Drilling, lic. #973. This is found in the MR7 files.

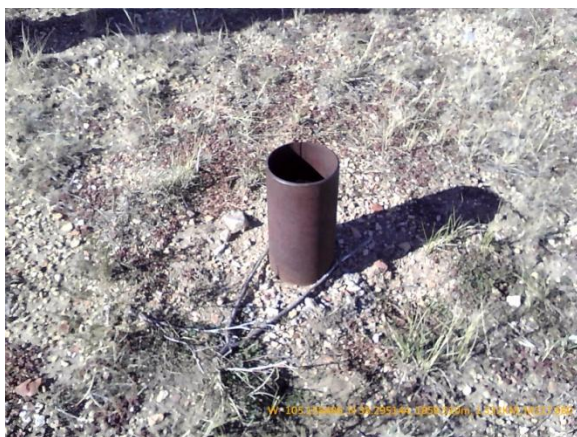
CC-11 is located just north of the Corley ranch road. This hole remains open with a steel casing and cap. The cap is not locked. The Division is researching if EFCI is responsible for this well.

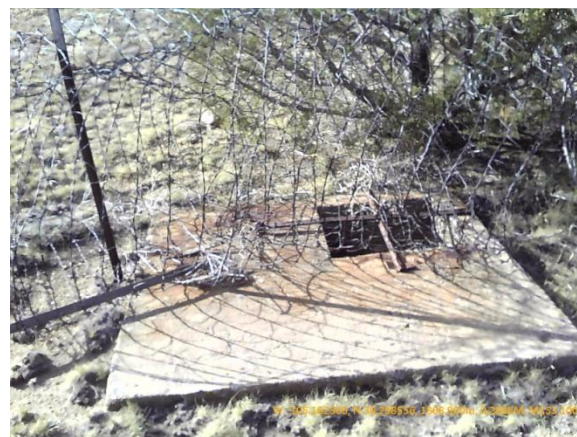
DH-5 consists of a concrete vault with a pipe and valve in it. No borehole was observed in this location. A discussion with the landowner, Doug Corley, later in the day, Dr. Corley believed that DH-5 was a valve access to the old abandoned Florence waterline.

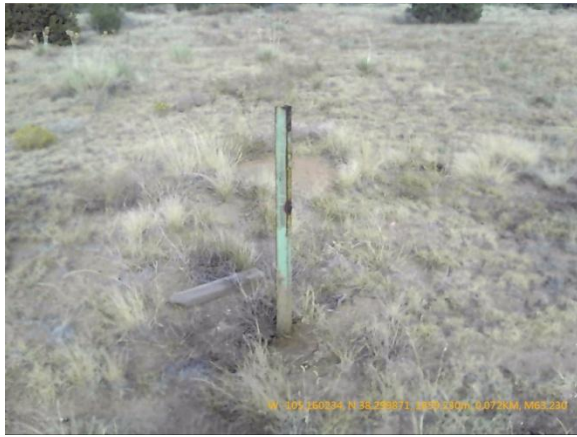
WCC-10 was marked with a green steel post. The hole had been sealed, the area reclaimed and revegetated.

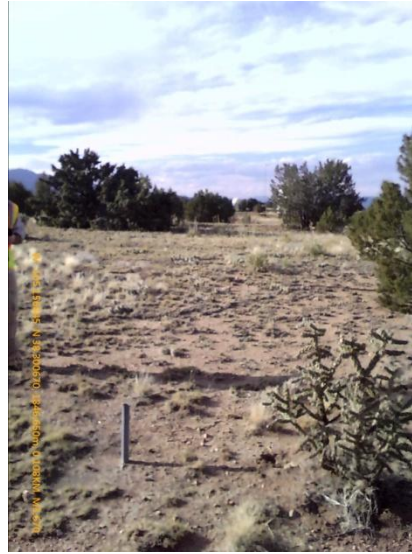
CC-16 had been sealed, reclaimed and marked with an aluminum post.

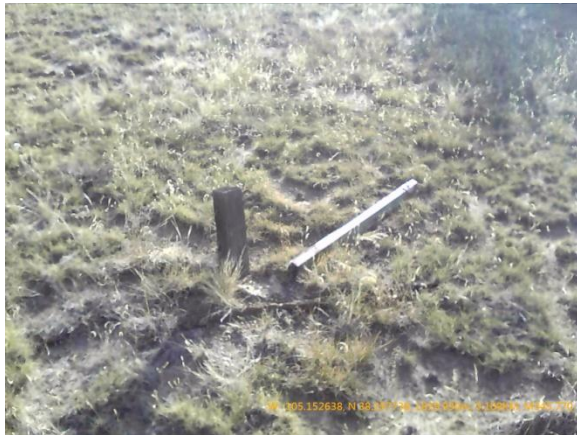
WCC-03

WCC-03: A 4X4 wooden post was cemented into the ground with a steel post lying nearby on the ground. The site has been sealed and reclaimed.

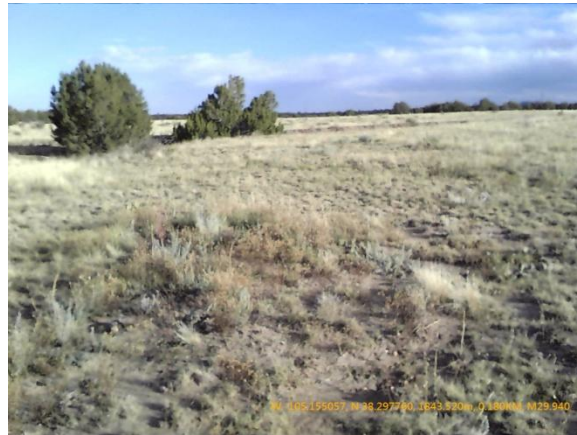
WCC-06

WCC-06: Unable to locate disturbance, casing, hole or marker at this location.

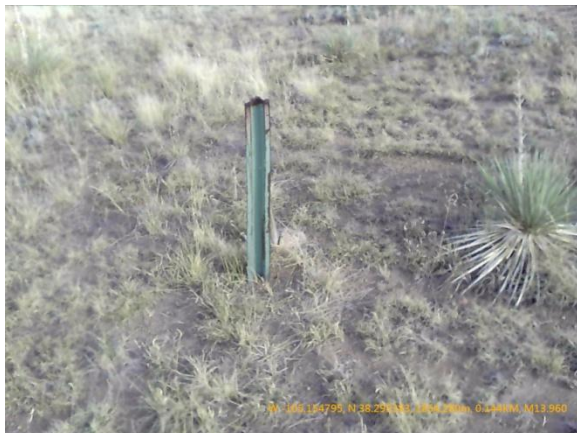
WCC-05

WCC-05: Hole has been sealed, site reclaimed and a steel post marking the location.

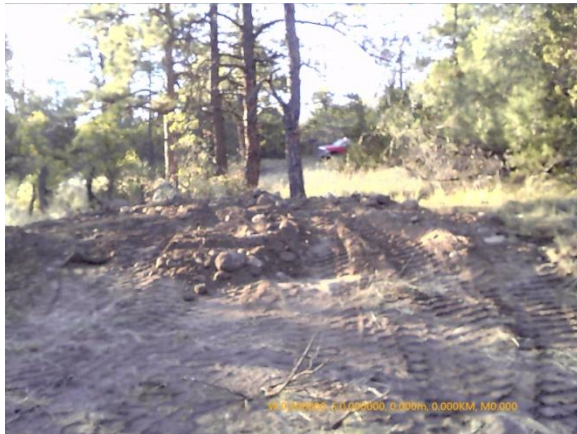
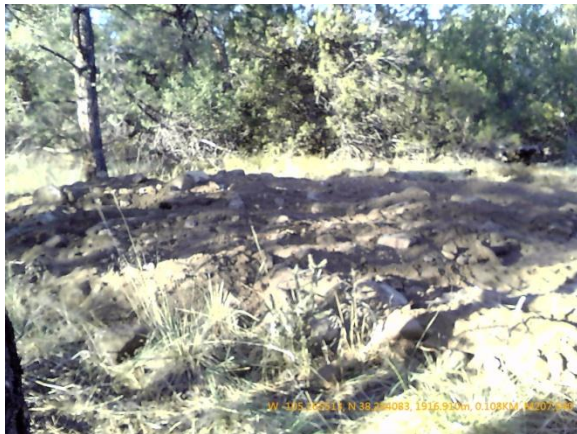
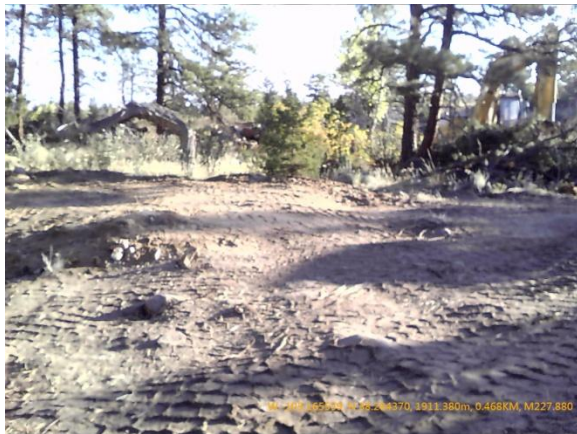
Six subsidence holes had previously been identified located west of the Thompson Ranch road and east of Fremont County road No. 15, adjacent to Newlin Creek. EFCI is in the process of repairing these subsidence holes. Repair consists of filling with additional rock/dirt mixture, compacting this material with the bucket of the excavator, grading the surface to blend with the surrounding area, topsoil placement, seeding with the permitted seed mix, chipping the tree branches and spreading the chipped organic material as a surface mulch. A contractor, Kessler Construction, was on site conducting this work during both days of the inspection.

Repairs to subsidence holes

Repair to subsidence hole

Subsidence hole repair

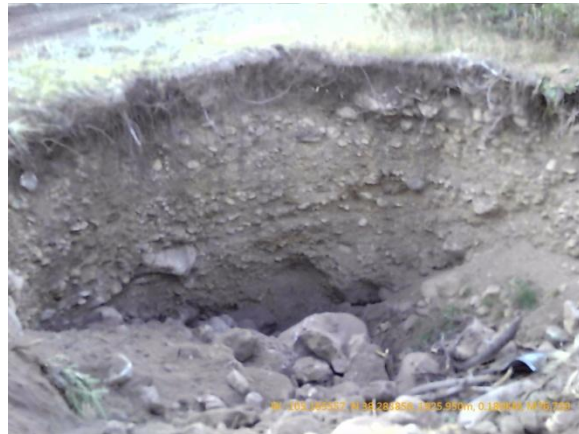
Use of this material was acceptable to the landowner and is addressed in MR58. Five of the 6 holes had been filled, compacted and graded by Friday morning (10/12/2012). The contractor was in the process of filling the remaining hole with dirt and rock mixture from the pre-existing spoil pile. Observation of the spoil material did not visually indicate any cause for concern regarding use of this material.

final subsidence hole to fill

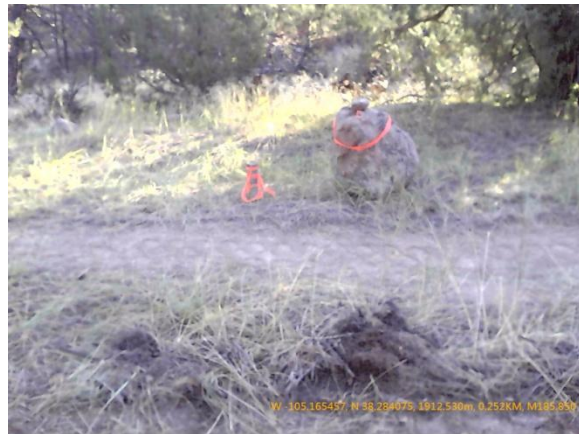
The contractor was taking precaution not to disturb the AML brass cap markers from a project conducted by the Division in the early 1980's. Five of the 6 holes were already filled, compacted and graded at the time the inspectors observed the repair work on the morning of 10/12/12. The contractor said that the holes did not collapse any further as rock/dirt material was packed into them. No further subsidence was encountered. The contractor was using a Cat 950 wheeled front end loader and an excavator to conduct the repair. The contractor also committed to repair to any fences and access routes used to access the site.

AML brasscap. Contractor avoidance

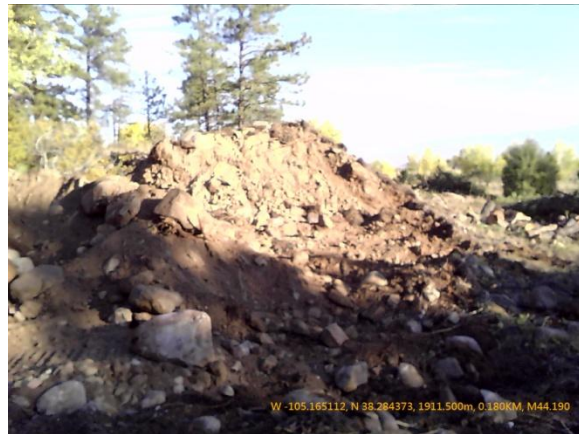
EFCI had contractors on site filling the previously identified subsidence holes with spoil material. The spoil material used for filling the holes is a stockpile that is located immediately adjacent to the subsided area that is believed to be remnant from reclamation of a surface pit conducted by the DRMS-Inactive Mines Program in the 1980's.

spoil used for fill in subsidence holes

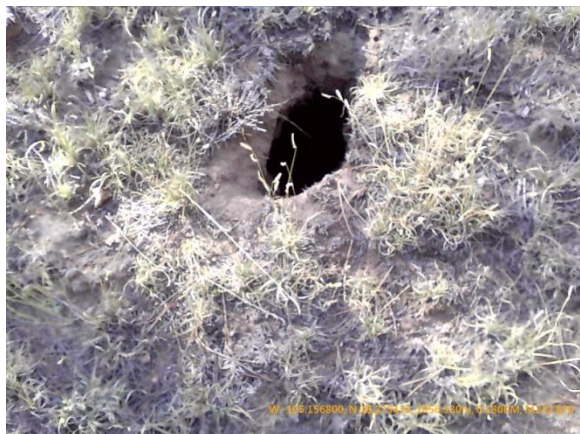
Unidentified hole located west of TH6 almost on fence line. This hole is between TH6 and HW-1 on the map. Hole appears sealed with about 2 ft. open at the surface. There was no marker or casing remaining. Pieces of wood on the ground near this opening.

Open surface of hole near TH6 [HW-1(?)]

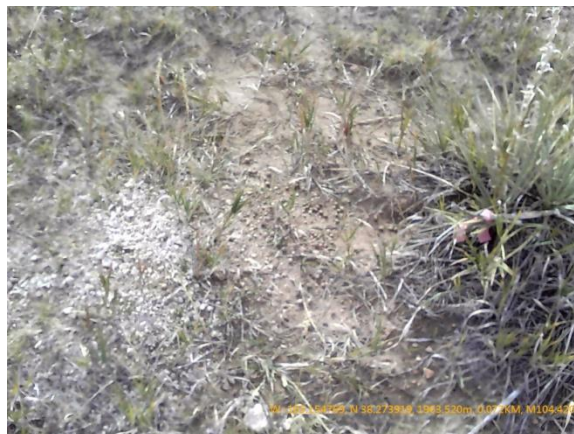
SR-55

SR55: vegetation dominated by smooth brome typical of reclaimed drill pad, cuttings on surface, pink flagging tape on yucca next to cuttings. No marker.

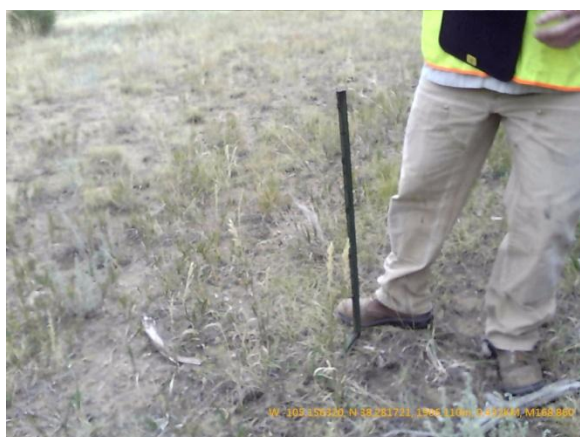
NC-1

NC-1: A steel T-post was located on the edge of the Newlin Creek Mine reclamation.

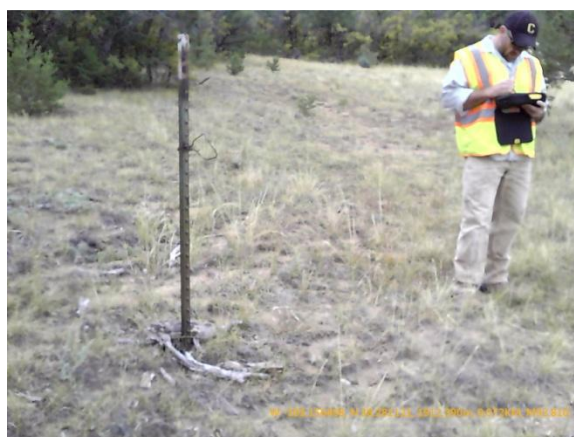
TH-2

TH2: T-post marker located, area appears reclaimed.
