COLORADO DIVISION OF RECLAMATION, MINING AND SAFETY
MINERALS PROGRAM INSPECTION REPORT
PHONE: (303) 866-3567

MINE NAME: LZ Minerals Exploration Program	MINE/PROSPECTING ID#: P-2008-044	MINERAL: Silver, gold, copper, lead and zinc	COUNTY: Mineral
INSPECTION TYPE: Mineral Prospect Inspection	INSPECTOR(S): Bob Oswald	INSP. DATE: September 27, 2012	INSP. TIME: 12:00
OPERATOR: NFI Ventures LLC	OPERATOR REPRESENTATIVE: None	TYPE OF OPERATION: MP - Mineral Prospecting

REASON FOR INSPECTION: Surety Release Requested	BOND CALCULATION TYPE: None	BOND AMOUNT: \$7,000.00
DATE OF COMPLAINT: NA	POST INSP. CONTACTS: U.S. Forest Service	JOINT INSP. AGENCY: None
WEATHER: Clear	INSPECTOR'S SIGNATURE:

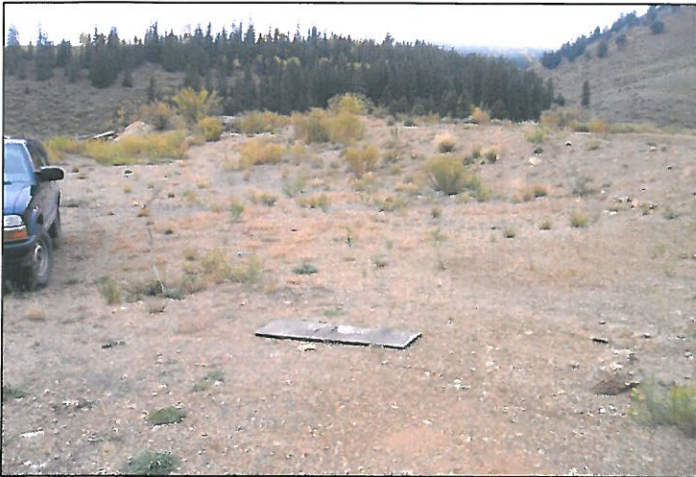
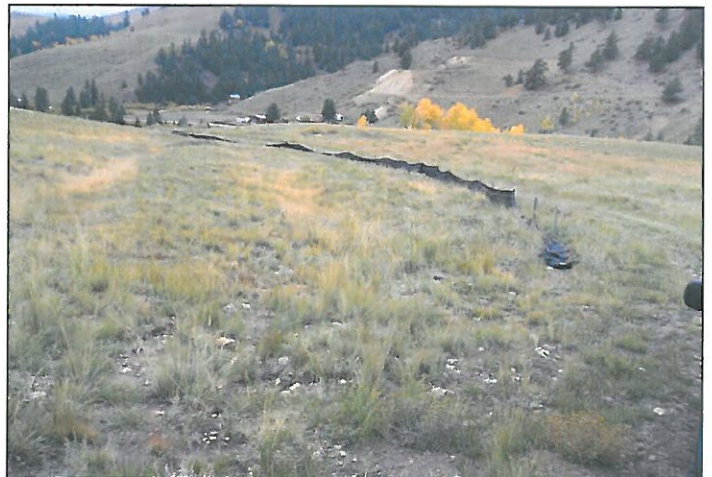
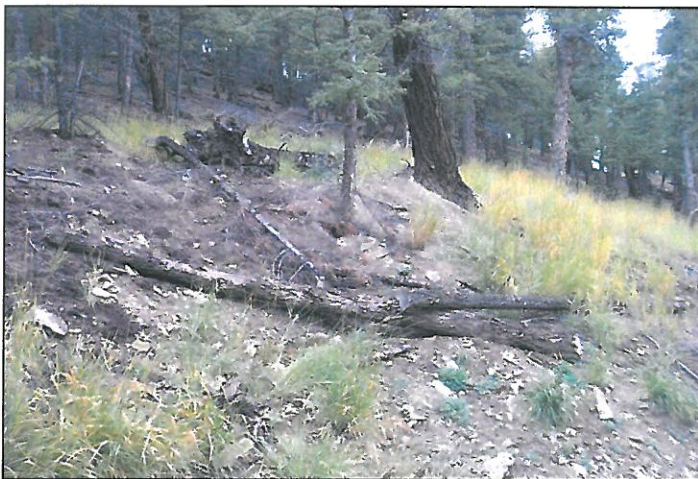
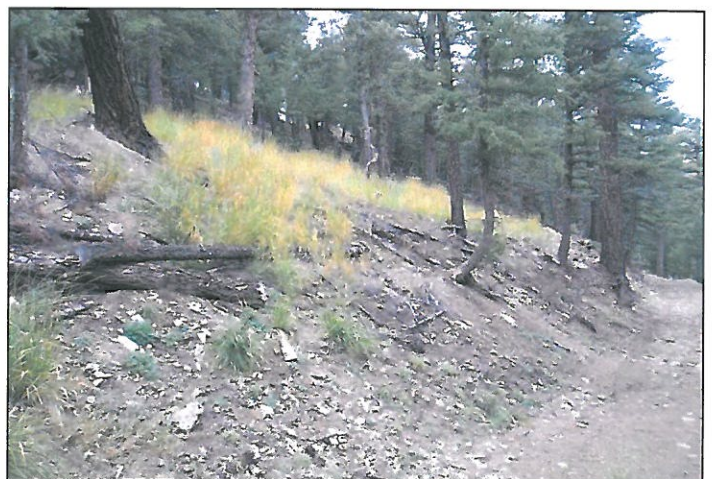
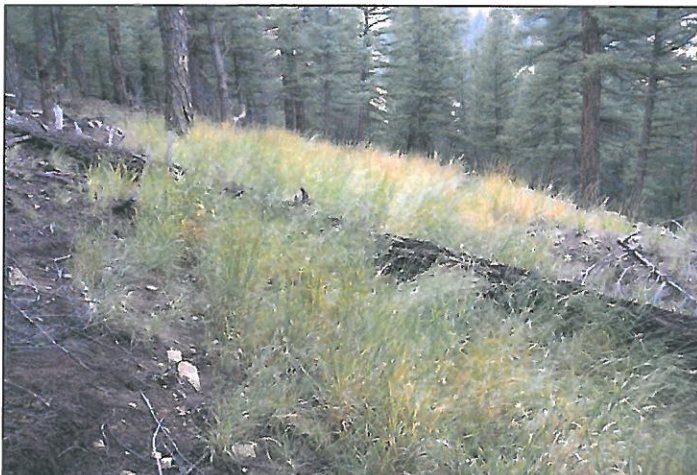
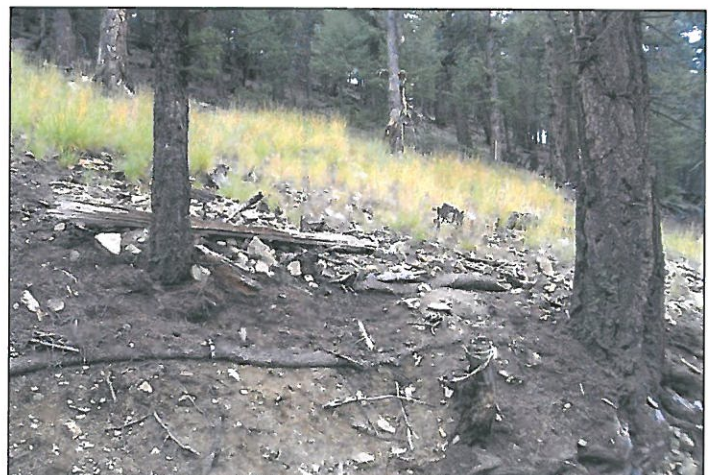
PHOTOGRAPHS

The project area consists of two separate parts: the lower portal and staging area, and the upland drilling site. No new roads were constructed for the project. The portal in the lower area was reopened several years ago, producing a flush of impounded water, all of which was captured and retained onsite. No offsite discharge occurred. Marks on the ribs showed the mine pool depth was only five feet at the portal. The portal was reclosed adequately, and it is presumed that the impounded mine pool is refilling but also re-establishing its groundwater drainage pathway again. There have never been any seeps or surface drainage observed anywhere below the site, and stream water sampling has not detected any adverse impacts. The recontouring of the face-up has been successful also. All equipment, stockpiles, debris and contaminants have been removed from this area, and the site is stable. The Division considers this to be adequately reclaimed.

The upper drilling area is also reclaimed. All drill holes were backfilled and sealed, the drill pad was recontoured and topsoiled, and the area was seeded. The operator scattered all the woody slash across the disturbed area. The topsoil is not eroding or weedy. The seeding has been successful, in producing better grass cover than the natural forest understory adjacent to the site. No sediment has deposited on the adjacent roadway. The Division considers this area to be adequately reclaimed.

The one reclamation item that needed to be completed before the Division can approve the release of the bond was the removal of the silt fence that the operator installed along the road up to the upper area. The silt fence was the standard black woven geotextile, about 2 ft x 300 ft, with wooden stakes every 10 feet. The operator was contacted about this remaining task, and prior to the writing of this report had provided photo-documentation to the Division showing the removal of the silt fence.
