COLORADO DIVISION OF RECLAMATION, MINING AND SAFETY
MINERALS PROGRAM INSPECTION REPORT
PHONE: (303) 866-3567

MINE NAME: Klondike Prospect	MINE/PROSPECTING ID#: P-2011-008	MINERAL: Gold and tellurium	COUNTY: Saguache
INSPECTION TYPE: Mineral Prospect Inspection	INSPECTOR(S): Bob Oswald	INSP. DATE: September 26, 2012	INSP. TIME: 16:00
OPERATOR: Bellevue Land & Mineral Co. LLC	OPERATOR REPRESENTATIVE: None	TYPE OF OPERATION: MP - Mineral Prospecting

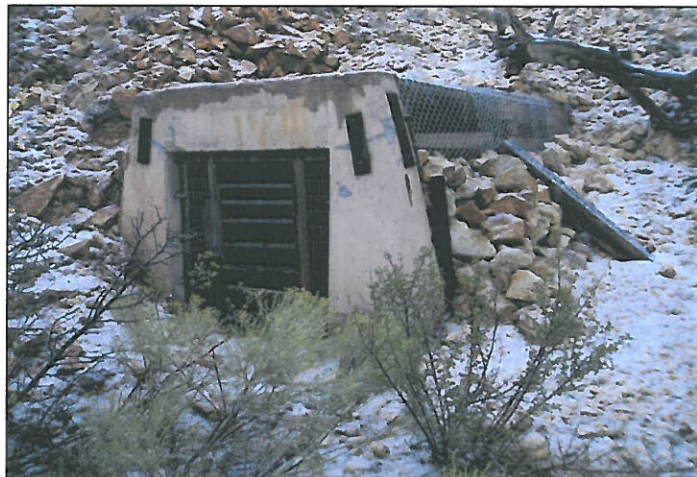
Inspection photograph: Homestake portal with new bat gate (below).
