COLORADO DIVISION OF RECLAMATION, MINING AND SAFETY
MINERALS PROGRAM INSPECTION REPORT
PHONE: (303) 866-3567

MINE NAME: Bulldog Mine Operation	MINE/PROSPECTING ID#: M-1977-215	MINERAL: Lead and silver	COUNTY: Mineral
INSPECTION TYPE: Preoperation Inspection	INSPECTOR(S): Bob Oswald	INSP. DATE: September 27, 2012	INSP. TIME: 10:00
OPERATOR: Rio Grande Silver, Inc.	OPERATOR REPRESENTATIVE: Randy McClure, Tom Day	TYPE OF OPERATION: 112 - Hard Rock Regular Operation

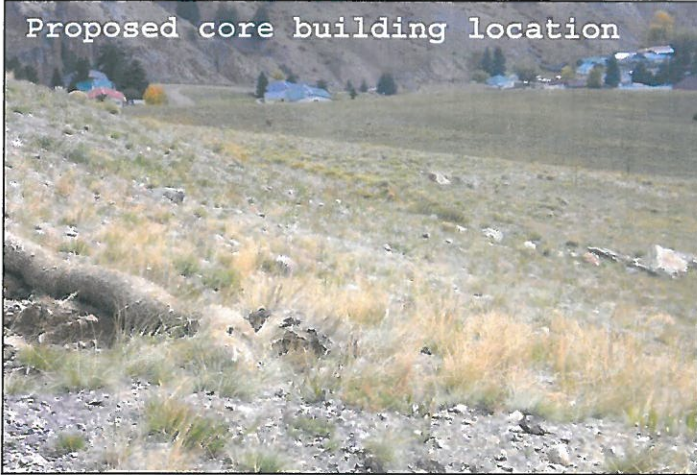
TR-20 was submitted originally to propose the construction of a core logging building, on a pad to be constructed by cut and fill earthwork, and accessed by a new road leading down a short distance from the office building. All disturbance would be contained within the present permit boundary and on the patented Acanthus claim. The permit boundary was marked on the ground, as was the claim boundary, making it easy to estimate the location of the access road and core building pad. Since all construction would be on a hill slope, it will be important for the operator to control sediment and runoff that will potentially increase, by use of standard sediment and runoff control measures. Likewise, all necessary earthwork practices to ensure adequate compaction and stability must be employed. These details will need to be specified in the revision before it is approved.

Proposed core building location

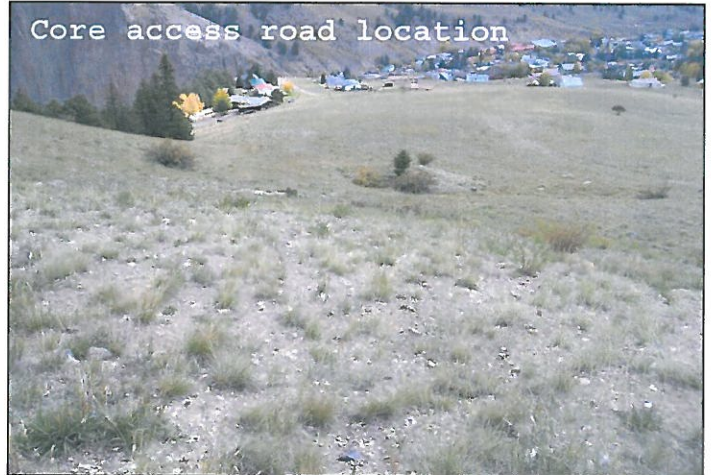
Core access road location

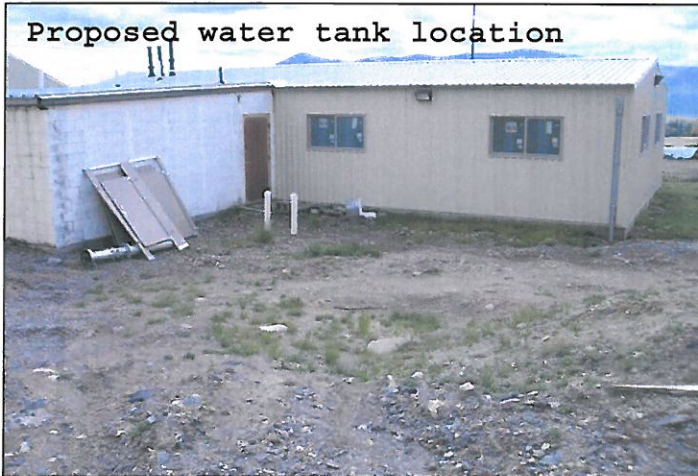
The operator also wishes to install a water storage tank, to supply water for the facilities and offices, plus fire suppression. A suitable location behind the office building, which is currently being remodeled, was identified. The tank would need to be installed on a competent base and inside a heated building space. The location being considered would therefore require constructing a room to adjoin the existing building. This addition would also be appropriate to include in the revision TR-20 that is under review.

Proposed water tank location

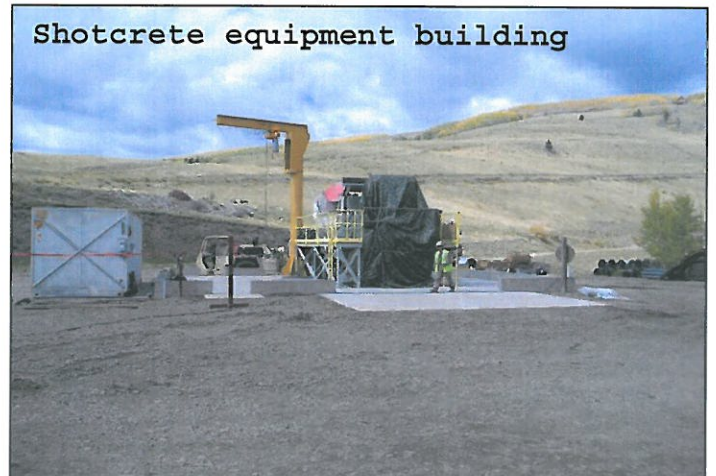
The building approved in TR-19 for the shotcrete equipment was not fully completed, as it still lacked its superstructure and cover. The diesel fuel storage area appeared clean with no spilled fuel. The impermeable liner appeared to be performing well, since a small amount of precipitation was impounded in it. The operator wished to install a roof or cover structure over the fuel tanks and liner, before winter arrives. It was agreed that it could be included in the revision TR-20 that is under review.

Shotcrete equipment building

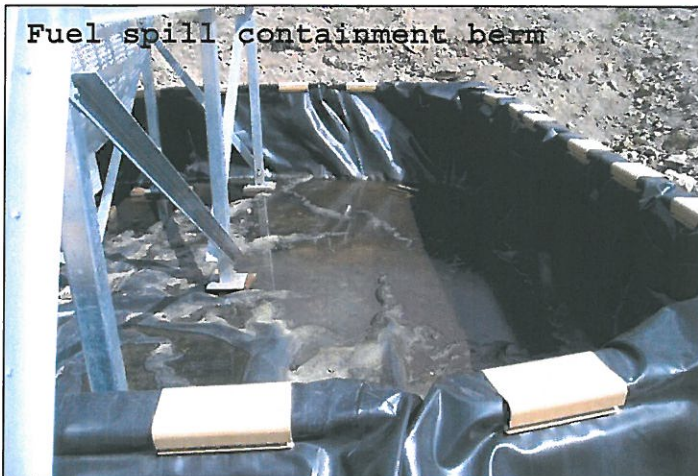
Fuel spill containment berm

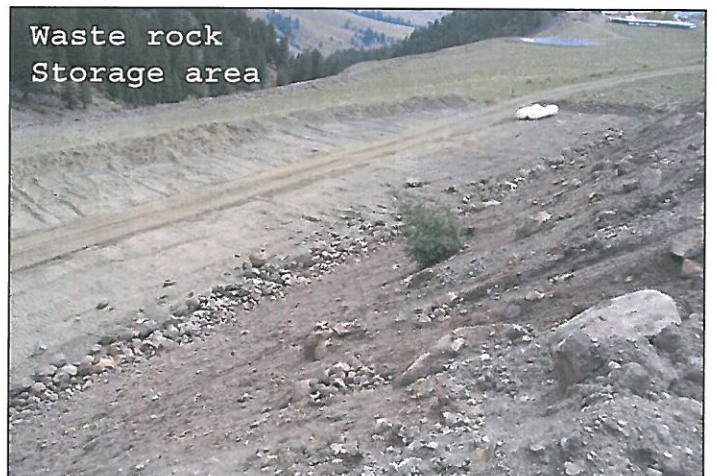
Waste rock
Storage area

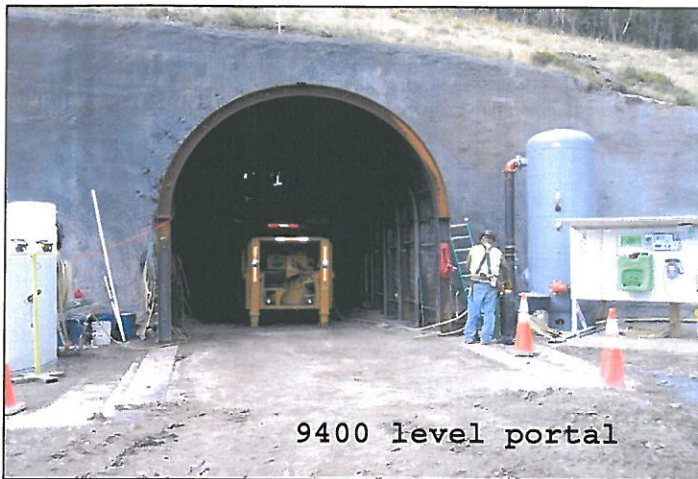
9400 level portal

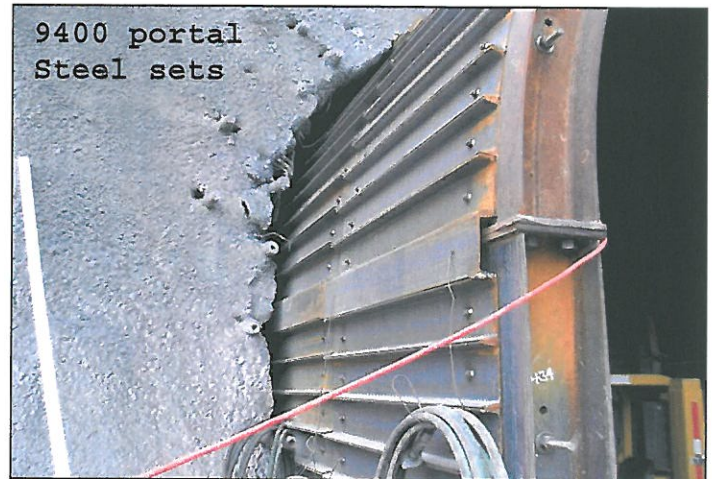
Onsite activities at the 9360 level facilities area observed during the inspection included the continuing advancement of the new 9400 decline and portal area. The arched steel sets and lacing now extend out from the face up approximately six feet, and the operator reported that the decline has been driven about 70 feet inby. The development rock generated by the drift has been deposited below the portal in the approved manner such that it is creating a wider staging pad at the 9400 level. Topsoil has been stripped back from the area where development rock is being dumped, and windrowed along the NE edge of the waste rock area footprint. Sediment fence was installed along the lower edge of the topsoil berm.

9400 portal
Steel sets

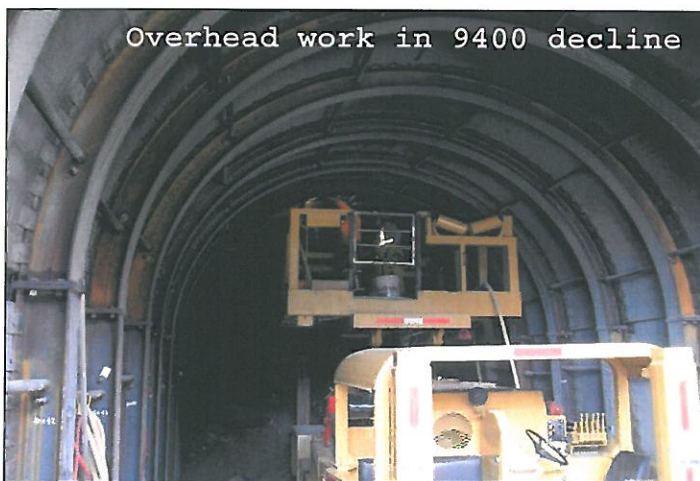
Overhead work in 9400 decline

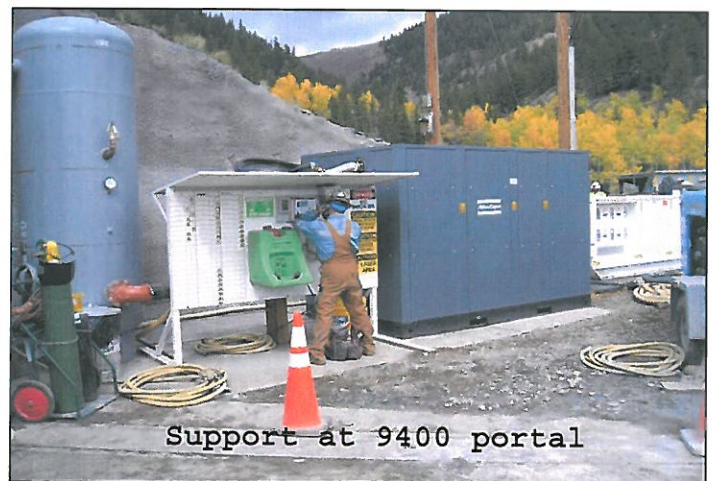
Support at 9400 portal

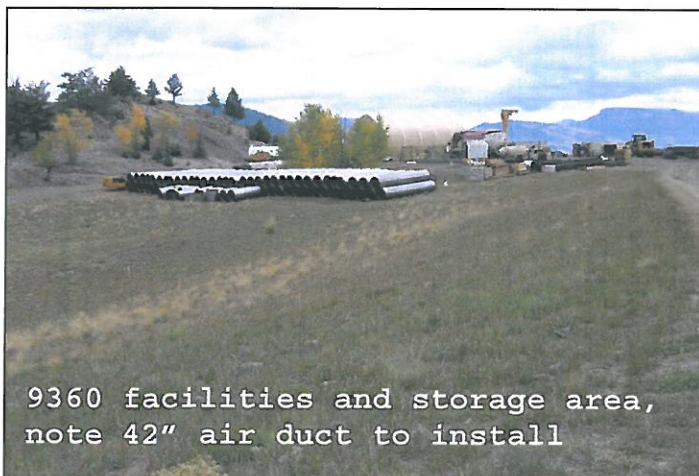
9360 facilities and storage area,
note 42" air duct to install

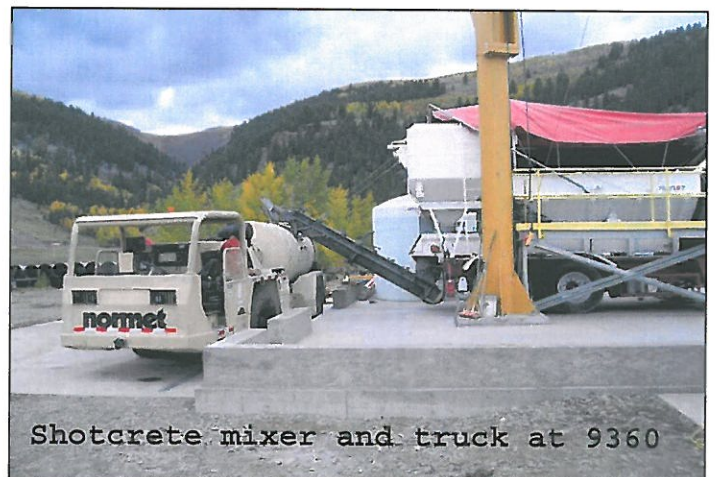
Shotcrete mixer and truck at 9360
