**COLORADO DIVISION OF RECLAMATION, MINING AND SAFETY
MINERALS PROGRAM INSPECTION REPORT
PHONE: (303) 866-3567**

MINE NAME: Whirlwind Mine	MINE/PROSPECTING ID#: M-2007-044	MINERAL: Uranium and vanadium	COUNTY: Mesa
INSPECTION TYPE: Monitoring	INSPECTOR(S): Travis H. Marshall	INSP. DATE: September 28, 2012	INSP. TIME: 13:00
OPERATOR: Energy Fuels Resources Corporation	OPERATOR REPRESENTATIVE: N/A	TYPE OF OPERATION: 112d-1 - Designated Mining Operation	
REASON FOR INSPECTION: Normal I&E Program	BOND CALCULATION TYPE: None	BOND AMOUNT: \$375,078.00	
DATE OF COMPLAINT: NA	POST INSP. CONTACTS: U.S. BLM	JOINT INSP. AGENCY: U.S. BLM	
WEATHER: Clear	INSPECTOR'S SIGNATURE: 	SIGNATURE DATE: October 29, 2012

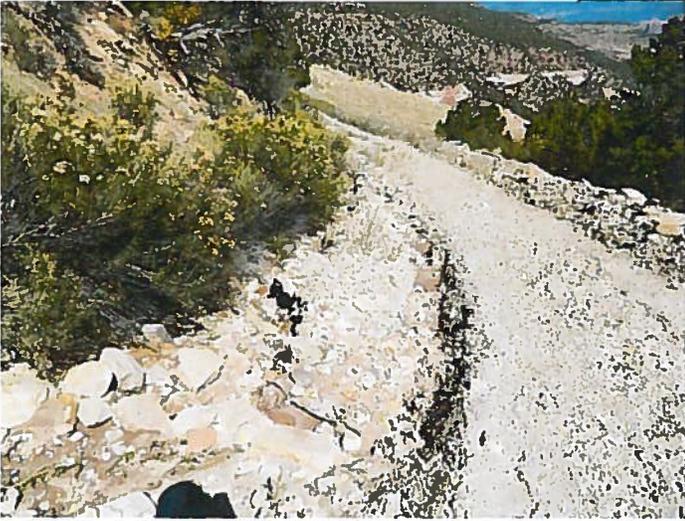
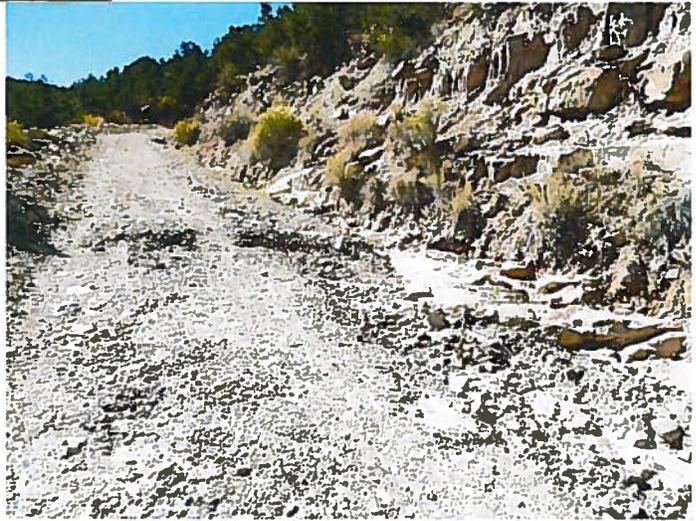
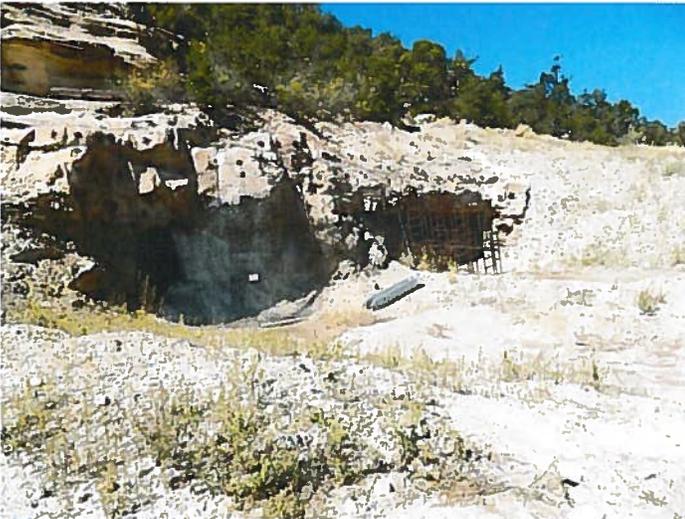
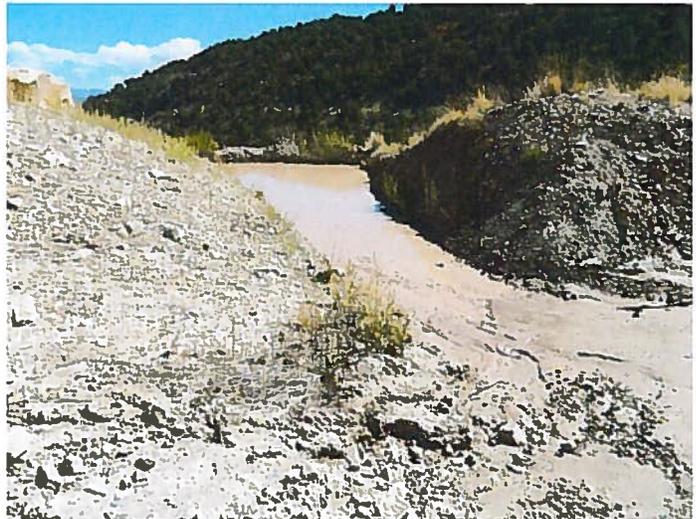
The Packrat portal was also inspected. The road the leads to the Packrat had recently been eroded by a precipitation event. The erosion was minor on the upper portion of the road but towards the bottom of the road increasingly significant erosional features were observed. The operator may want to install a culvert in the future to minimize erosional impact to the road.
