COLORADO DIVISION OF RECLAMATION, MINING AND SAFETY
MINERALS PROGRAM INSPECTION REPORT
PHONE: (303) 866-3567

MINE NAME: Lamar East Pit	MINE/PROSPECTING ID#: M-1977-572	MINERAL: Sand and gravel	COUNTY: Prowers
INSPECTION TYPE: Surety-Related Inspection	INSPECTOR(S): T C. Wait	INSP. DATE: October 25, 2012	INSP. TIME: 11:20
OPERATOR: Valco Inc.	OPERATOR REPRESENTATIVE: Tom Brubaker	TYPE OF OPERATION: 112c - Construction Regular Operation

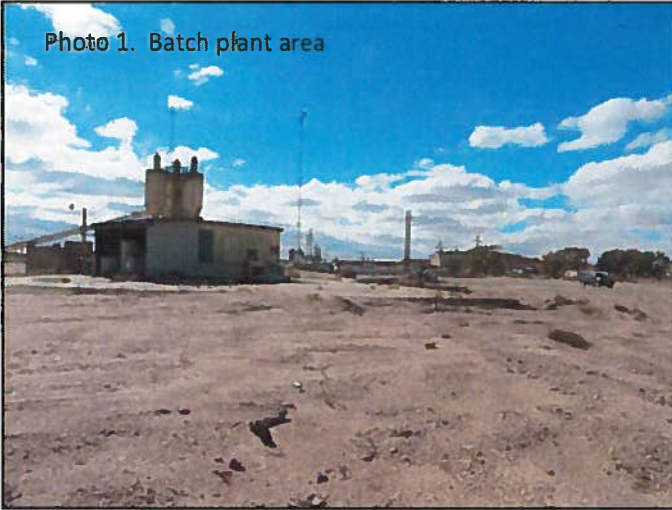
Photo 1. Batch plant area

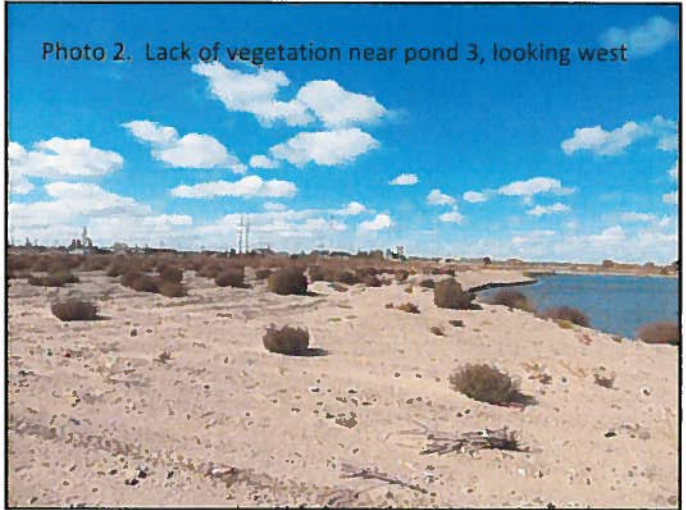
The initial seeding was not successful and will need to be re-seeded per the reclamation plan on file. Weed control should be implemented.

Photo 2. Lack of vegetation near pond 3, looking west

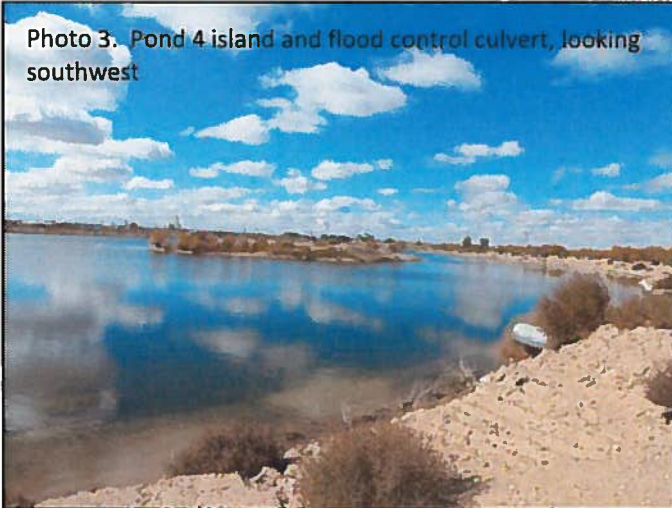
Photo 3. Pond 4 island and flood control culvert, looking southwest

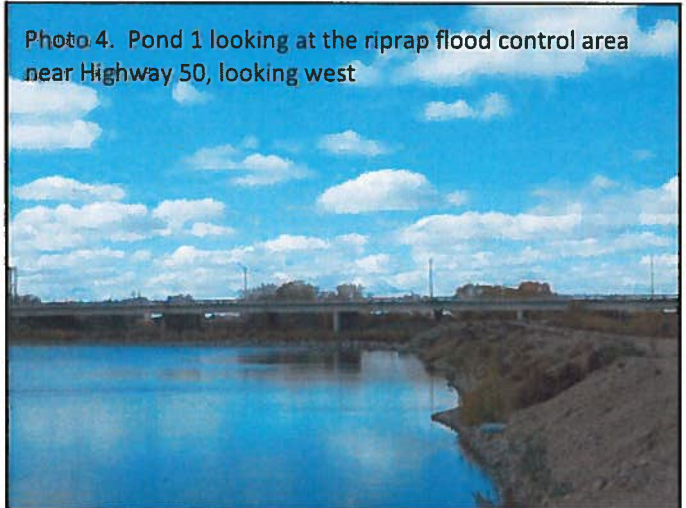
Photo 4. Pond 1 looking at the riprap flood control area near Highway 50, looking west

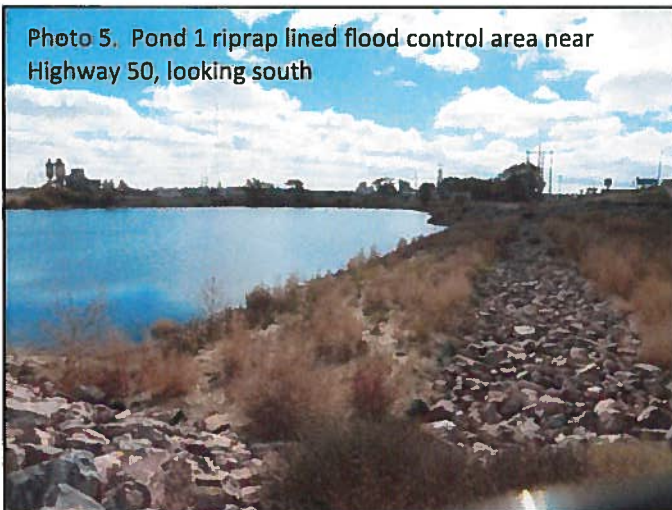
Photo 5. Pond 1 riprap lined flood control area near Highway 50, looking south

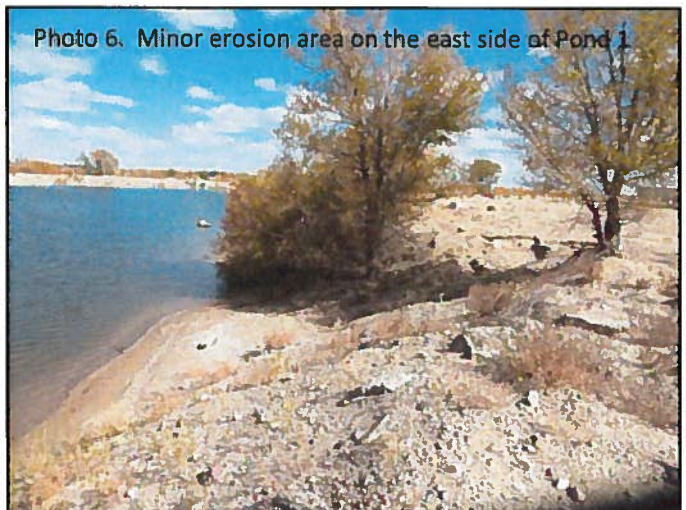
Photo 6. Minor erosion area on the east side of Pond 1
