COLORADO DIVISION OF RECLAMATION, MINING AND SAFETY
MINERALS PROGRAM INSPECTION REPORT
PHONE: (303) 866-3567

MINE NAME: Hawkeye Mine	MINE/PROSPECTING ID#: M-1978-311	MINERAL: Uranium & vanadium	COUNTY: San Miguel
INSPECTION TYPE: Monitoring	INSPECTOR(S): Bob Oswald	INSP. DATE: October 16, 2012	INSP. TIME: 15:30
OPERATOR: Gold Eagle Mining, Inc.	OPERATOR REPRESENTATIVE: None	TYPE OF OPERATION: 110d - Designated Limited Impact

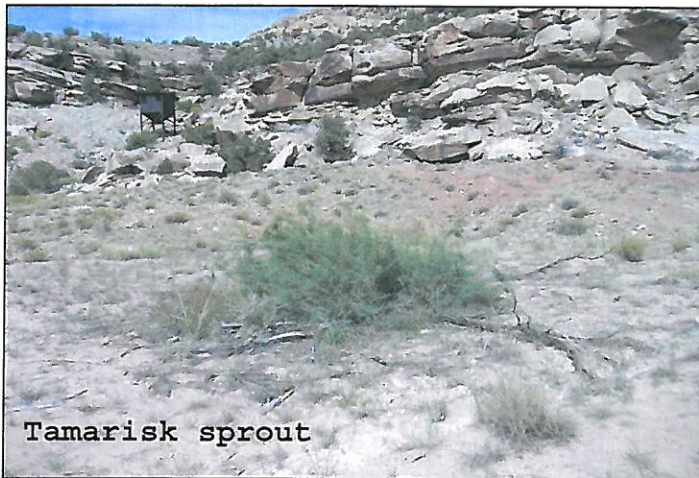
The operator has worked to control a small patch of Tamarisk that had infested the sediment pond floor. The large old plants were dead, but there were about 4 or 5 young sprouts emerging from the patch, which the operator should endeavor to re-treat this year. Weakening the plants now will help make 2013 treatments more effective. Treatments and results should be summarized in the upcoming annual reports.

Tamarisk sprout

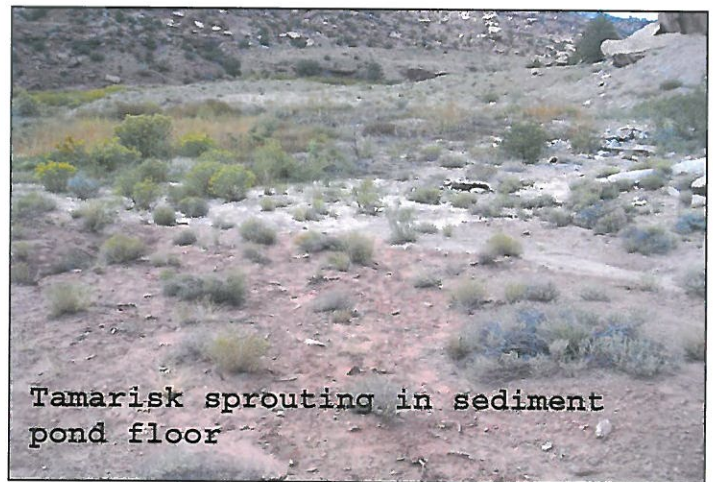
Tamarisk sprouting in sediment
pond floor

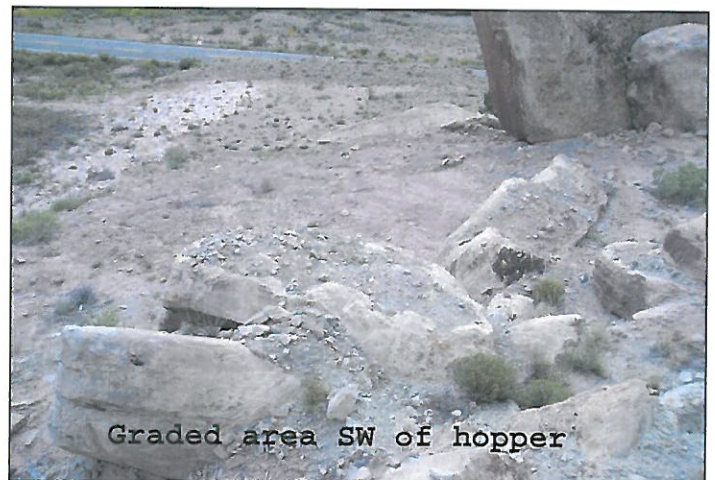
There are no disturbances up on the upper rim rock level of the permit. Grading and seeding was carried out several years ago on the slope below the hopper west of the gully.

Graded area SW of hopper
