**COLORADO DIVISION OF RECLAMATION, MINING AND SAFETY  
MINERALS PROGRAM INSPECTION REPORT  
PHONE: (303) 866-3567**

<b>MINE NAME:</b> Juniper Mountain Gravel	<b>MINE/PROSPECTING ID#:</b> M-2003-073	<b>MINERAL:</b> Gravel	<b>COUNTY:</b> Moffat
<b>INSPECTION TYPE:</b> Monitoring	<b>INSPECTOR(S):</b> Stephanie J. Reigh	<b>INSP. DATE:</b> November 6, 2012	<b>INSP. TIME:</b> 15:30
<b>OPERATOR:</b> Moffat Limestone Co. Inc.	<b>OPERATOR REPRESENTATIVE:</b> Darryl Steele, Moffat Limestone Company	<b>TYPE OF OPERATION:</b> 112c - Construction Regular Operation

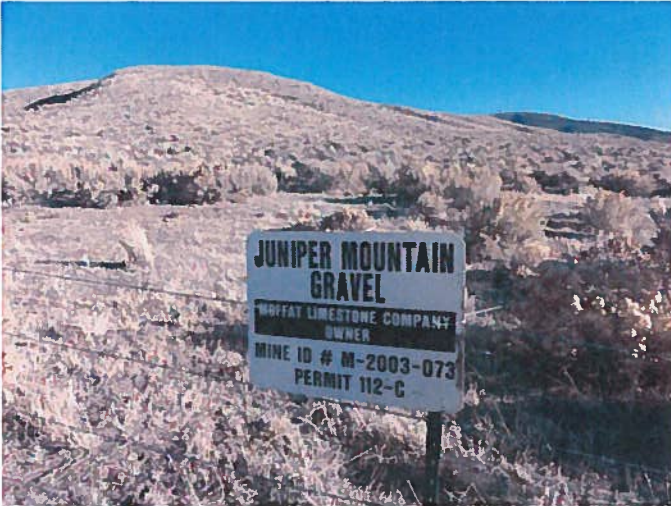
Permit Sign at Entrance

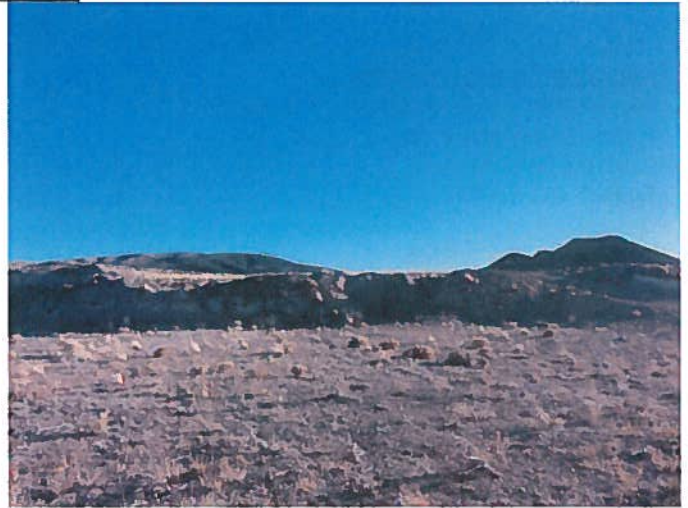
The appropriate mine entrance sign was in place. The permit boundaries were all clearly marked with t- posts. The current disturbance is located in the western portion of the permit area and is approximately 12 acres in size, and moving to the east. The excavation is about 10 to 12 feet deep with a vertical highwall with an eastern aspect. The highwall appears to be in the center of the permit area. Topsoil has been stripped and is located in the southwest corner of the site and is stabilized with vegetative cover. No erosion or sedimentation issues were observed.

Looking east to 10' highwall

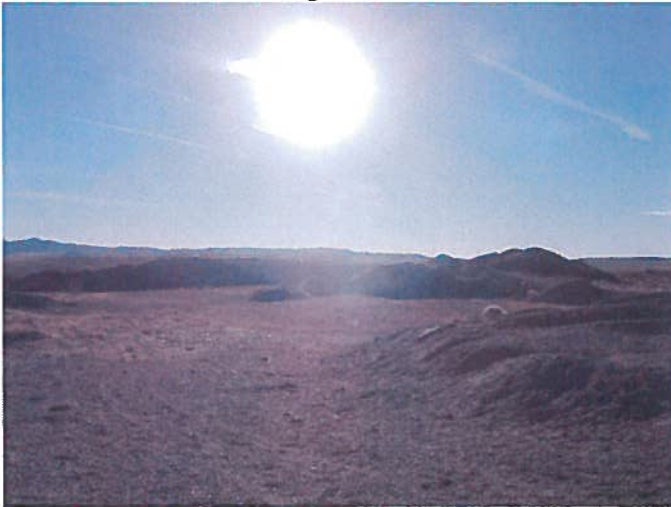
Looking West at top soil stockpiles

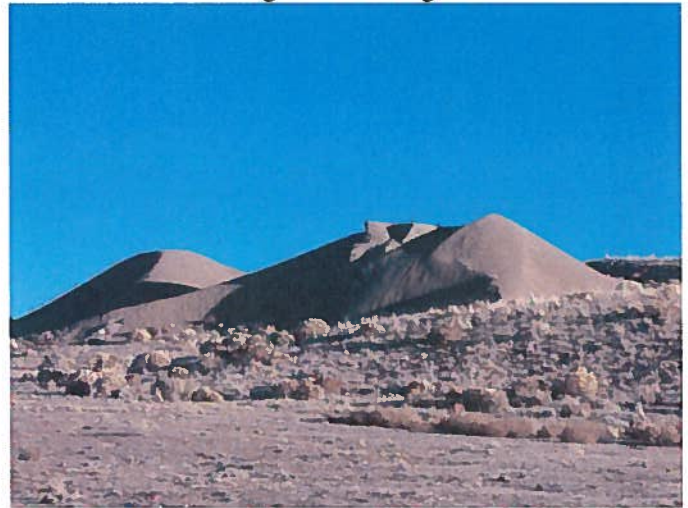
Material Stockpiles, pit run

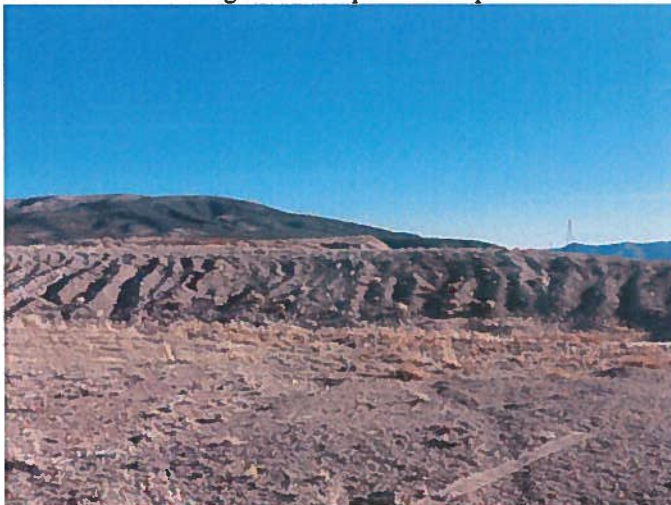
Graded topsoil in efforts to initiate contemporaneous reclamation

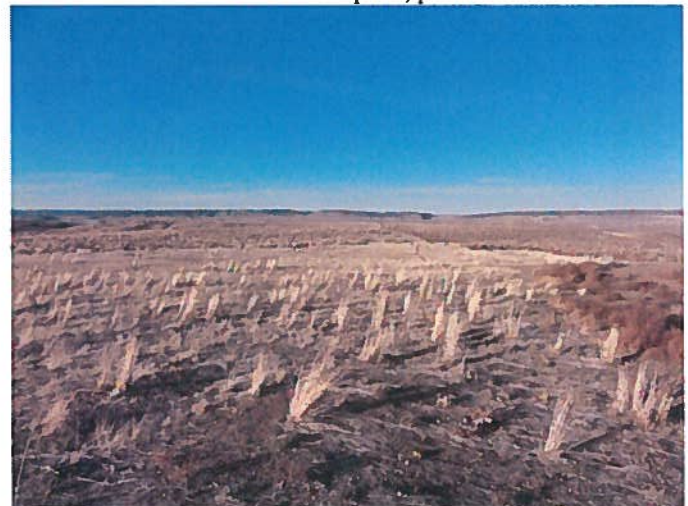
There was a drill seeder on site at the time of inspection. Reclamation is progressing on the eastern half of the site with established vegetation. This area has been drill seeded and notable vegetation is thickspike and western wheatgrasses.

Drill seeded established vegetation
