COLORADO DIVISION OF RECLAMATION, MINING AND SAFETY
MINERALS PROGRAM INSPECTION REPORT
PHONE: (303) 866-3567

MINE NAME: Flying Triangle Ranch Pit	MINE/PROSPECTING ID#: M-2008-018	MINERAL: Sand and gravel	COUNTY: Moffat
INSPECTION TYPE: Monitoring	INSPECTOR(S): Stephanie J. Reigh	INSP. DATE: November 5, 2012	INSP. TIME: 12:00
OPERATOR: Hard Rock Paving and Redi-Mix, Inc	OPERATOR REPRESENTATIVE:	TYPE OF OPERATION: 112c - Construction Regular Operation

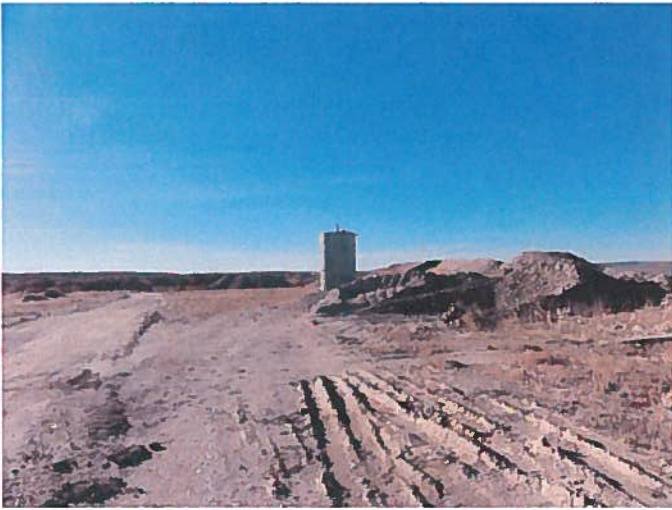
Looking southeast, topsoil stockpiles and frac tank

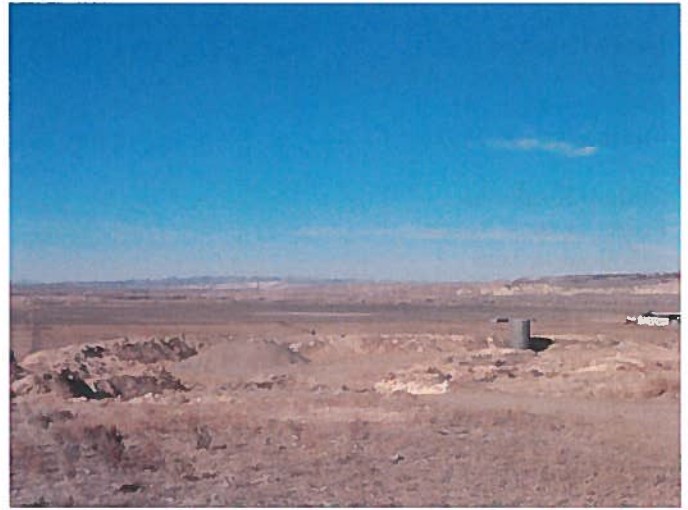
Site looking northwest, with Flying Triangle Ranch on left side of photo

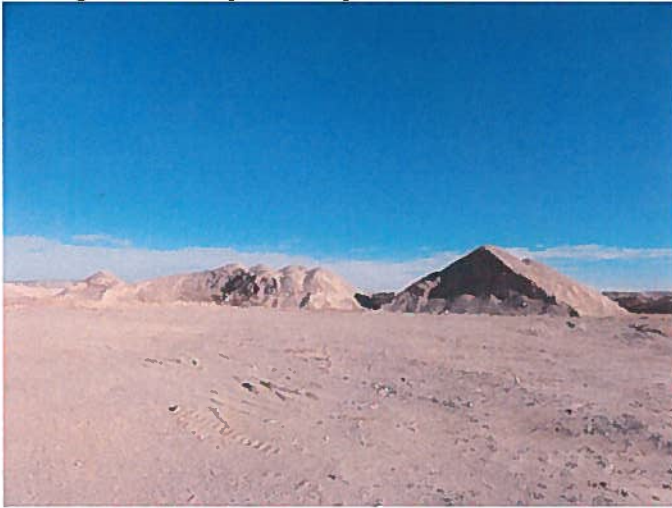
Material Stockpiles

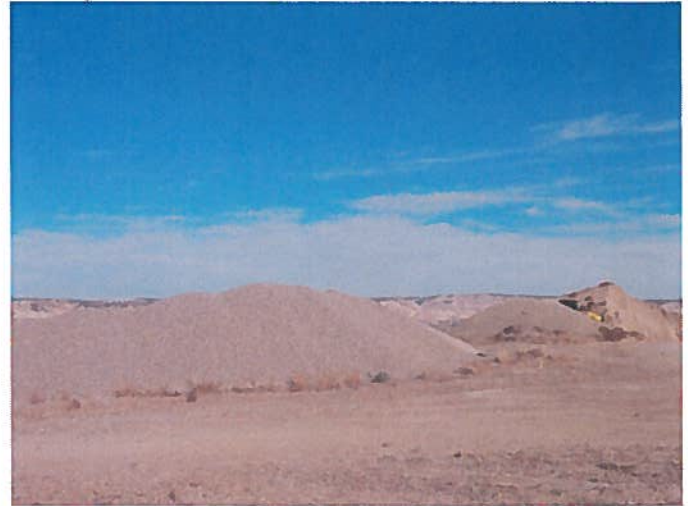
Looking north, material stockpiles

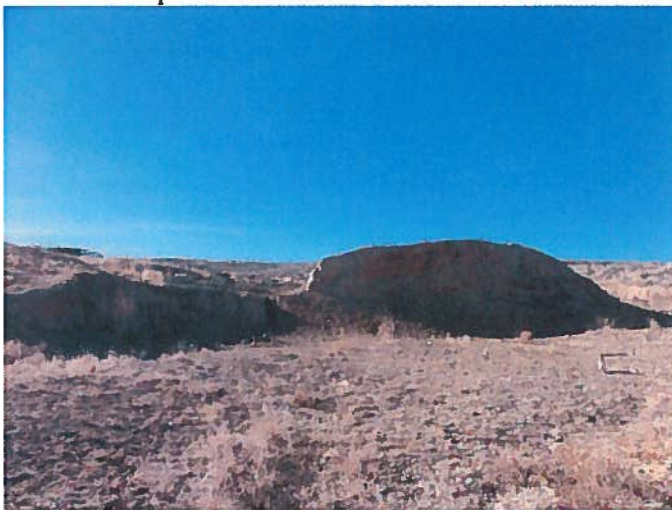
Looking south, topsoil stockpiles
