Re: Proctor Pit (M-2004-055 & M-2009-054)
Corrective Actions – PAST DUE

**COLORADO DIVISION OF RECLAMATION, MINING AND SAFETY
MINERALS PROGRAM INSPECTION REPORT
PHONE: (303) 866-3567**

MINE NAME: Proctor Pit	MINE/PROSPECTING ID#: M-2004-055 & M-2009-054	MINERAL: Gravel and sand	COUNTY: Otero
INSPECTION TYPE: Monitoring	INSPECTOR(S): T C. Wait	INSP. DATE: August 28, 2012	INSP. TIME: 11:40
OPERATOR: All Rite Paving & Redi-Mix, Inc.	OPERATOR REPRESENTATIVE: Herb Pearson	TYPE OF OPERATION: 112c - Construction Regular Operation

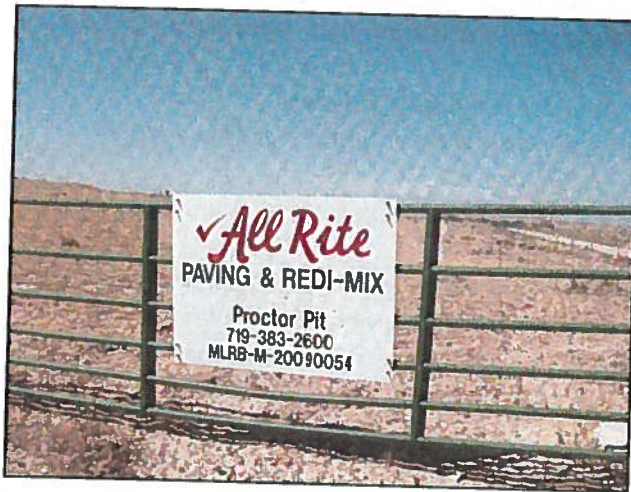
The site includes an access road from the County Road. The mine was accessed by vehicle. The permit sign was posted, and the permit boundaries have been marked. There are stockpiled materials in the west and southeast areas of the mine. Mr. Pearson estimated about 90,000 cubic yards of material on site. The mine has not been worked in about 3 years, but they are hauling from the stockpiles on a monthly basis.

Photo 1. Permit sign

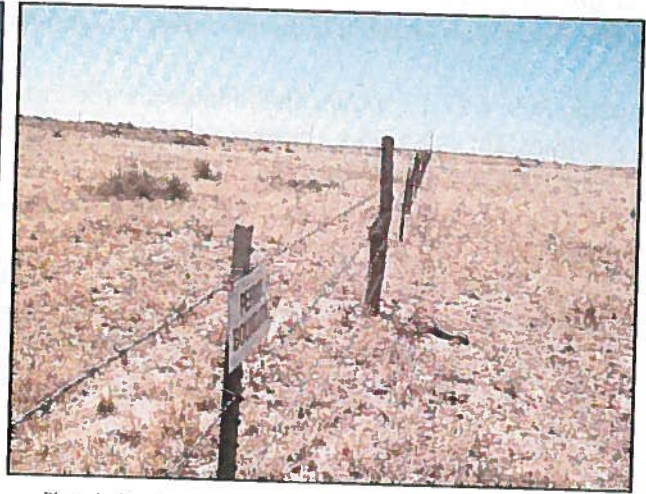
Photo 2. Permit boundary fence line and marker (east side looking south)

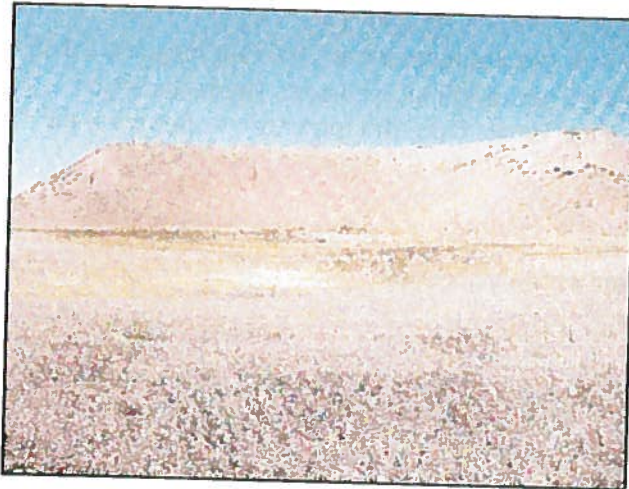
Photo 3. Stockpile and mine floor looking west

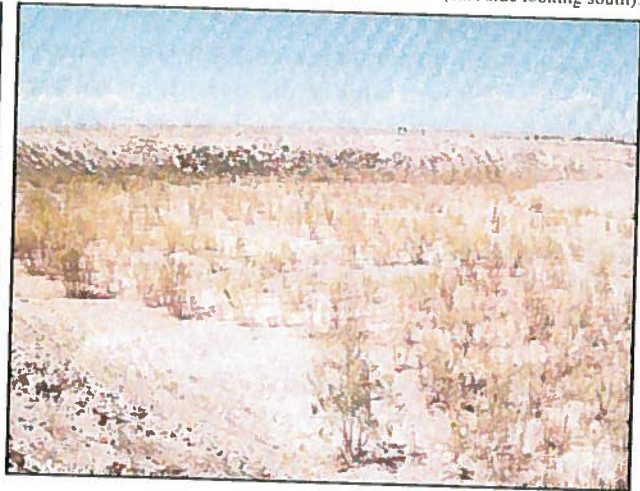
PROBLEM/POSSIBLE VIOLATION: Problem: Tamarisk (salt cedar) trees are present within or have volunteered into the permit area and are becoming established. This is a problem for failure to employ weed control methods for a state listed noxious weed species within the permitted area, and to reduce the spread of weeds to nearby areas as required by Section 3.1.10 (6) of the rule.

The southern end of the mine pit includes a highwall approximately 12 feet high and 1,200 feet in length. This area may collect runoff water and multiple tamarisk plants are growing. The DRMS file includes a weed control plan from the Operator (D. Gonzales, 8/27/04) that requires monthly inspections for noxious weeds, and herbicide spraying and removal of any noxious weeds present. The number and size of tamarisk present on the site indicates that the Operator is not following their weed control plan.

Photo 4. Active highwall area. Note tamarisk growing in pit.

CORRECTIVE ACTIONS: The operator shall implement the existing weed control plan in accordance with Section 3.1.10 (6) of the Rule. This plan should include specific control measures to be applied, a schedule for when control measures will be applied and a post-treatment monitoring plan. This weed control plan shall be implemented and photographic evidence submitted to the Division by the corrective action date.

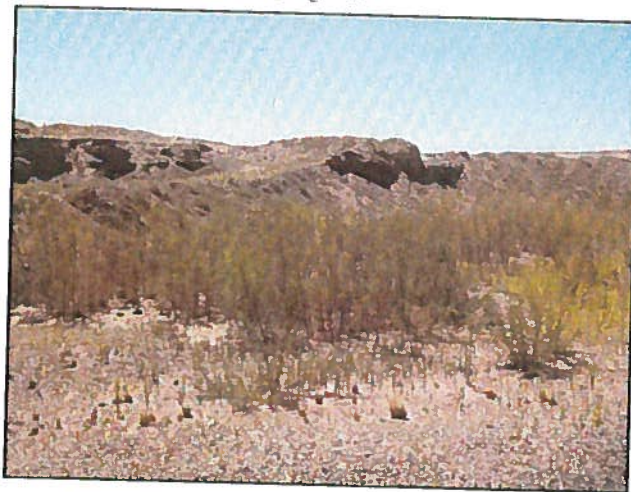
The mine has not changed much since 2009. The mine has a highwall approximately 1200 feet long and 10-12 ft high along the southern edge of the mine area. No backfilling or grading has occurred. The reclamation plan for the 112 permit (M-2009-054) states that final grading will be 4:1 from the top of the slope to the pit floor, then approximately a 1% grade downward to the north.

Photo 5. Looking southeast at highwall and tamarisk.

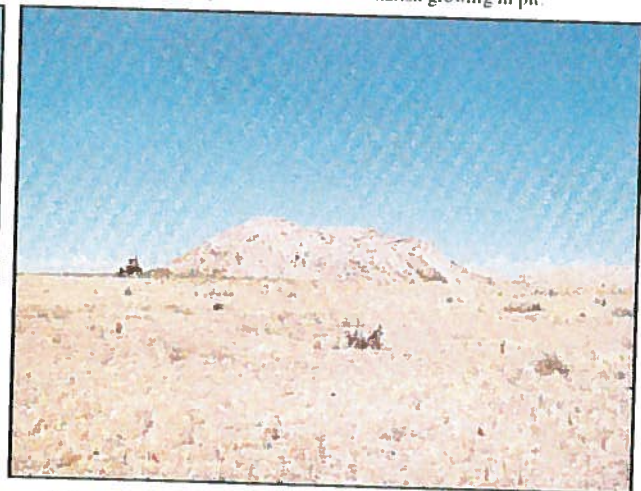
Photo 6. Southern stockpile of site with loading equipment (looking west)
