**COLORADO DIVISION OF RECLAMATION, MINING AND SAFETY**  
**MINERALS PROGRAM INSPECTION REPORT**  
**PHONE: (303) 866-3567**

<b>MINE NAME:</b> Idarado Mining Co	<b>MINE/PROSPECTING ID#:</b> M-1977-403-HR	<b>MINERAL:</b> Lead, zinc, copper, c gold	<b>COUNTY:</b> San Miguel
<b>INSPECTION TYPE:</b> Monitoring	<b>INSPECTOR(S):</b> Bob Oswald	<b>INSP. DATE:</b> November 9, 2012	<b>INSP. TIME:</b> 09:00
<b>OPERATOR:</b> Idarado Mining Company	<b>OPERATOR REPRESENTATIVE:</b> Alfred Berry, Mark Parker	<b>TYPE OF OPERATION:</b> 112d-3 - Designated Mining Operation

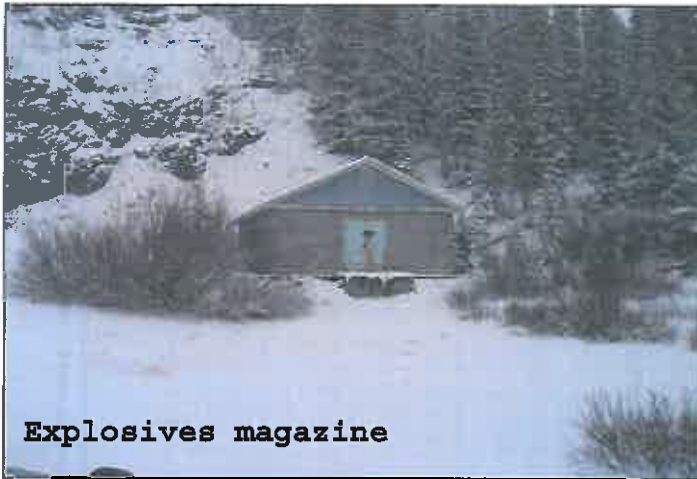
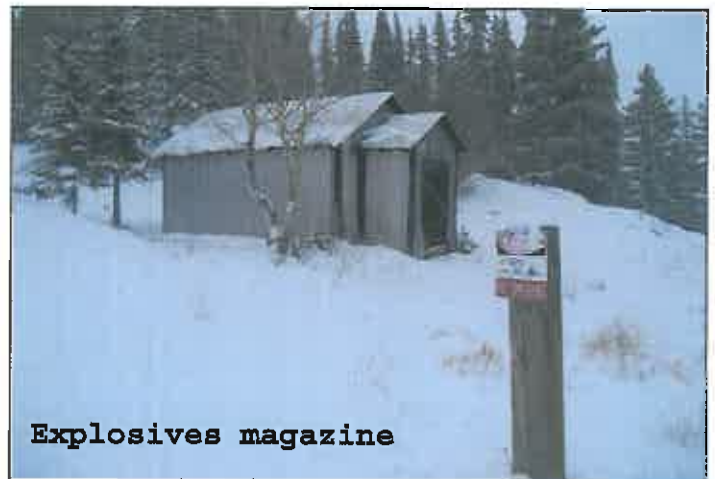
**Explosives magazine**

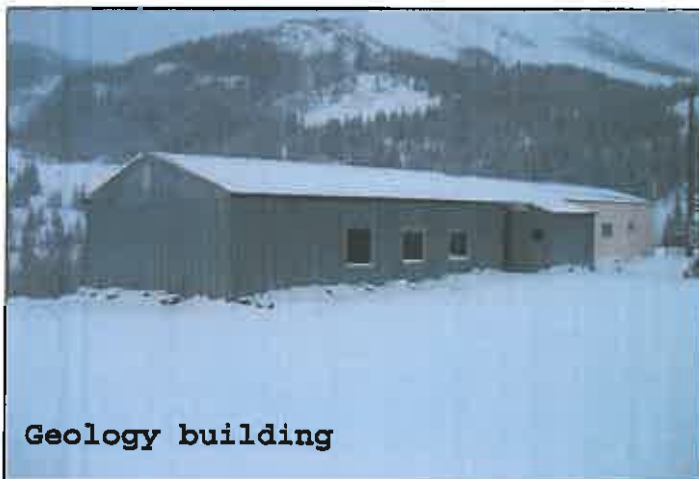
**Geology building**

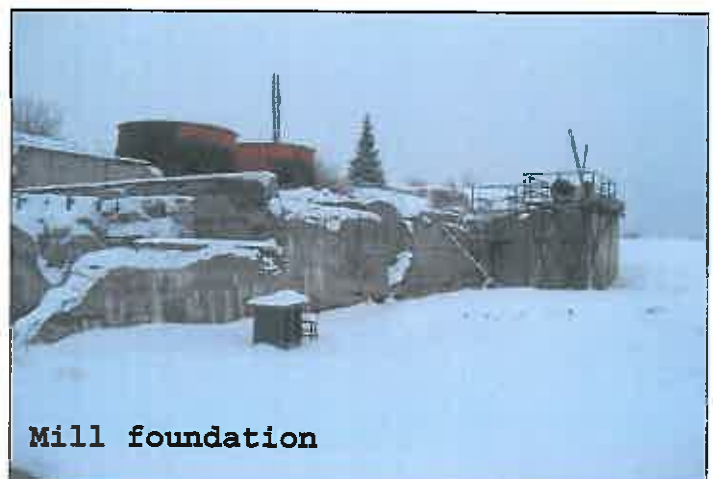
**Mill foundation**

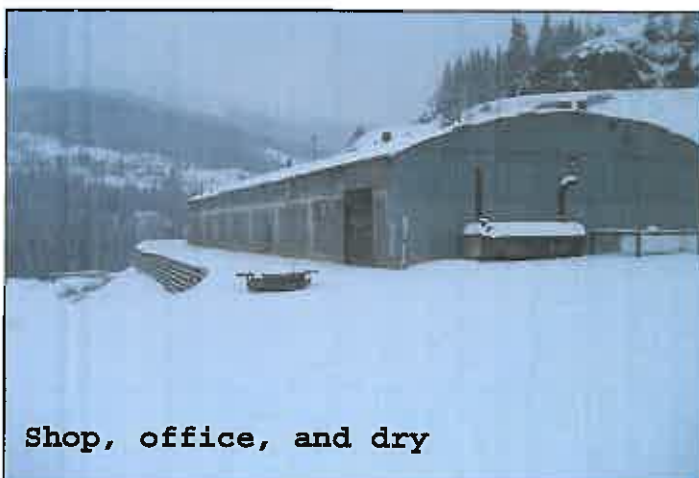
**Shop, office, and dry**

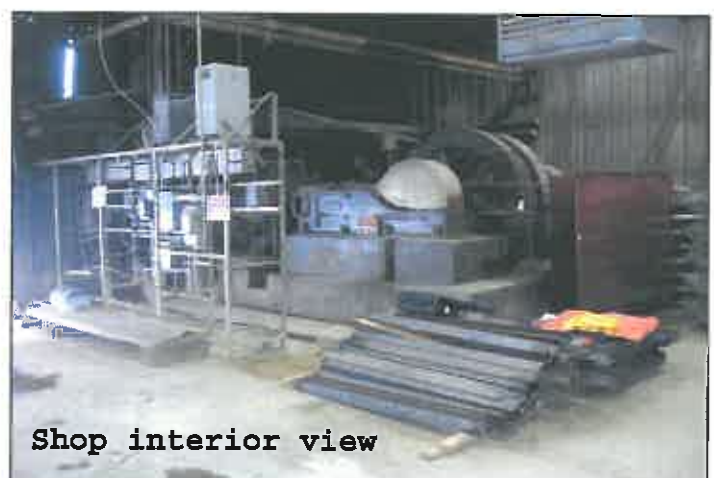
**Shop interior view**

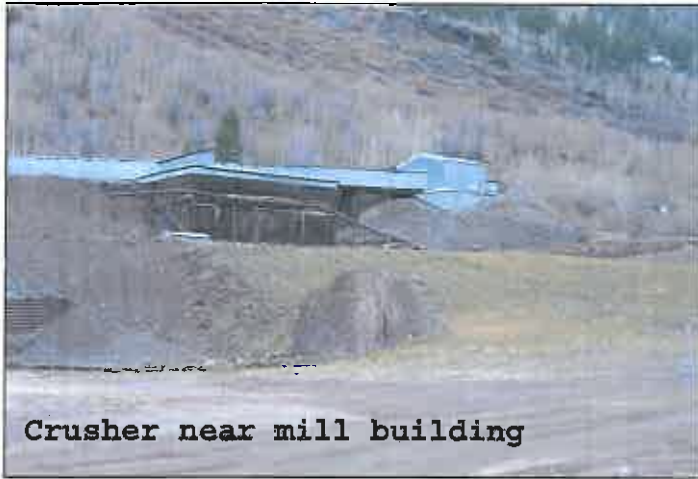
Crusher near mill building

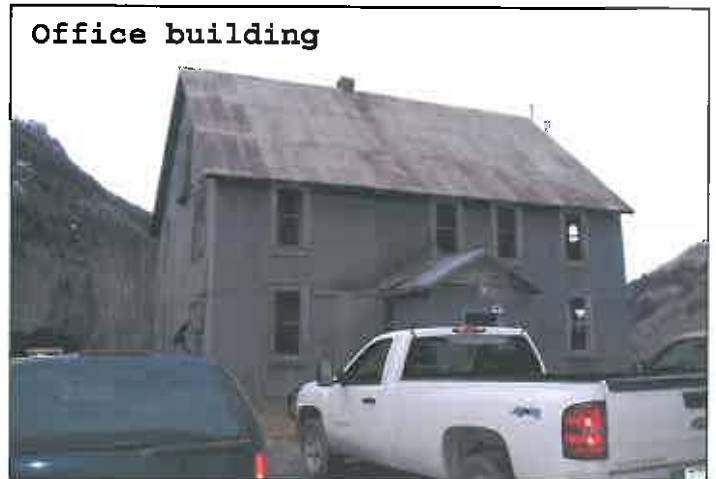
Office building

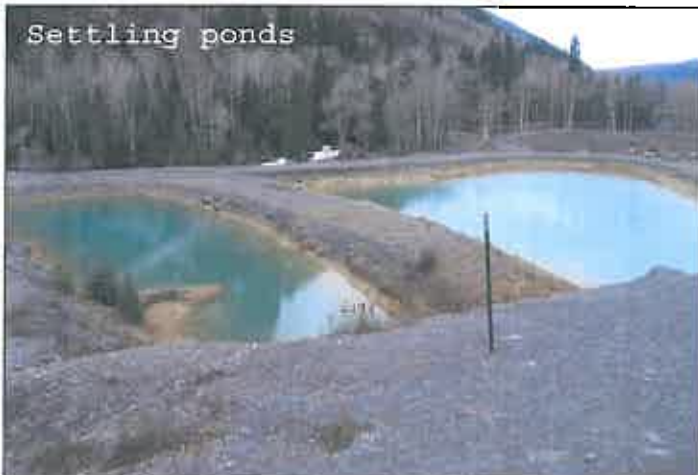
Settling ponds

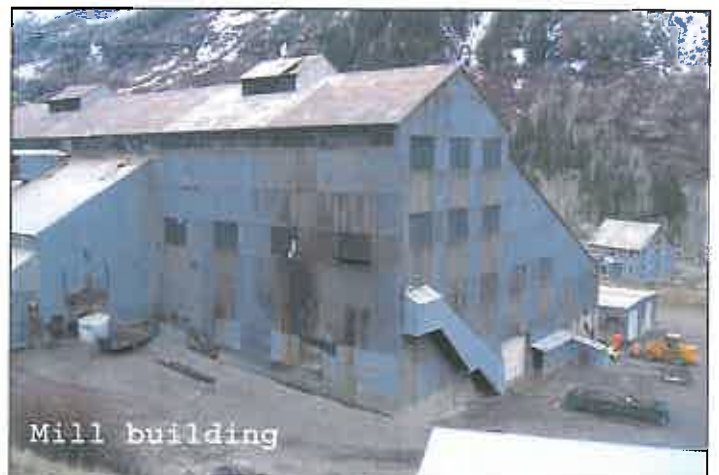
Mill building

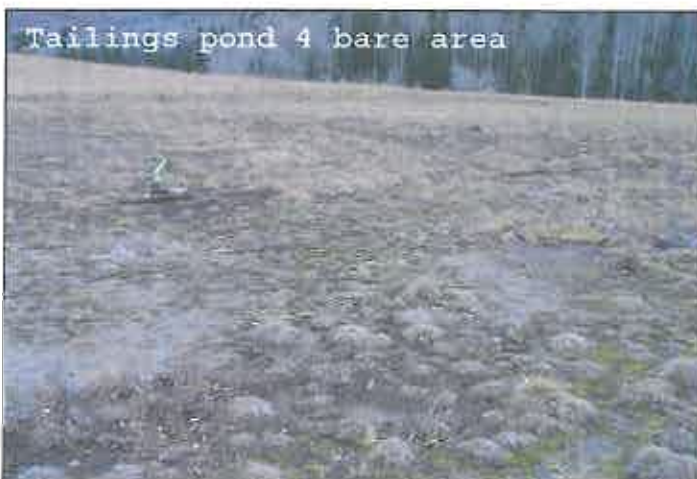
Tailings pond 4 bare area

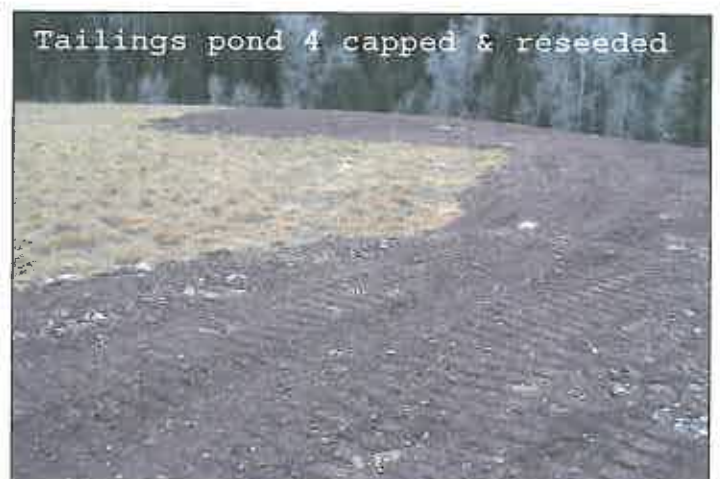
Tailings pond 4 capped & reseeded
