COLORADO DIVISION OF RECLAMATION, MINING AND SAFETY
MINERALS PROGRAM INSPECTION REPORT
PHONE: (303) 866-3567

MINE NAME: Clay Pit No. 21	MINE/PROSPECTING ID#: M-2009-060	MINERAL: Clay (general)	COUNTY: Moffat
INSPECTION TYPE: Monitoring	INSPECTOR(S): Stephanie J. Reigh	INSP. DATE: December 10, 2012	INSP. TIME: 12:30
OPERATOR: Moffat County Board of County Commission	OPERATOR REPRESENTATIVE: Marvin Moore	TYPE OF OPERATION: 112c - Construction Regular Operation

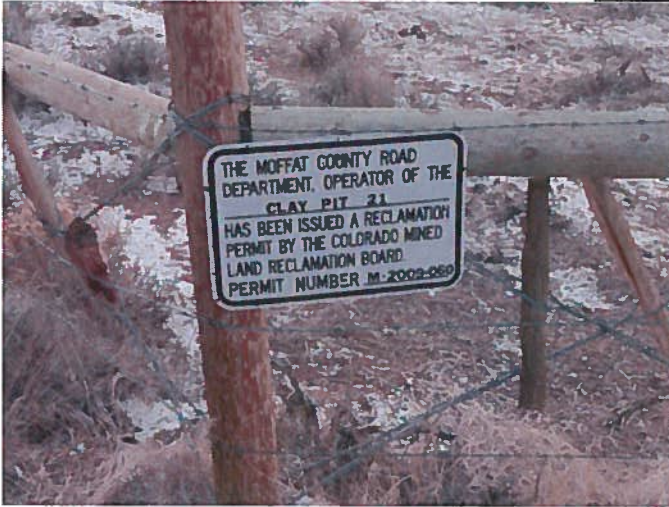
There were little or no weeds present at the site. The permit identification sign was properly placed and all permit boundary markers were present.

Permit Entrance Sign

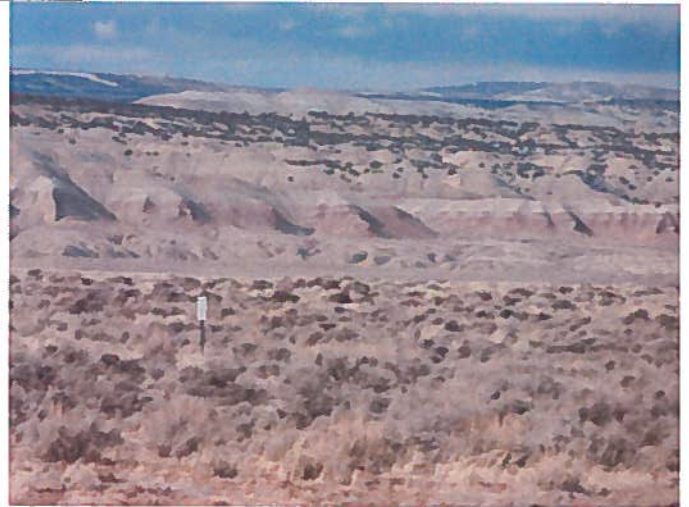
Looking north- not disturbed

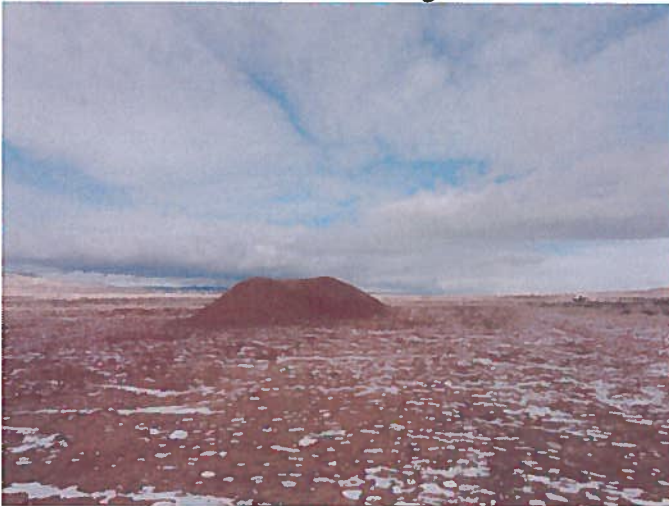
Topsoil Stockpile

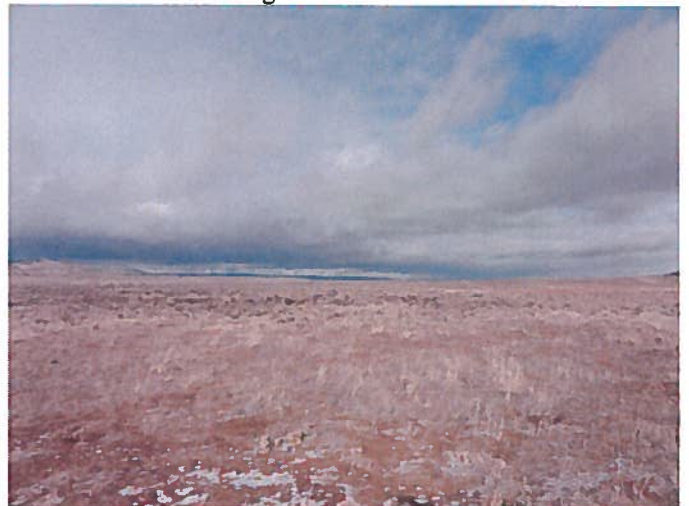
Looking NE

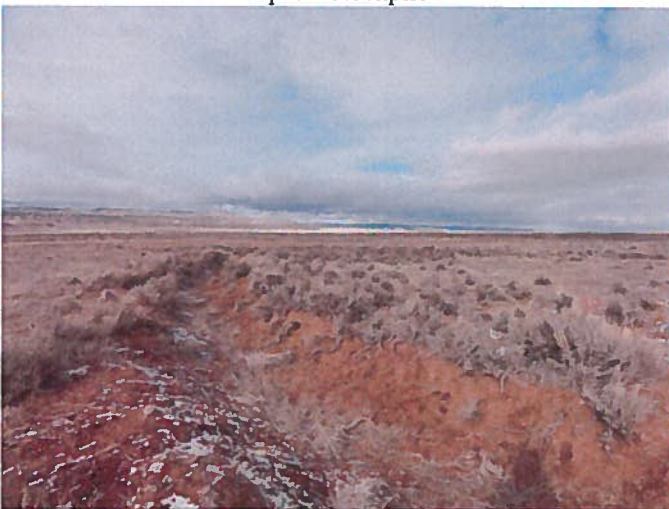
Storm water control ditch around perimeter of pit

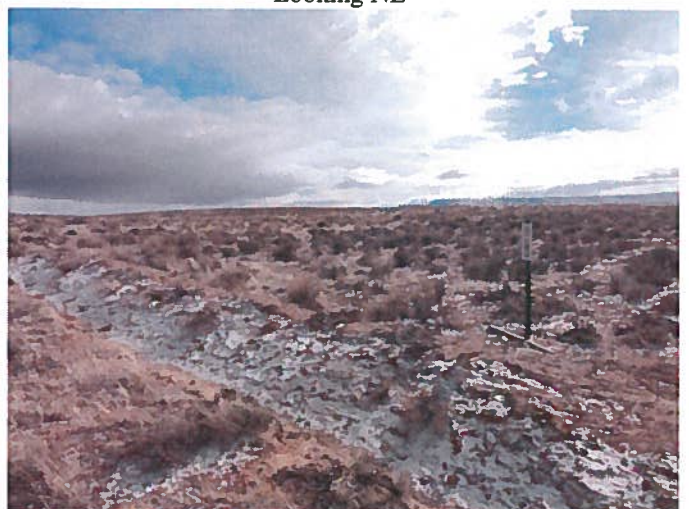
SW Boundary Marker
