COLORADO DIVISION OF RECLAMATION, MINING AND SAFETY
MINERALS PROGRAM INSPECTION REPORT
PHONE: (303) 866-3567

MINE NAME: Thomas Pit	MINE/PROSPECTING ID#: M-1976-020	MINERAL: Sand and gravel	COUNTY: La Plata
INSPECTION TYPE: Monitoring	INSPECTOR(S): Kate A. Pickford	INSP. DATE: December 6, 2012	INSP. TIME: 11:00
OPERATOR: Oldcastle SW Group, Inc dba Four Corners M	OPERATOR REPRESENTATIVE: Matt Carnahan	TYPE OF OPERATION: 112c - Construction Regular Operation

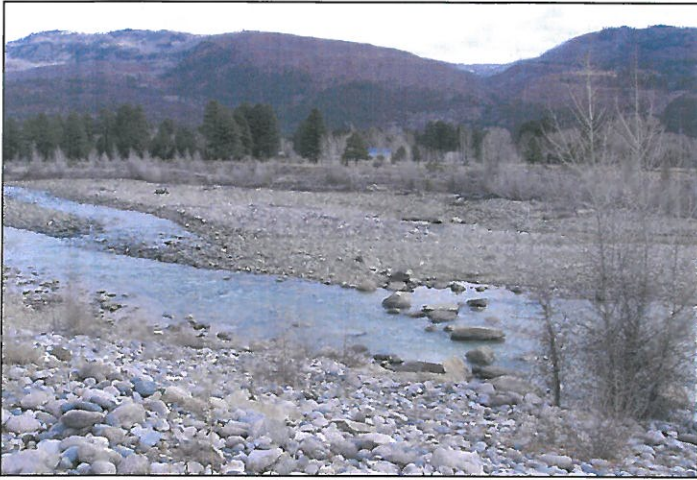
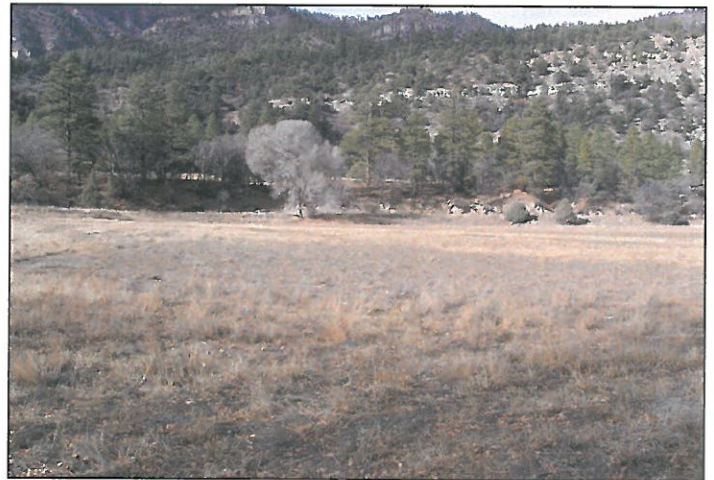
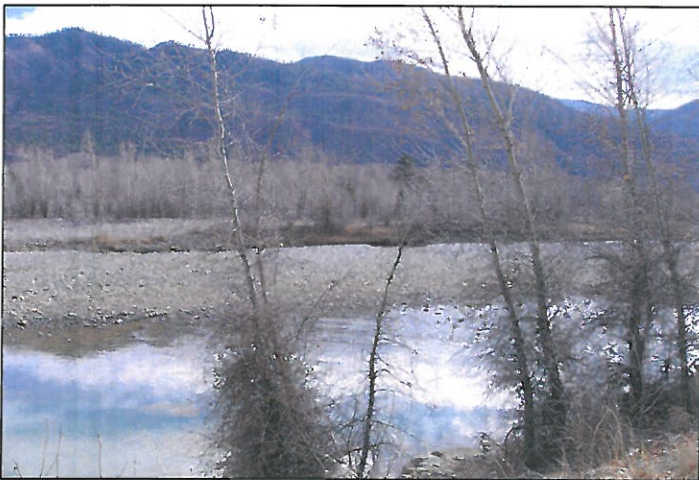
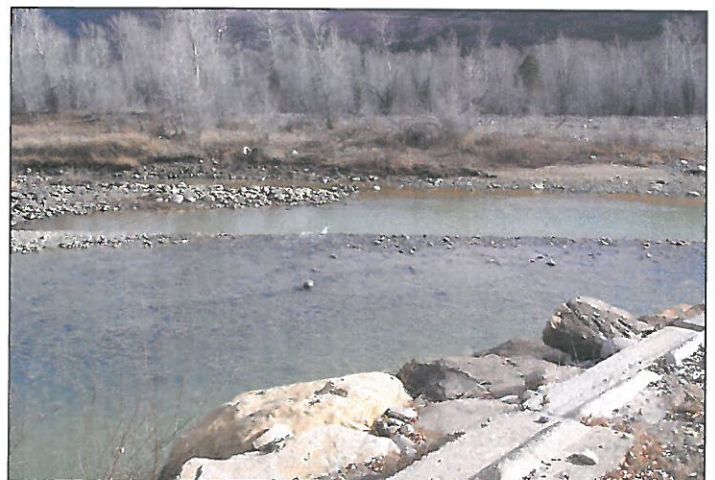
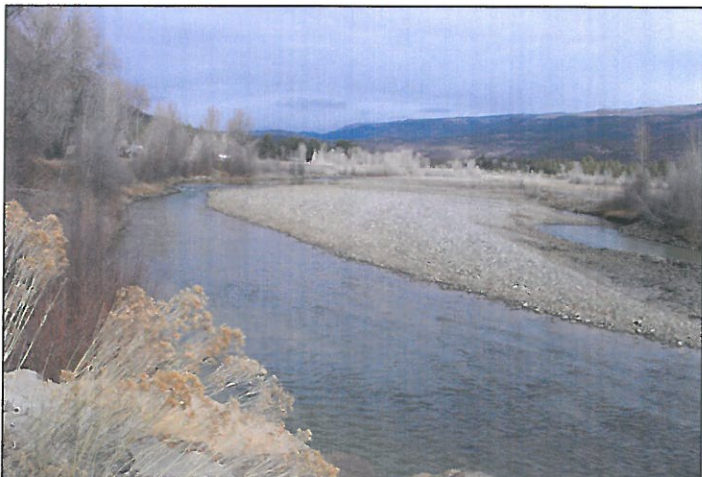
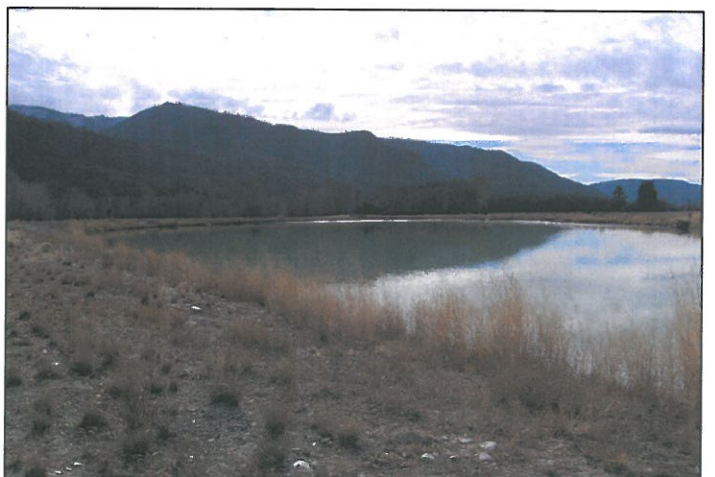
The site is in final reclamation. The remnants of a drop structure are present in the northern reach of the site in the river channel. The berm that was in the river channel has been removed and the area graded. A portion of the upper area on the western bank has been graded and seeded and will be irrigated for hay production. The south pond is graded and vegetation is growing in. The landowner stated that Cottonwoods still need to be planted in this area. The bank retention structures along the south end of the river channel appear to be stable and holding up well.
