## COLORADO DIVISION OF RECLAMATION, MINING AND SAFETY COAL PROGRAM INSPECTION REPORT

Permit Number: C-1981-019 Mine Name: Colowyo Coal Mine Operator: Colowyo Coal Company L.P. Operator Address: Mr. Tony Tennyson 5731 State Highway 13 Meeker, CO 81641 County: Moffat, Rio Blanco Operation Type: Surface Permit Status: Active Ownership: Federal

Inspection Start Date: December 19, 2012 Inspection Start Time: 12:00 Inspection End Date: December 20, 2012 Inspection End Time: 10:30		Inspection	<b>Inspection Type:</b> Coal Complete Inspection <b>Inspection Reason:</b> Normal I&E Program <b>Weather:</b> Clear	
Joint Inspection Agency:		Joint Inspection Contacts:		
None				
Post Inspection Agency:		Post Inspection Contacts:		
None				
Inspector(s):	Inspector'	's Signature:	Signature D	ate:
Robert D. Zuber	Ph	ut D.	2/26/20	12

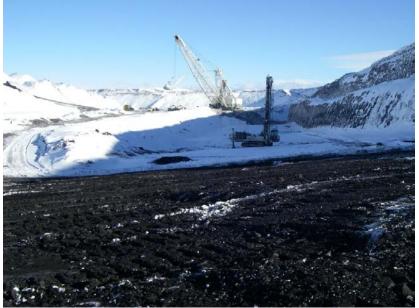
In the West Pit, the 103 dragline was idle. A drill rig was onsite but was not in operation at the time of the inspection.

West Pit – idle 103 dragline and drill rig. The 101 dragline is in background, on horizon.

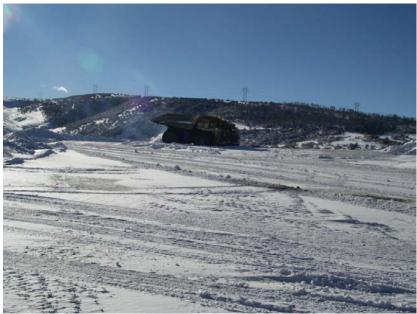
**South Taylor Pit – idle haul trucks**

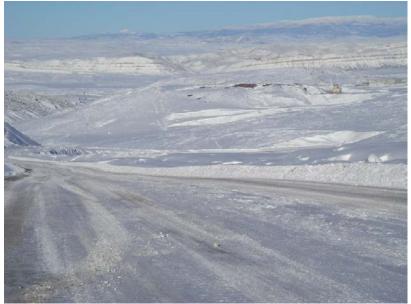
Several pieces of heavy equipment were clearing haul roads; the majority of the haul roads were clear at the time of the inspection, but other roads were generally blocked.

Haul Road to South Taylor (foreground) and West Pit reclamation (looking north)

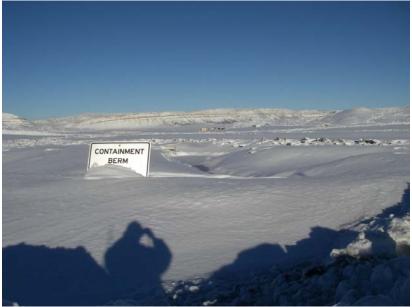
**Stoker Siding Pond**

The following ponds were (partially) inspected: Prospect, Streeter, Rail Loop, Gossard, and Stoker Siding. The inspection entailed looking at the ponds from the nearest road. All were holding water. Streeter was observed to be discharging. It could not be determined if others were discharging. No problems were identified with embankments, spillways, or other aspects of the ponds.

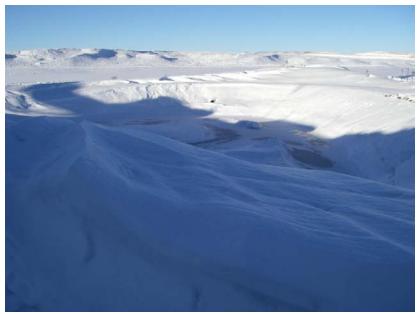
**Gossard Pond – water level below pipe invert**

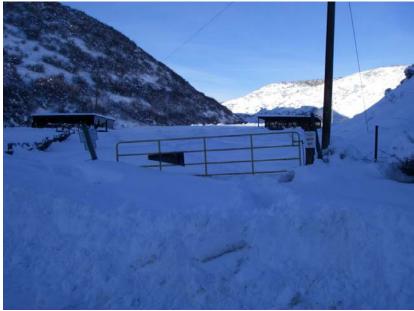
Road to Section 28 Pond

The road to the Section 28 Pond was not passable due to snow.

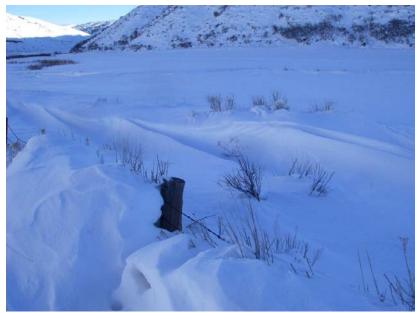
Prospect Pond – flume covered with snow

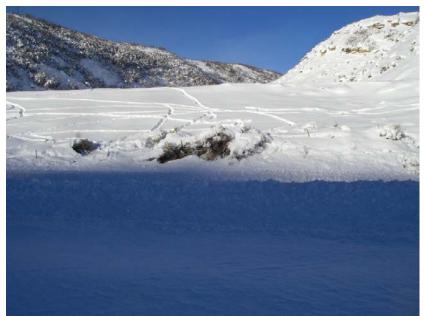
Prospect Pond – embankment (photo from County Road 13)

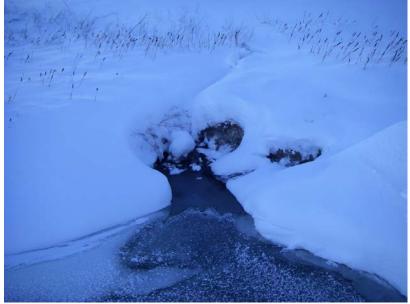
Streeter Pond – sign of discharge

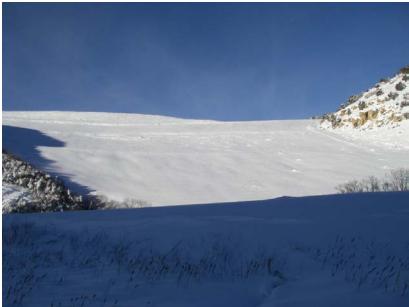
**Streeter Fill**

No problems were identified at the Streeter Fill, the West Taylor Fill, or the East Taylor Fill. At the West Taylor Fill, a dozer was clearing snow at the dump area.

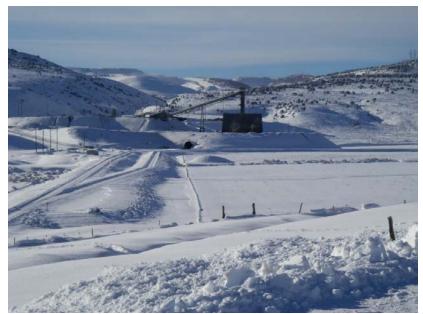
**Gossard Loadout (looking south)**

The main facilities area, the Gossard Loadout, and the South Taylor Ready Line were inspected. They were only partially cleared of snow. No problems were observed.
