COLORADO DIVISION OF RECLAMATION, MINING AND SAFETY
MINERALS PROGRAM INSPECTION REPORT
PHONE: (303) 866-3567

MINE NAME: Alma Placer Mine	MINE/PROSPECTING ID#: M-1985-029	MINERAL: Gold	COUNTY: Park
INSPECTION TYPE: Surety Reduction Inspection	INSPECTOR(S): Tom Kaldenbach	INSP. DATE: September 28, 2012	INSP. TIME: 13:15
OPERATOR: High Mountain Mining Co., LLC	OPERATOR REPRESENTATIVE: Jim Murray, Greg Lewicki, Mary Burns	TYPE OF OPERATION: 112 - Hard Rock Regular Operation

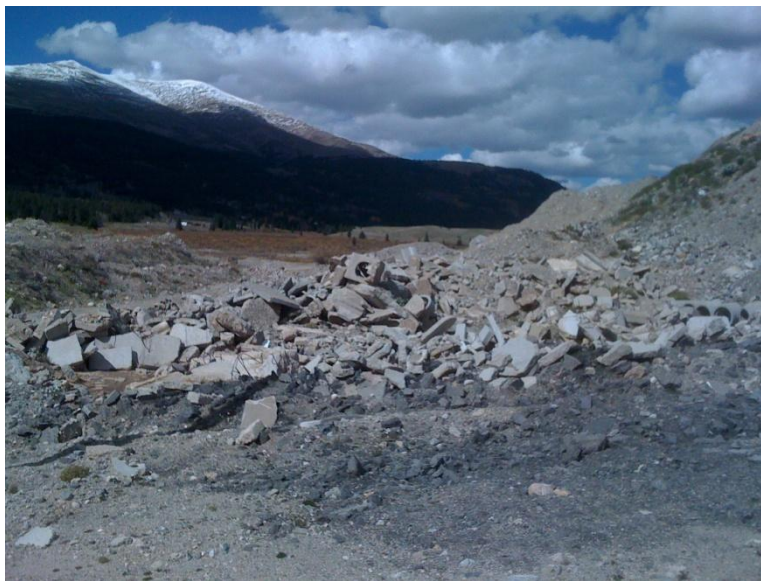
Photo 2 – Gravel operation. Concrete that is imported to the site, is processed, then hauled offsite (is not used for backfill).

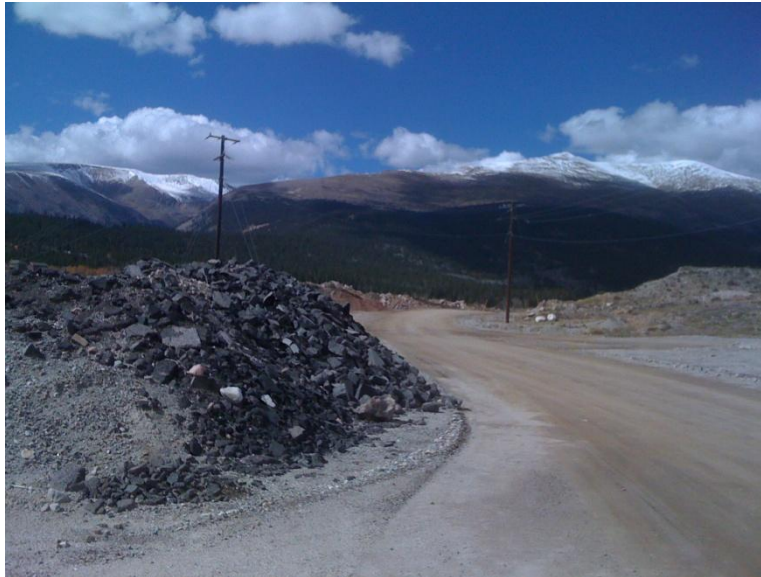
Photo 3 – Gravel operation. Asphalt that is imported to the site, is processed, then hauled offsite (is not used for backfill).

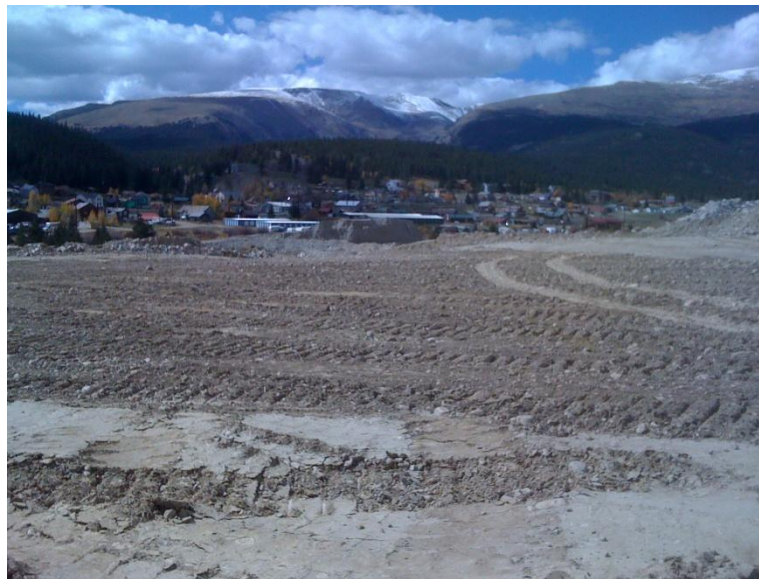
Photo 4 – Gold operation. Recent regrading.

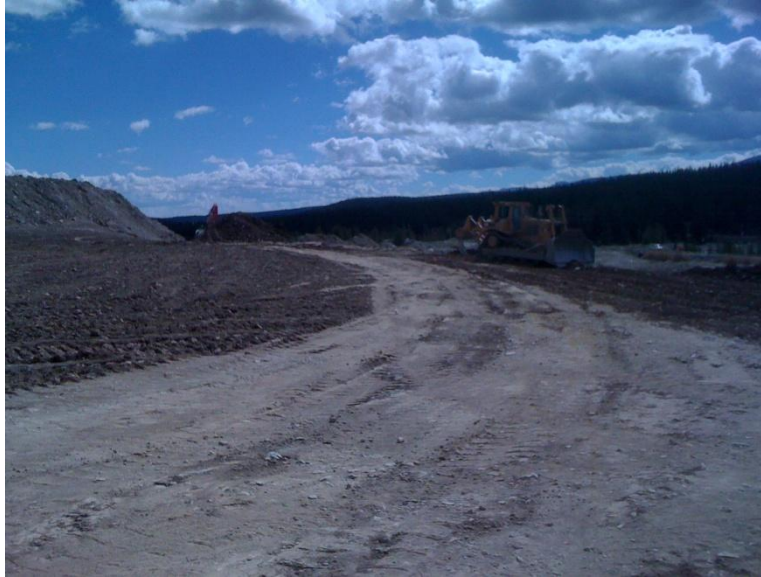
Photo 5 – Gold operation. Regrading of reclaimed area being conducted during inspection.

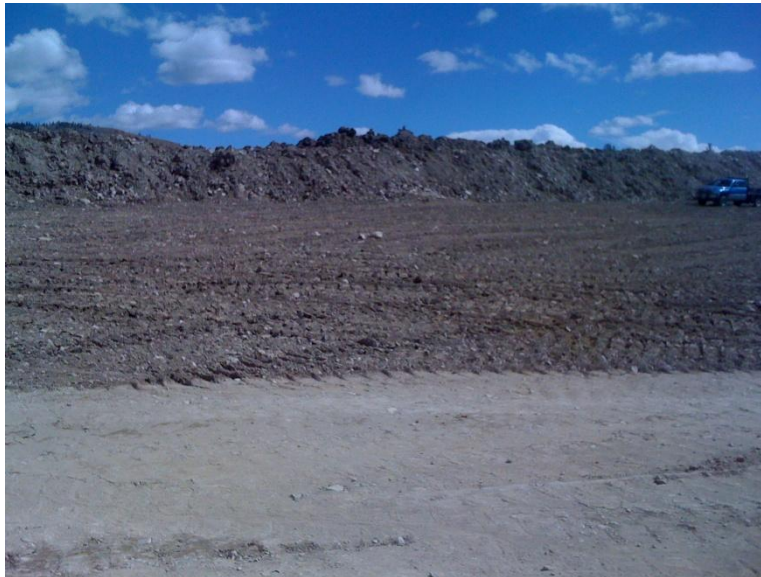
Photo 6 – Gold operation. Recently regraded area.

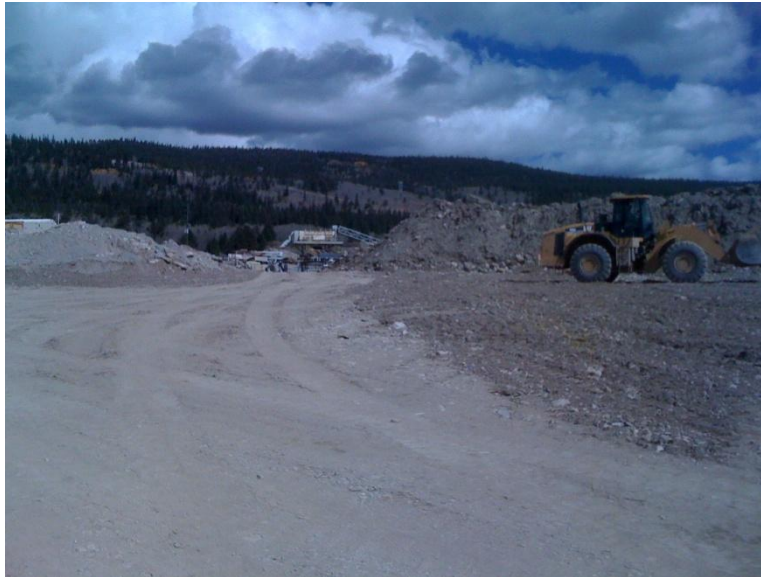
Photo 7 – Gold operation. Recently regraded area.

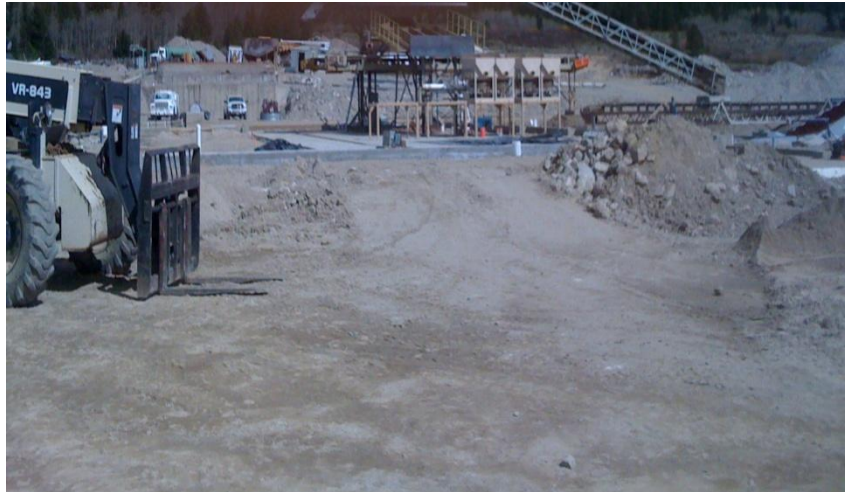
Photo 9 – Gold operation. New mill building footers and steel structure.

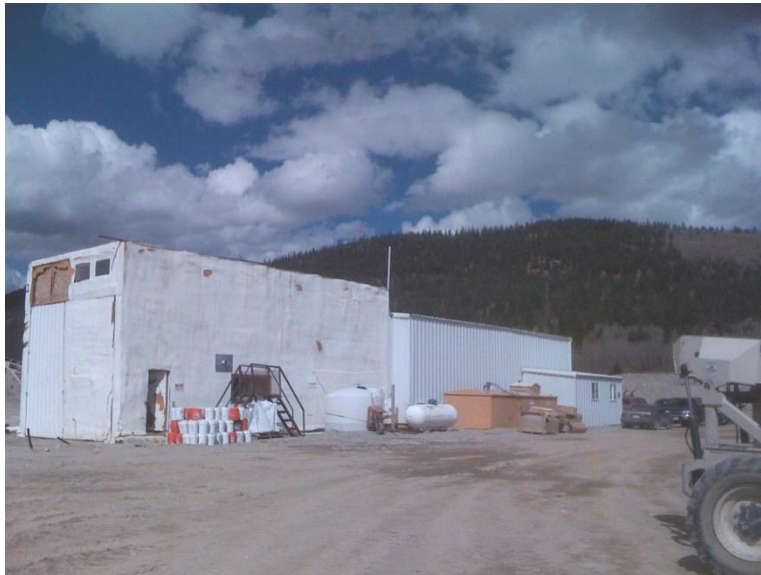
Photo 10 – Gold operation. Office building and old processing plant building.
