**COLORADO DIVISION OF RECLAMATION, MINING AND SAFETY
MINERALS PROGRAM INSPECTION REPORT
PHONE: (303) 866-3567**

MINE NAME: Camp Bird Tailings Exploration Project	MINE/PROSPECTING ID#: P-2012-017	MINERAL: Au, Ag, Pb, Zn, W	COUNTY: Ouray
INSPECTION TYPE: Multi Person Inspection	INSPECTOR(S): Wallace H. Erickson, Robert C. Oswald	INSP. DATE: December 3, 2012	INSP. TIME: 11:40
OPERATOR: Caldera Mineral Resources, LLC	OPERATOR REPRESENTATIVE: Mike Thompson, Robert Larson	TYPE OF OPERATION: MP - Mineral Prospecting	
REASON FOR INSPECTION: Normal I&E Program	BOND CALCULATION TYPE: Complete Bond	BOND AMOUNT: \$11,000.00	
DATE OF COMPLAINT: NA	POST INSP. CONTACTS: None	JOINT INSP. AGENCY: None	
WEATHER: Cloudy	INSPECTOR'S SIGNATURE:

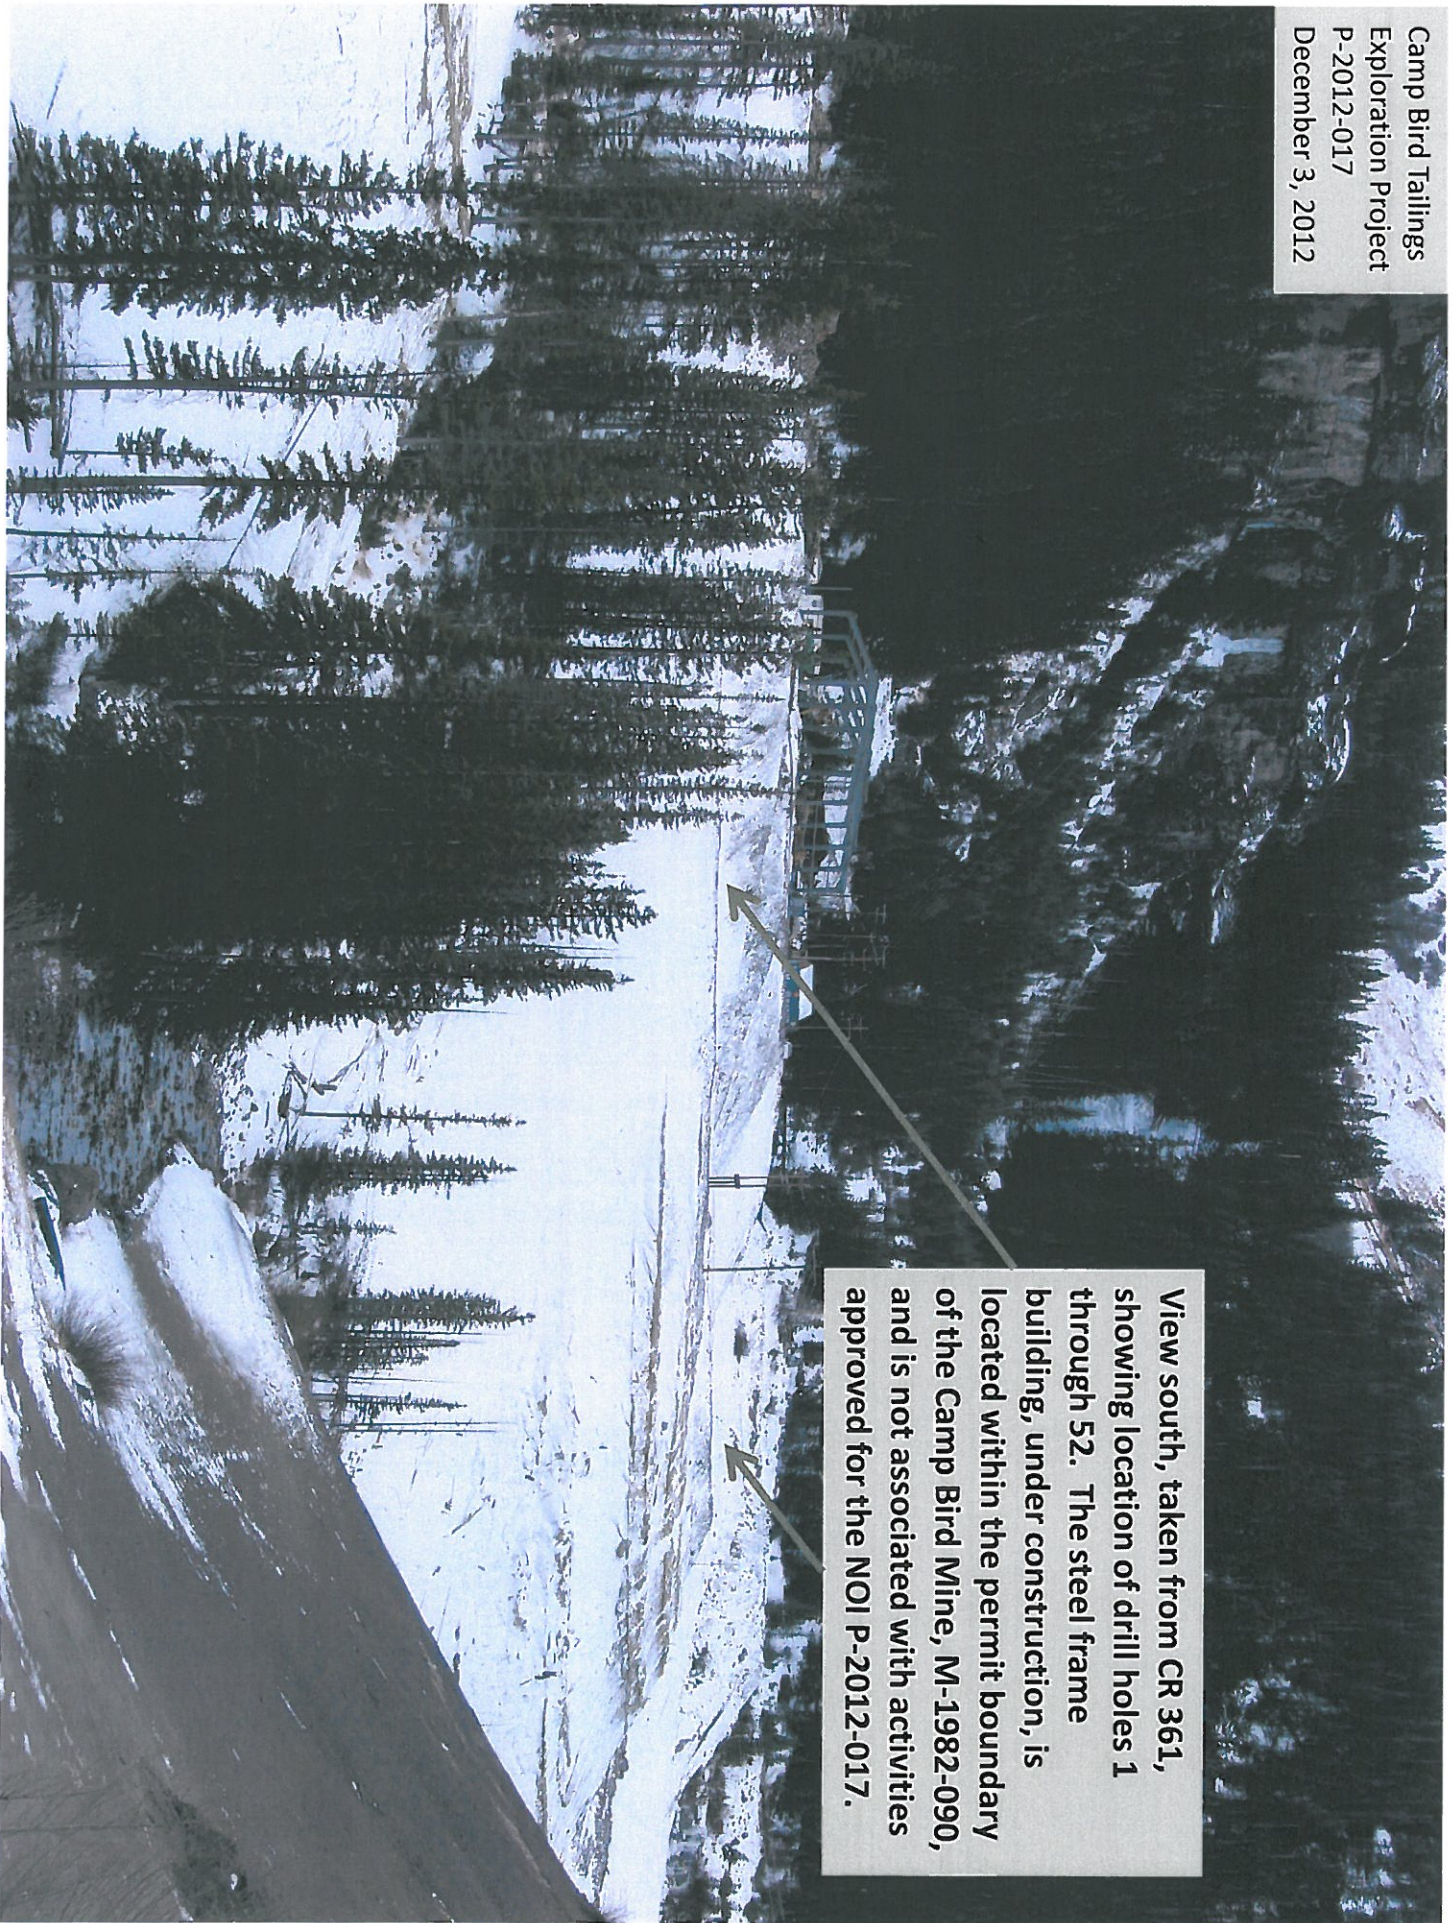
View south, taken from CR 361, showing location of drill holes 1 through 52. The steel frame building, under construction, is located within the permit boundary of the Camp Bird Mine, M-1982-090, and is not associated with activities approved for the NOI P-2012-017.

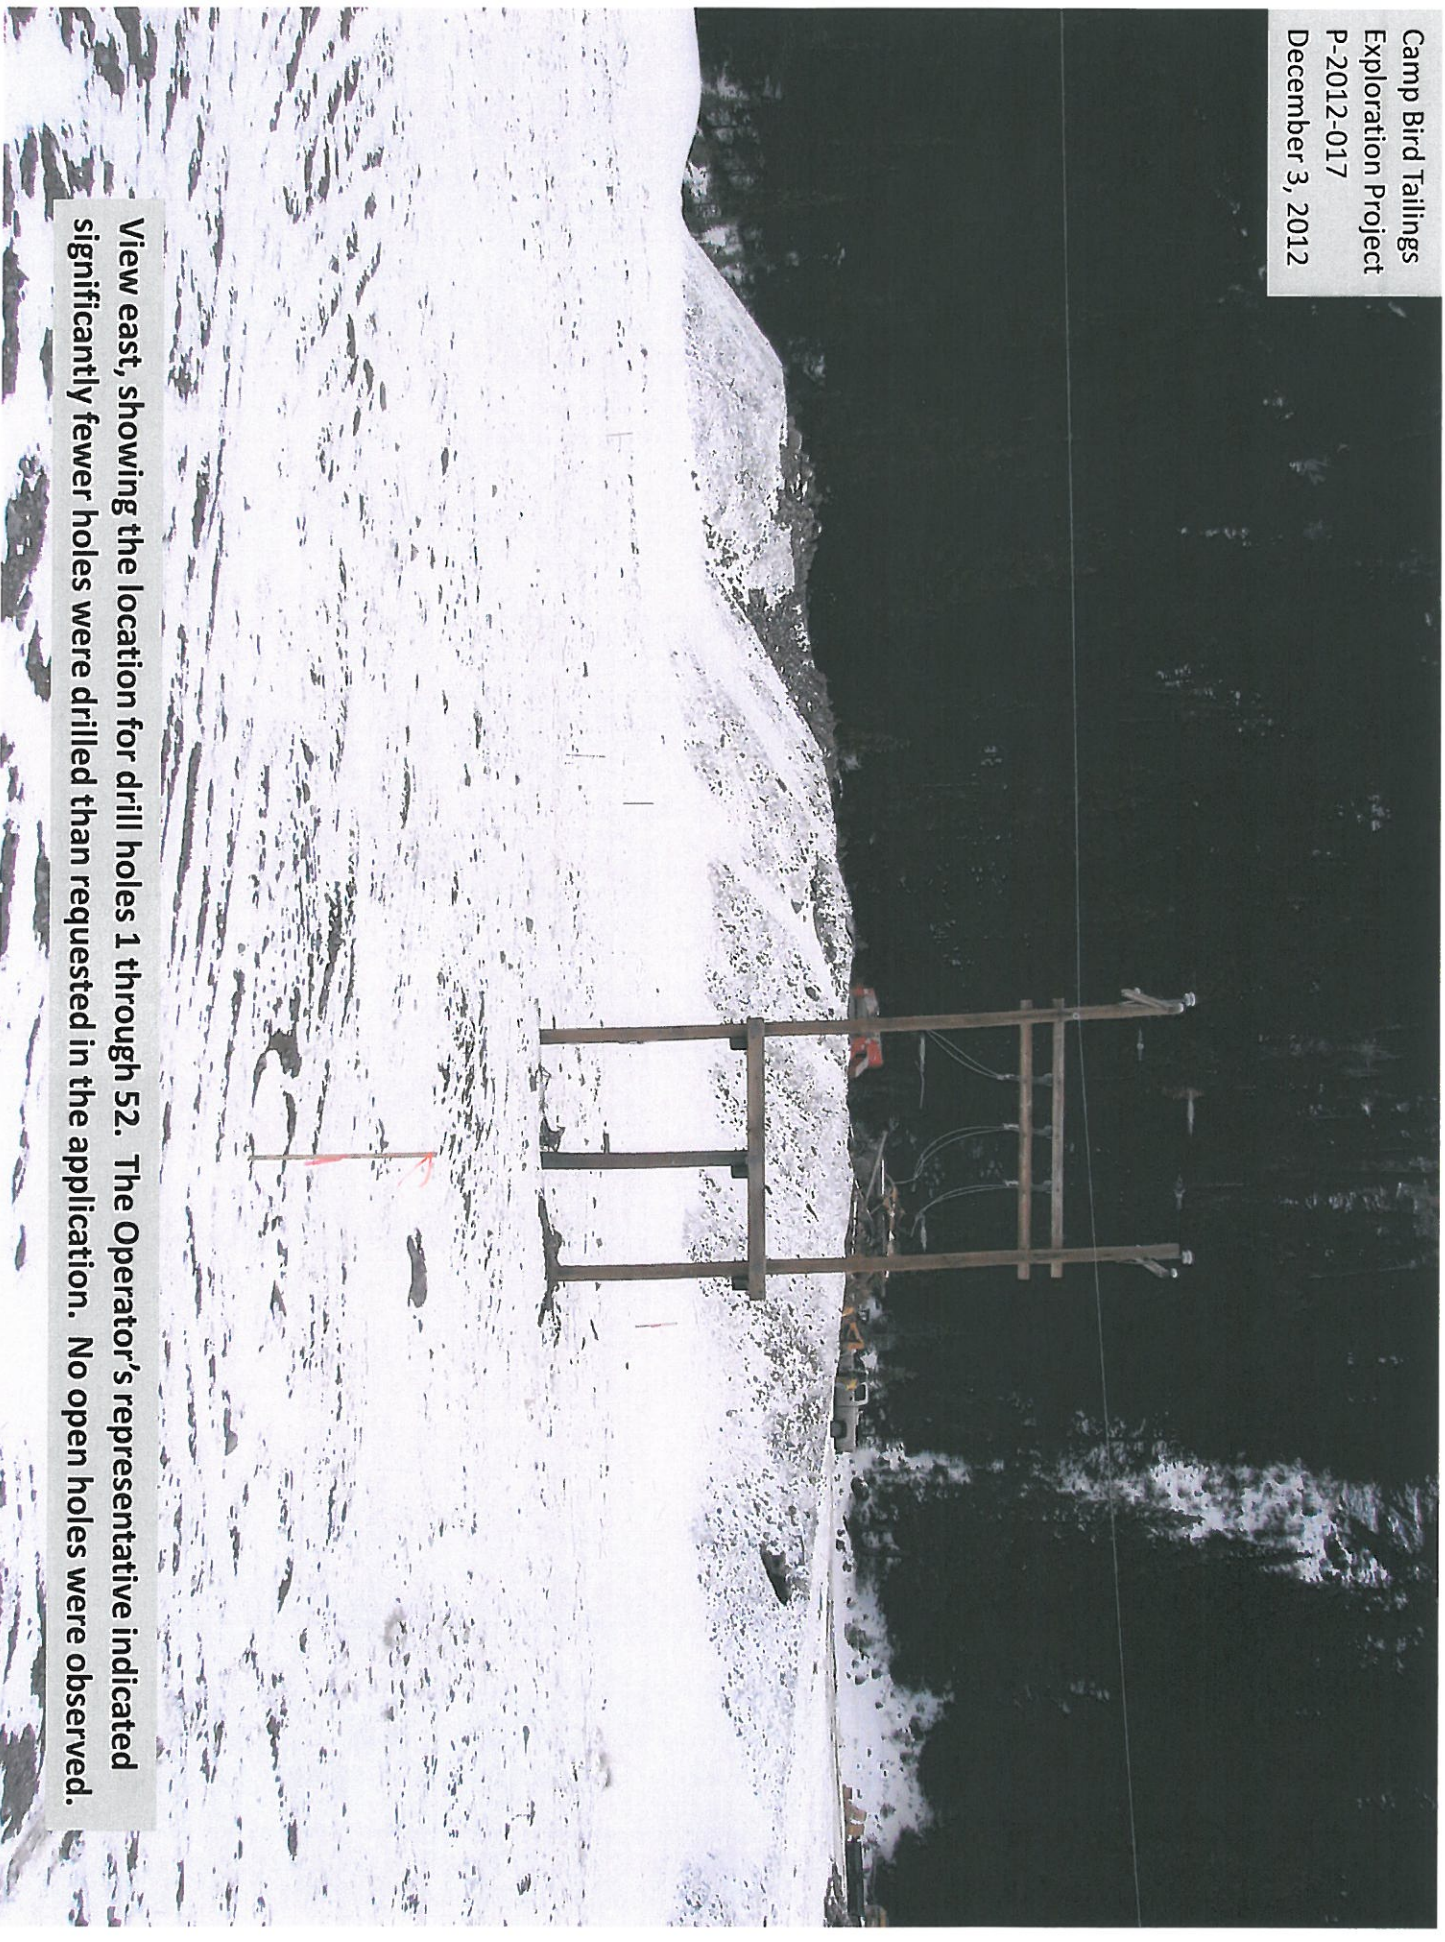
View east, showing the location for drill holes 1 through 52. The Operator's representative indicated significantly fewer holes were drilled than requested in the application. No open holes were observed.

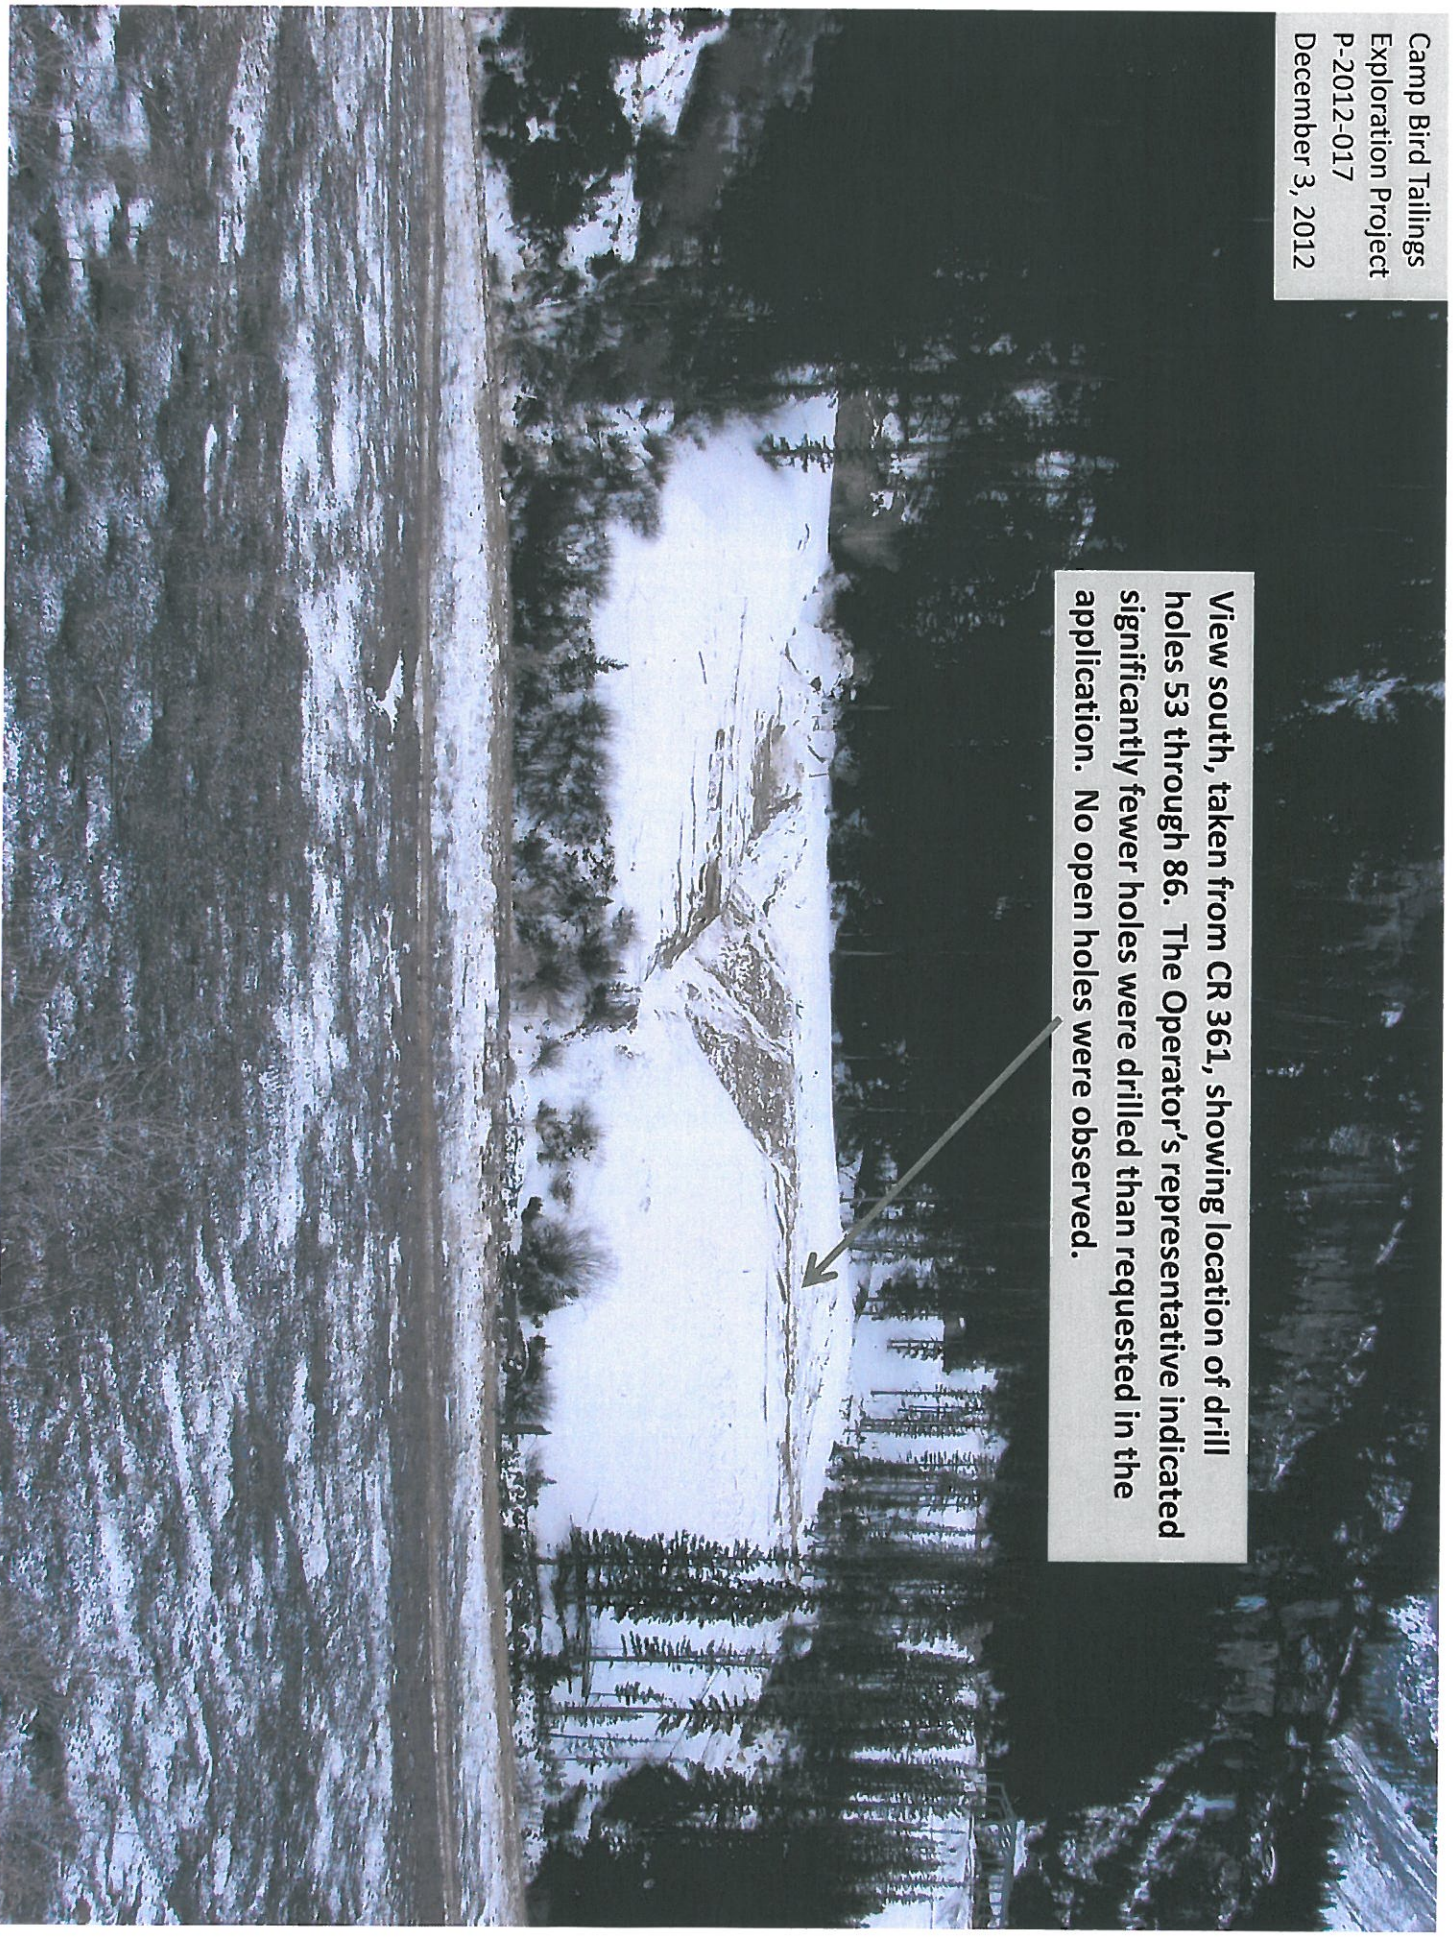
View south, taken from CR 361, showing location of drill holes 53 through 86. The Operator's representative indicated significantly fewer holes were drilled than requested in the application. No open holes were observed.
