COLORADO DIVISION OF RECLAMATION, MINING AND SAFETY
MINERALS PROGRAM INSPECTION REPORT
PHONE: (303) 866-3567

MINE NAME: Alamosa County Pit No. 1	MINE/PROSPECTING ID#: M-2001-108	MINERAL: Sand and gravel	COUNTY: Conejos
INSPECTION TYPE: Monitoring	INSPECTOR(S): Wallace H. Erickson	INSP. DATE: January 18, 2013	INSP. TIME: 10:20
OPERATOR: Alamosa County	OPERATOR REPRESENTATIVE: Phil West	TYPE OF OPERATION: 110c - Construction Limited Impact

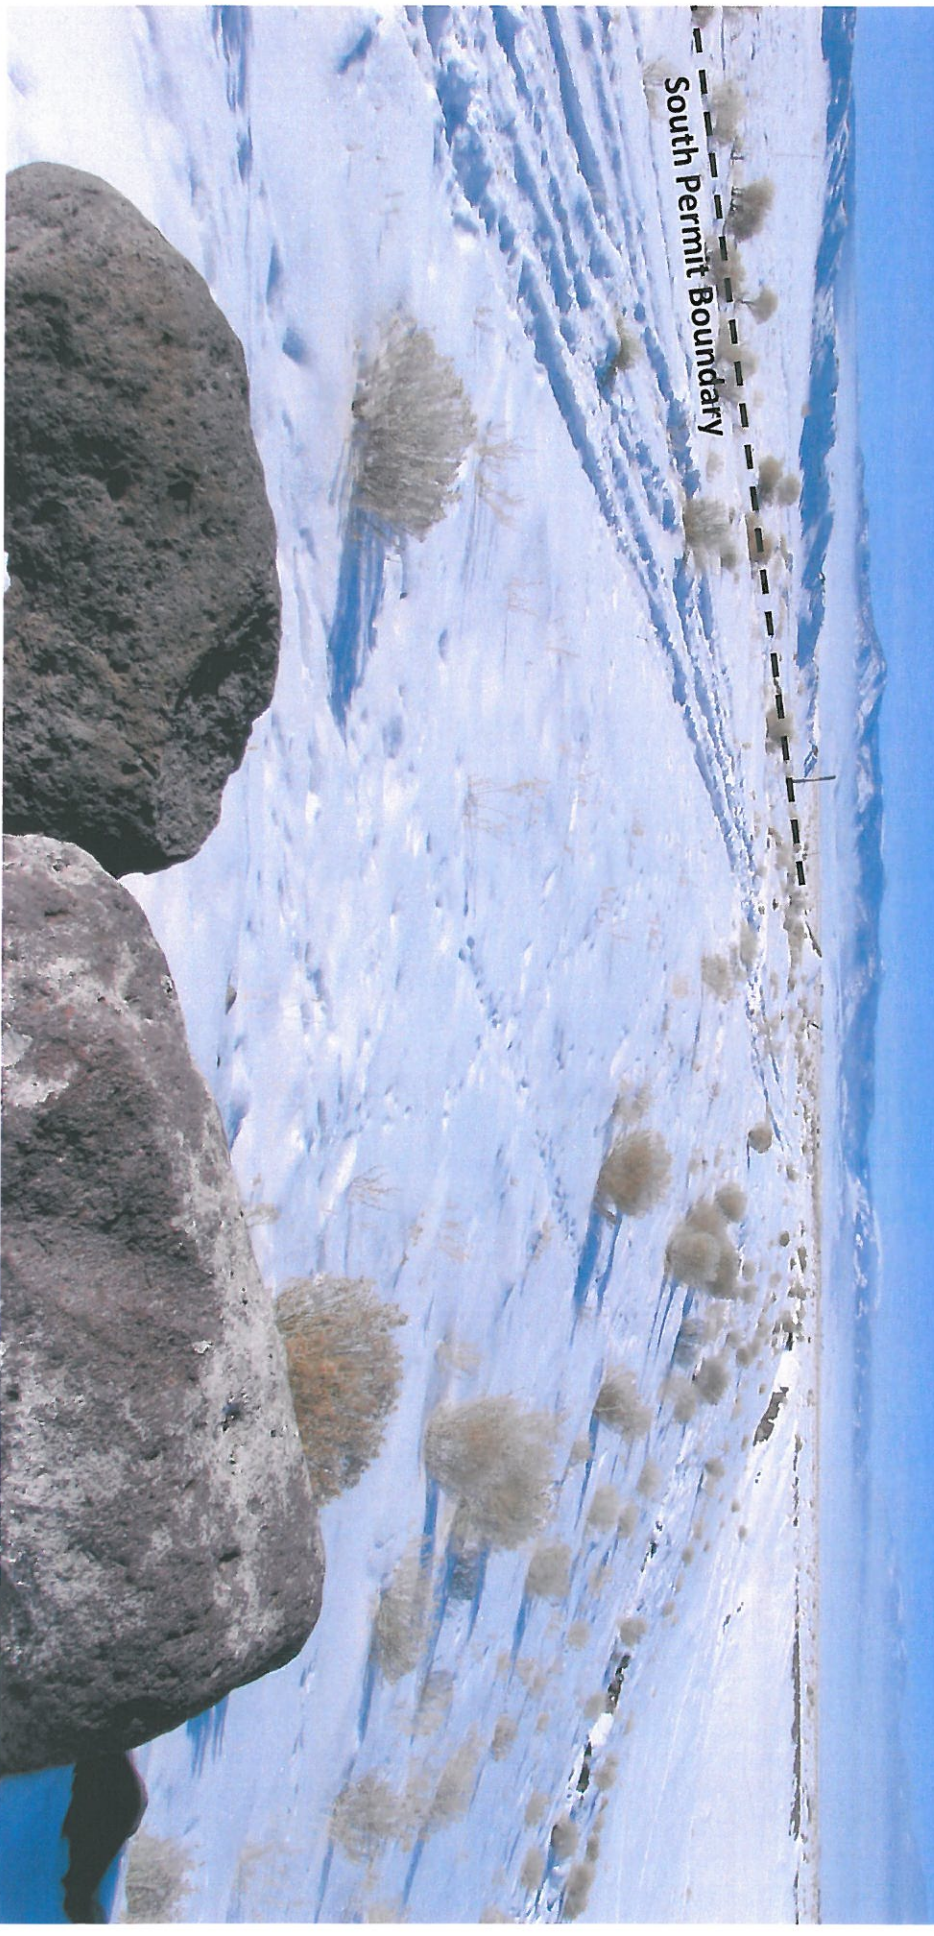
South Permit Boundary

View west, taken nearby the south permit boundary and showing portions of the affected lands.

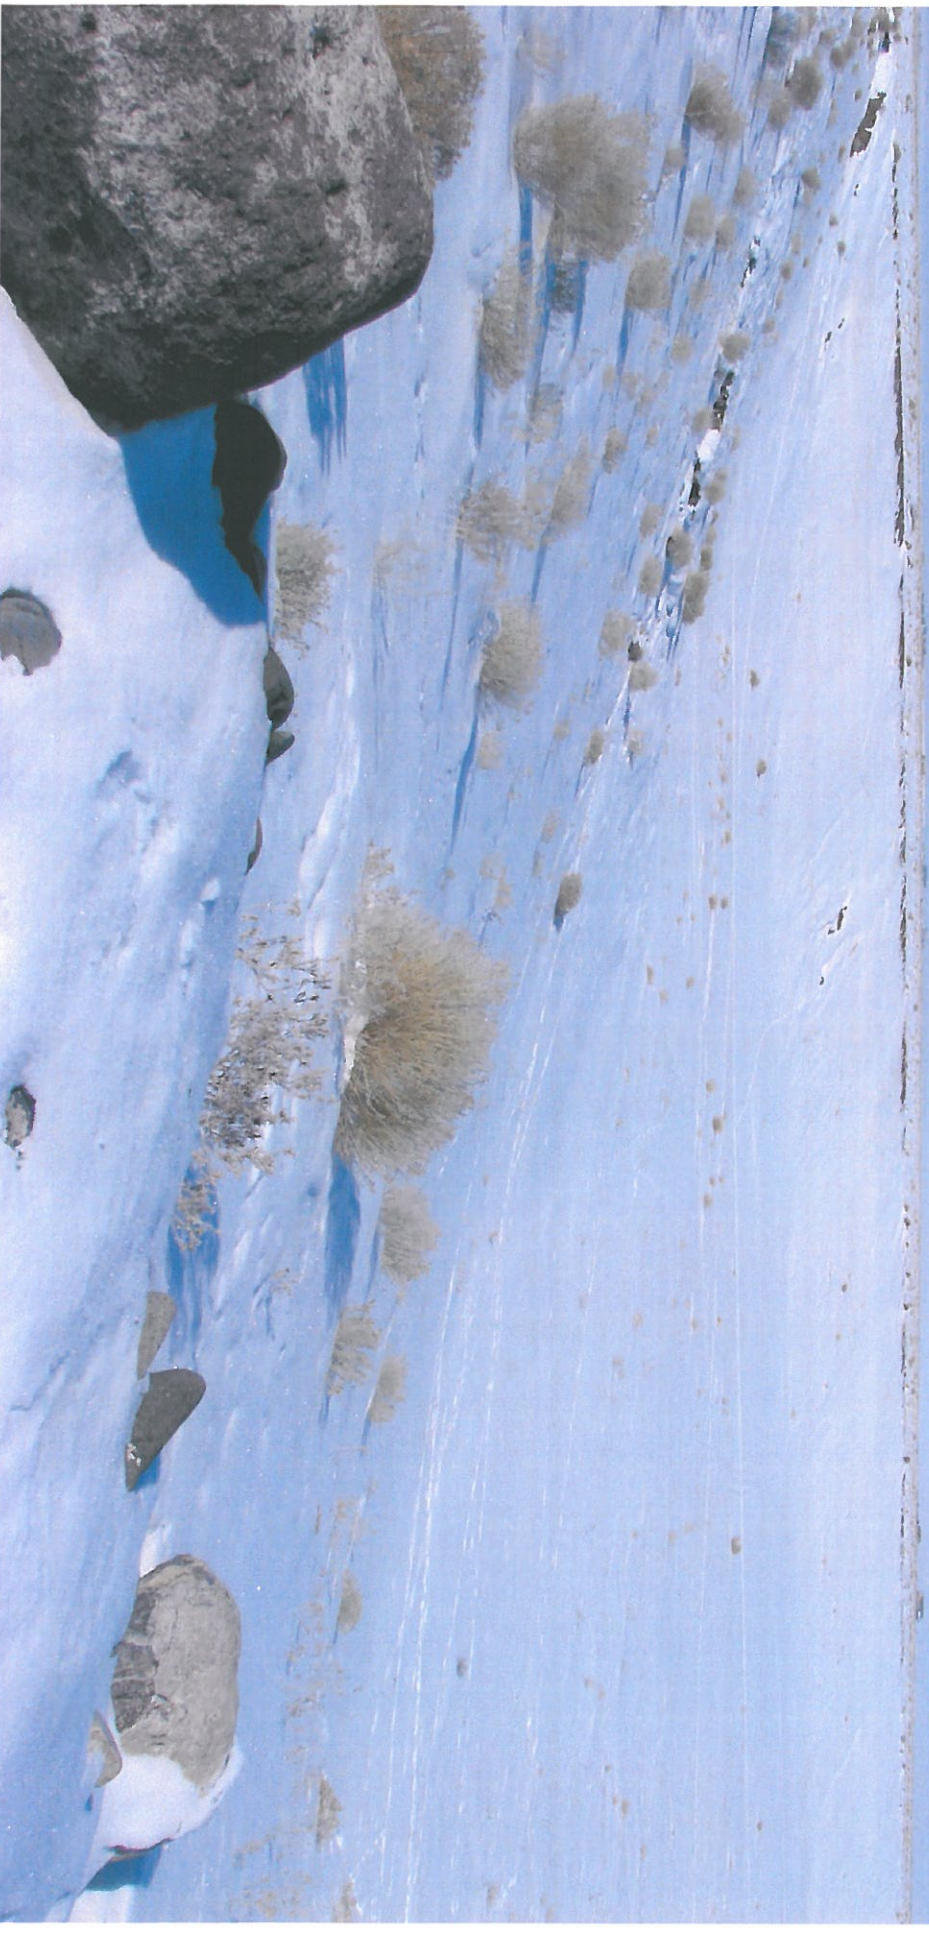
Alamosa Pit No. 1
M-2001-108
January 18, 2013
Photo 2

**View west northwest, taken from the same location
as Photo 1 and panning towards the north.**

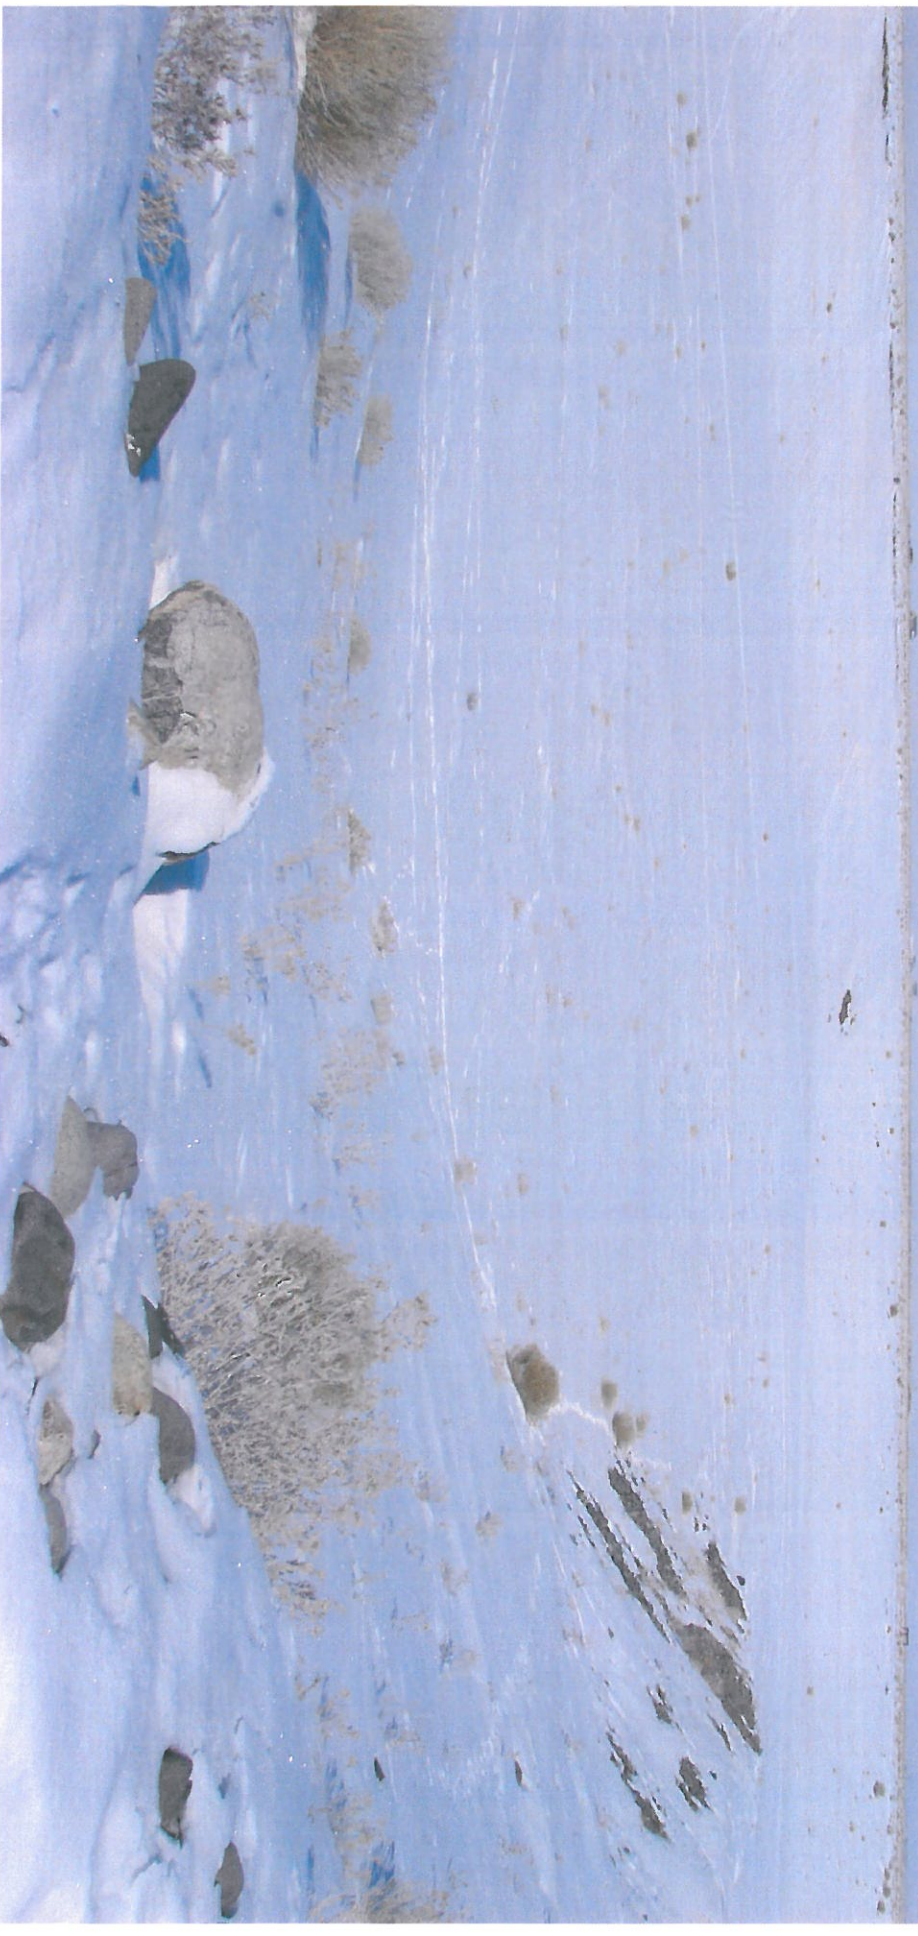
Alamosa Pit No. 1
M-2001-108
January 18, 2013
Photo 3

View northwest, taken from the same location
as Photo 1 and panning towards the north.

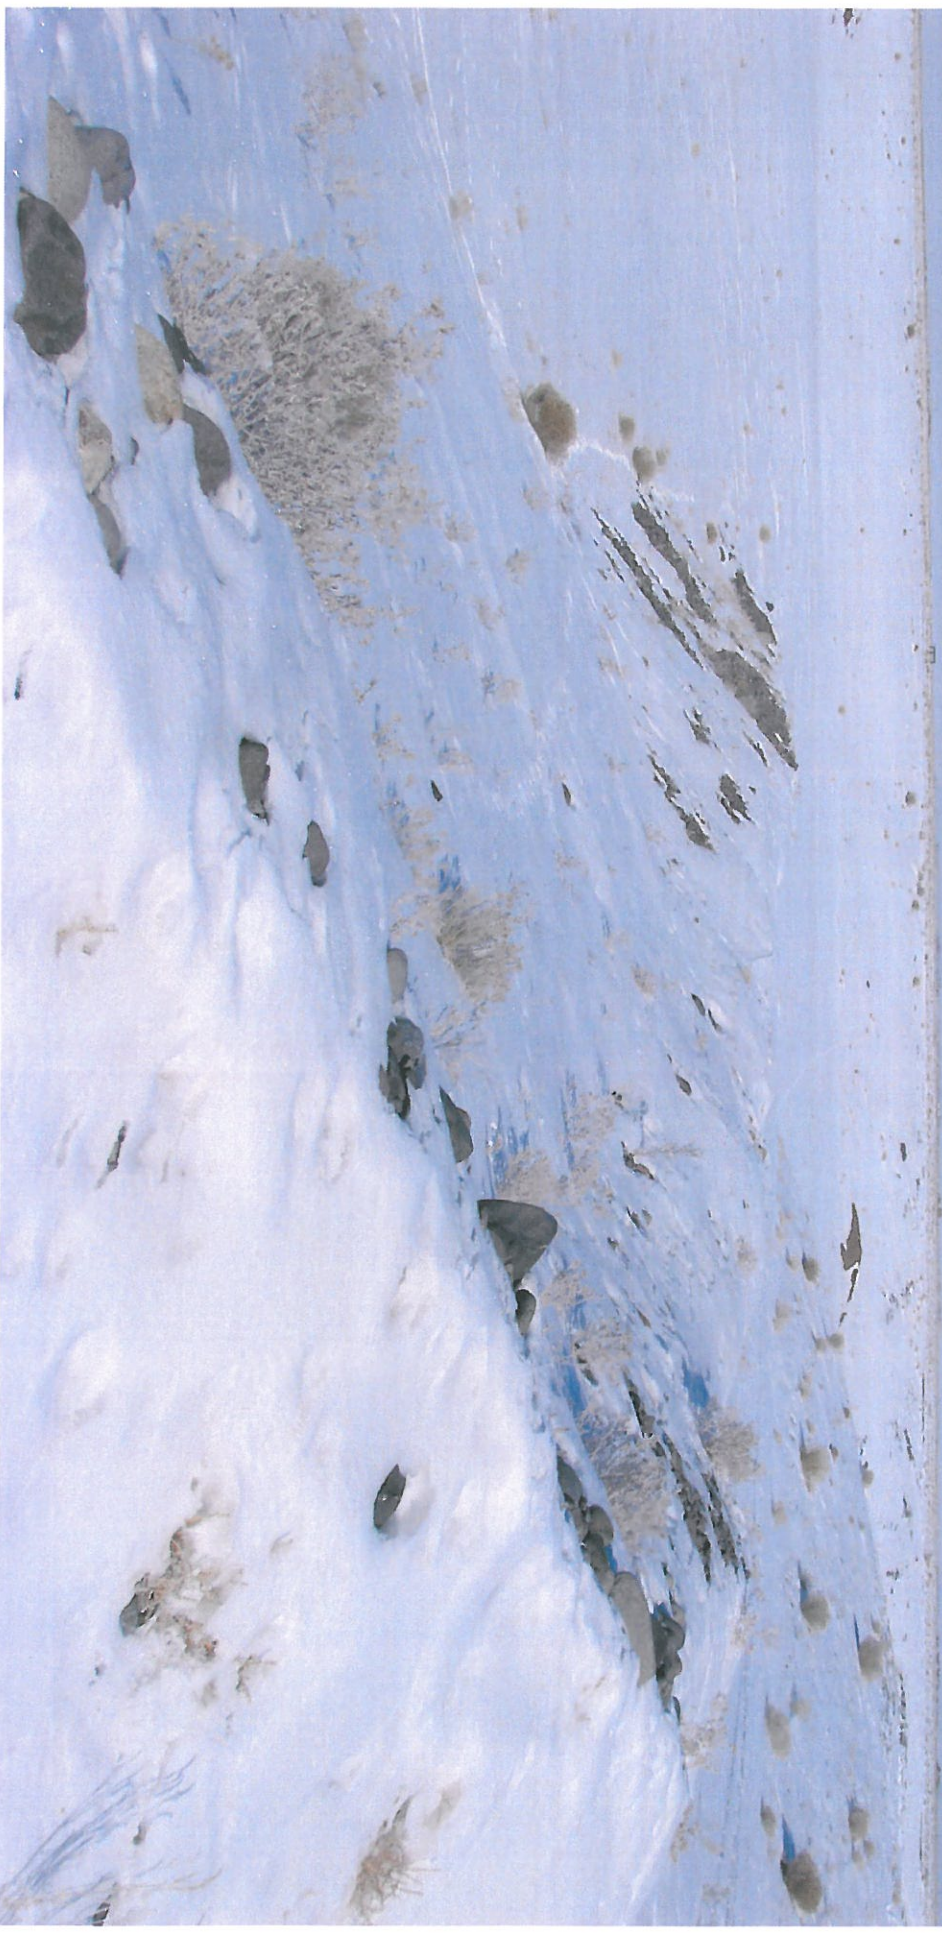
Alamosa Pit No. 1
M-2001-108
January 18, 2013
Photo 4

View north northwest, taken from the same
location as Photo 1 and panning towards the north.

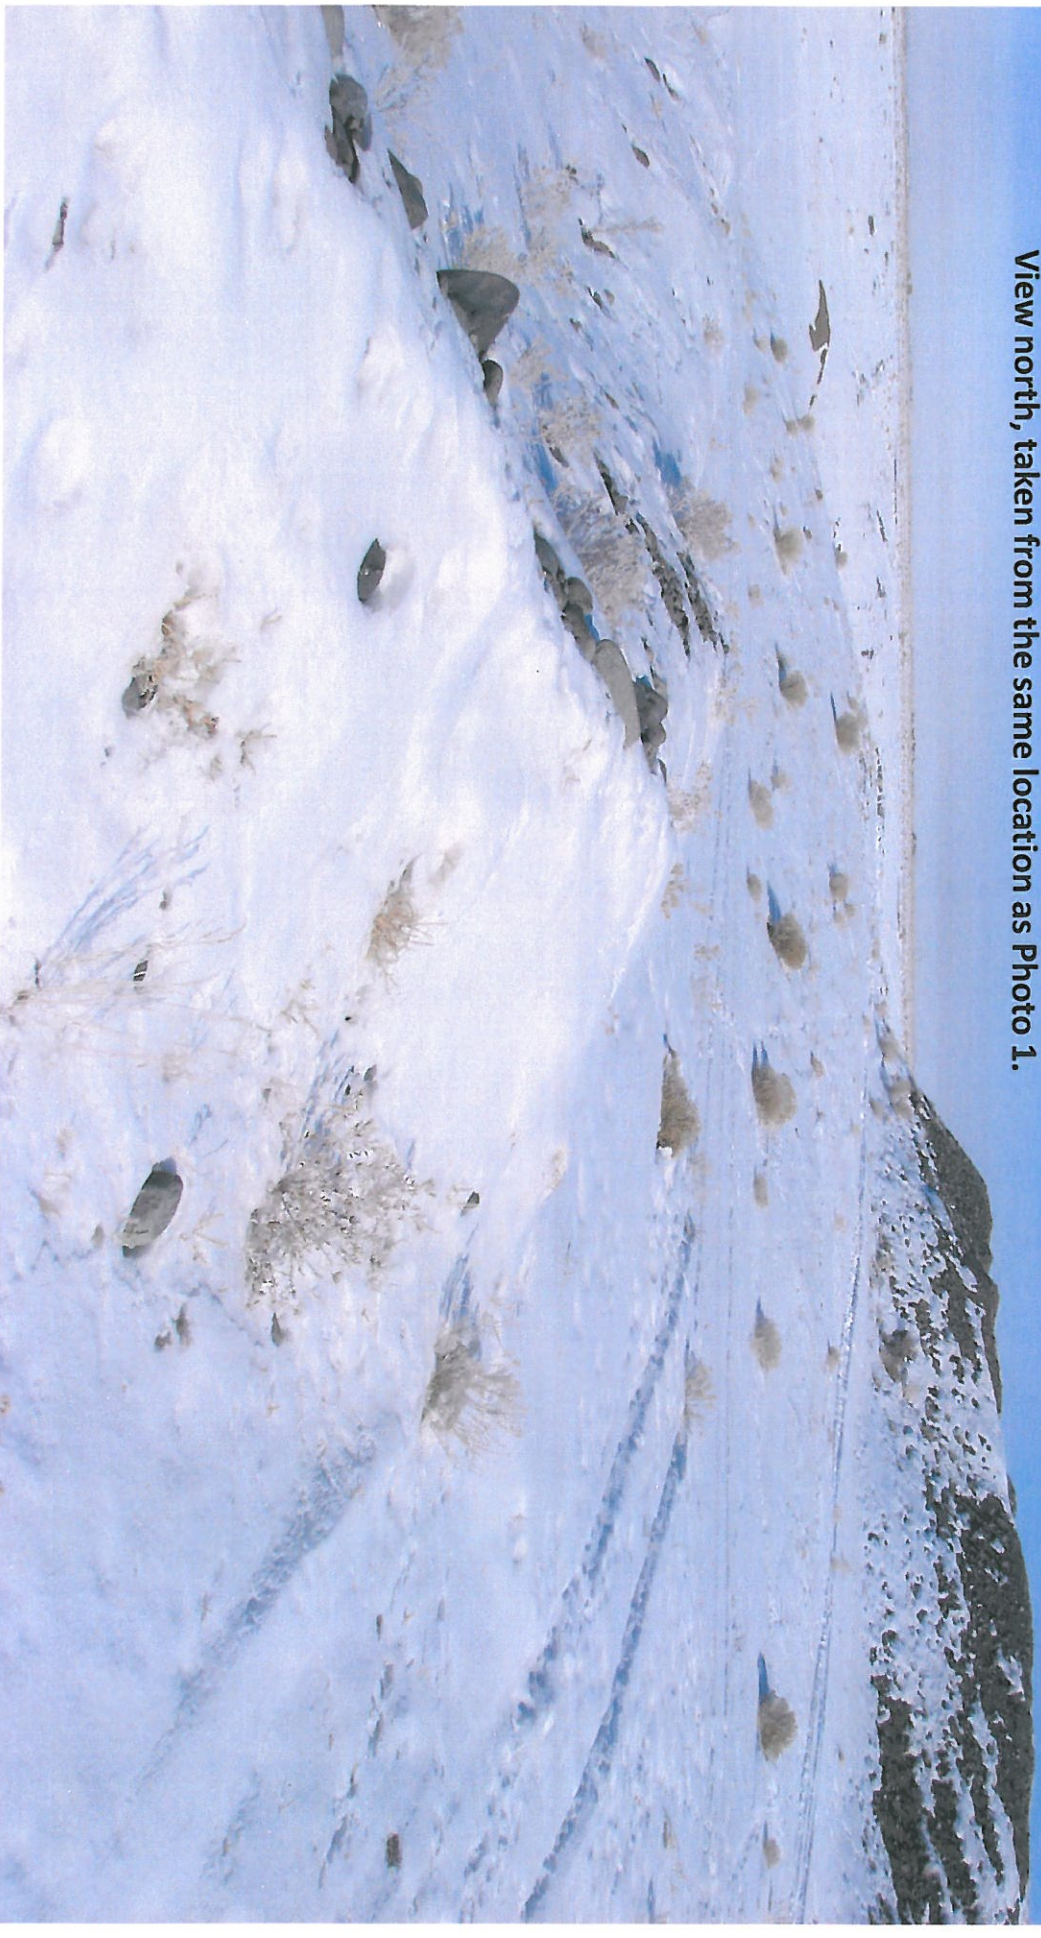
Alamosa Pit No. 1
M-2001-108
January 18, 2013
Photo 5

View north, taken from the same location as Photo 1.
