COLORADO DIVISION OF RECLAMATION, MINING AND SAFETY COAL PROGRAM INSPECTION REPORT

Permit Number: C-1983-059 Mine Name: Terror Creek Loadout Operator: Terror Creek LLC Operator Address: Mr James A Kiger P.O. Box 535 3737 Highway 133 Somerset, CO 81434	County: Delta Operation Type: Loadout Permit Status: Active Ownership: Private
	Operator Representative Present: None
Operator Representative Signature: (Field Issuance Only) NA – Report Issued from Denver Office

Inspection Start Date: January 17, 2013 Inspection Start Time: 14:15 Inspection End Date: January 17, 2013 Inspection End Time: 16:45	Inspection Type: Coal Partial Inspection Inspection Reason: Normal I&E Program Weather: Clear
Joint Inspection Agency: None	Joint Inspection Contacts: None
Post Inspection Agency: None	Post Inspection Contacts: None
Inspector(s): James R. Stark	Inspector's Signature:   Signature Date: 29 January 2013

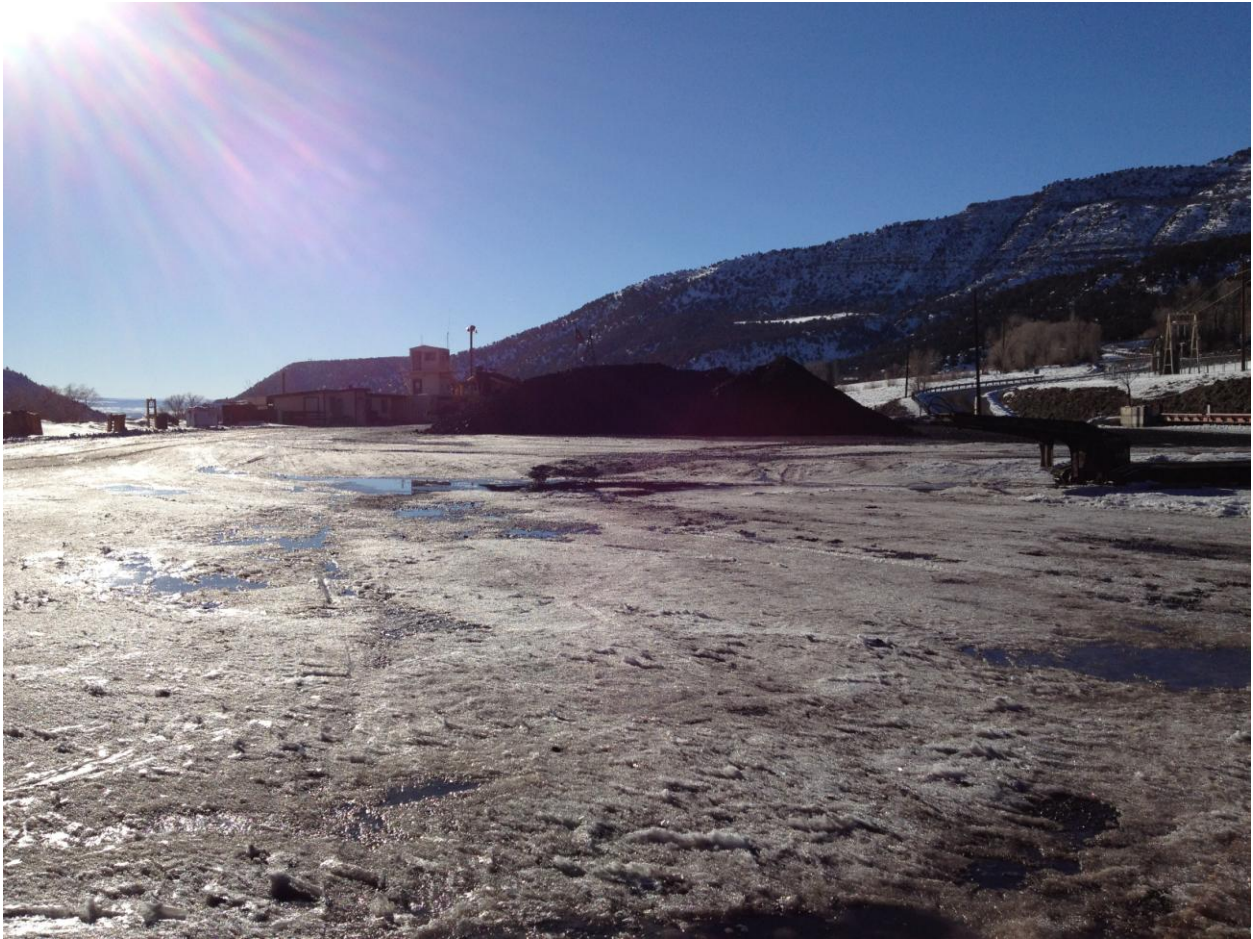
- The entire facilities area was wet and muddy from the melting snow. The area was still stable and in good condition.
- The fuel island area was in good condition at the time of the inspection. There was no sign of any spilled fuel.
- The loadout structure was stable at the time of the inspection. There was no coal spilled along the tracks or by the loadout structure.
- The coal crushing and stacking facility was idle at the time of the inspection. There is a large amount of coal in the lump, stoker and fines piles that can be shipped if needed.

Terror Creek Loadout facilities area
