**COLORADO DIVISION OF RECLAMATION, MINING AND SAFETY  
COAL PROGRAM INSPECTION REPORT**

<b>Permit Number:</b> C-1981-018 <b>Mine Name:</b> Deserado Mine <b>Operator:</b> Blue Mountain Energy, Inc <b>Operator Address:</b> Mr Scott Wanstedt 3607 County Road 65 Rangely, CO 81648	<b>County:</b> Rio Blanco <b>Operation Type:</b> Underground <b>Permit Status:</b> Active <b>Ownership:</b> Federal
	<b>Operator Representative Present:</b>  Scott Wanstedt
<b>Operator Representative Signature:</b> (Field Issuance Only)

<b>Inspection Start Date:</b> January 31, 2013 <b>Inspection Start Time:</b> 08:00 <b>Inspection End Date:</b> January 31, 2013 <b>Inspection End Time:</b> 12:00	<b>Inspection Type:</b> Coal Partial Inspection <b>Inspection Reason:</b> Normal I&E Program <b>Weather:</b> Clear
<b>Joint Inspection Agency:</b>  None	<b>Joint Inspection Contacts:</b>  None
<b>Post Inspection Agency:</b>  None	<b>Post Inspection Contacts:</b>  None
<b>Inspector(s):</b>  Zach T. Trujillo	<b>Inspector's Signature:</b>

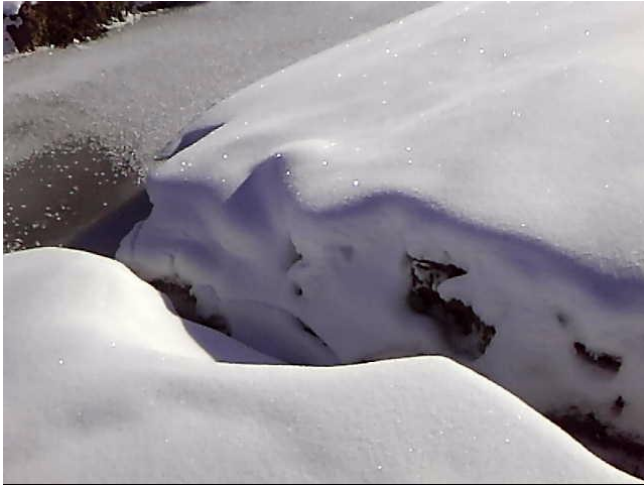
The B-Seam Mine Dewatering pump was not running during the time of the inspection. Water currently has been filled up to the 6th cell of the B-seam dewatering pond system. Up to the date of this inspection, no water has yet to discharge from the B-seam Mine Dewatering Pond system. Sediment build up within the 1st cell is becoming significant is in need of cleaning. An erosion crack has formed between the 3rd and 4th cell allowing water to pass between the ponds earlier than designed. All water is held within the pond system still and no discharge has occurred. Scott Wanstedt stated that the crack will be filled and repaired once the ground thaws.

Erosion gully in between dewatering ponds.

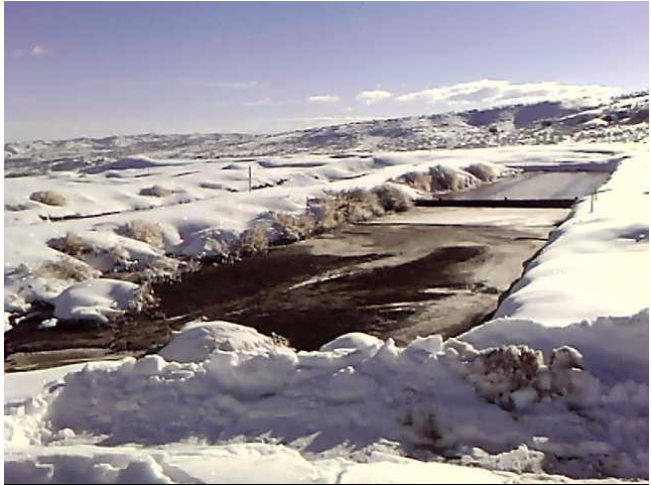
1<sup>st</sup> cell of dewater pond system filled with sediment.

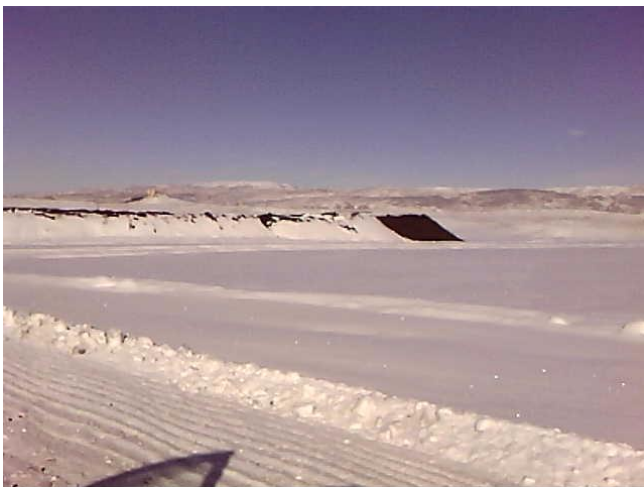
Refuse was currently being stocked on top of Refuse Pile 5A. Refuse will be stockpiled until weather allows the refuse to thaw, dry and be successfully compacted. Snow cover limited accessibility on top of each pile.

Refuse stockpile on RP-5A.

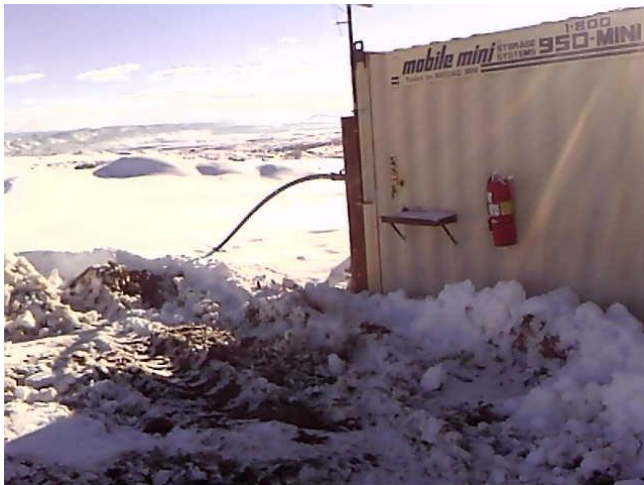
Nitrogen injection borehole and sample shed was inspected. Site area was cross ripped for erosion control.

Nitrogen injection and sample shed.

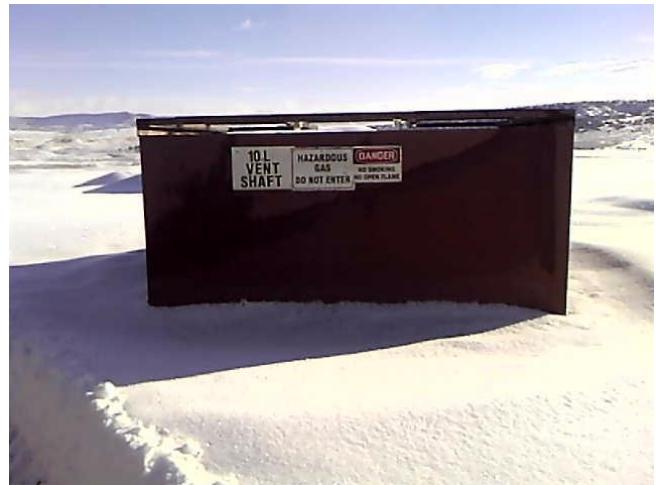
Vent Shaft 10L and pad was inspected. The pad recently has had berms and a rock check dam added as erosion control. Berms were stable and no signs of erosion were visible.

10L Vent Shaft.
