**COLORADO DIVISION OF RECLAMATION, MINING AND SAFETY
COAL PROGRAM INSPECTION REPORT**

Permit Number: C-1992-081 Mine Name: Hayden Gulch Loadout Operator: Hayden Gulch Terminal, LLC Operator Address: Mr. Roy Karo 37796 Routt County Road 53 P.O. Box 670 Hayden, CO 81639	County: Routt Operation Type: Loadout Permit Status: Permanent Cessation Ownership: Private
	Operator Representative Present: Roy Karo
Operator Representative Signature: (Field Issuance Only)

Inspection Start Date: February 4, 2013 Inspection Start Time: 10:20 Inspection End Date: February 4, 2013 Inspection End Time: 12:30	Inspection Type: Coal Complete Inspection Inspection Reason: Normal I&E Program Weather: Clear
Joint Inspection Agency: None	Joint Inspection Contacts:
Post Inspection Agency: None	Post Inspection Contacts:
Inspector(s): Jared L. Ebert	Inspector's Signature:

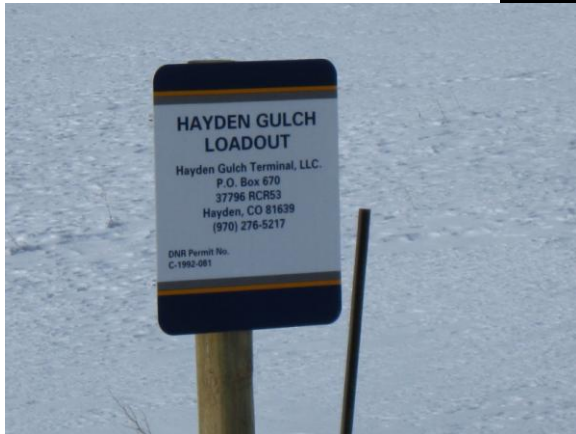
Mine identification signs were posted where public roads intersected the mine permit boundary. These signs are of uniform design and contain the required information.

Mine entrance sign on the east end of the Tie-Across Haul Road.

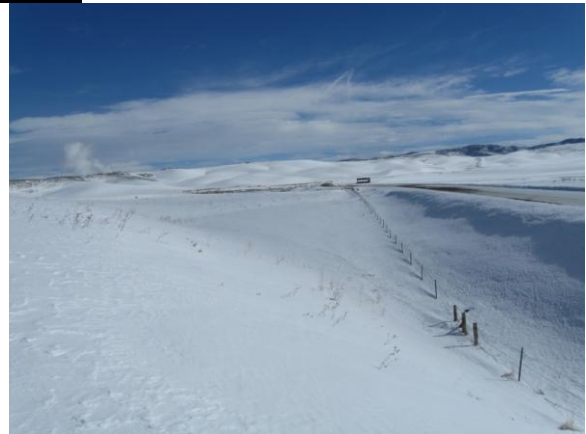
Ditch 3 area.

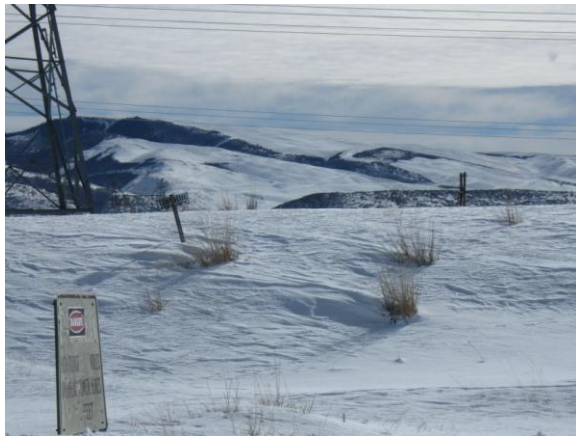
Topsoil stockpile A, C, D, E, F, G and the TWS pile along the Tie Across Haul Road were inspected. These piles were covered in snow but appeared stable. Berms were in place around the piles and each topsoil stockpile was identified with a topsoil sign marker.

Topsoil stockpile marker, pile covered with snow.

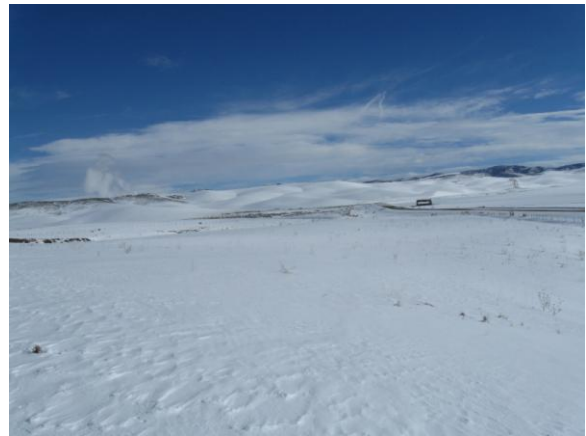
The former facilities area (SL1 bond release area) was covered with snow but it appeared stable.

From the west end of the former facilities area looking east.

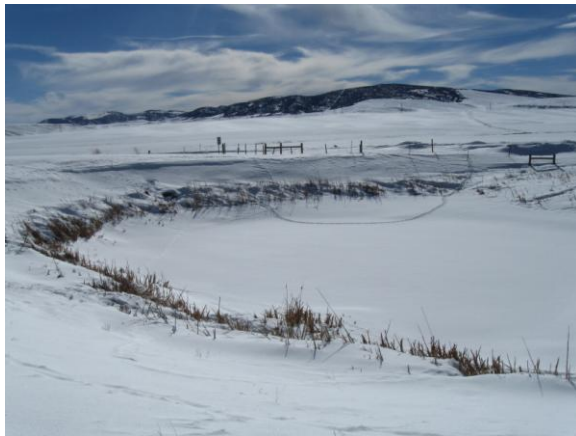
The Truck Loop pond was snow and ice covered. The primary and emergency spillway was clear of debris and appeared functional. The pond slopes and embankment were snow covered and appeared stable.

Truck loop pond.

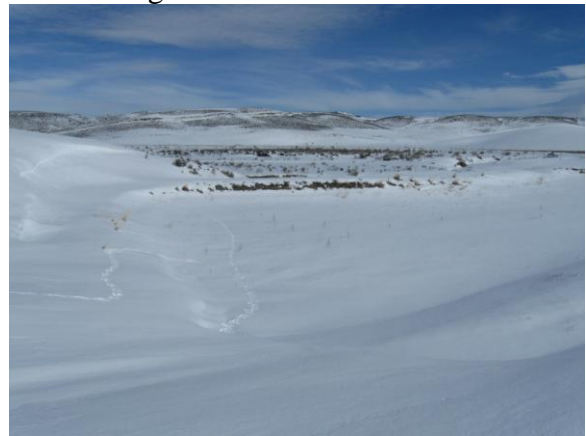
The Rail Loop pond was snow and ice covered. The primary and emergency spillway was clear of debris and appeared functional. The pond slopes and embankment were snow covered and appeared stable.

Rail Loop Pond.

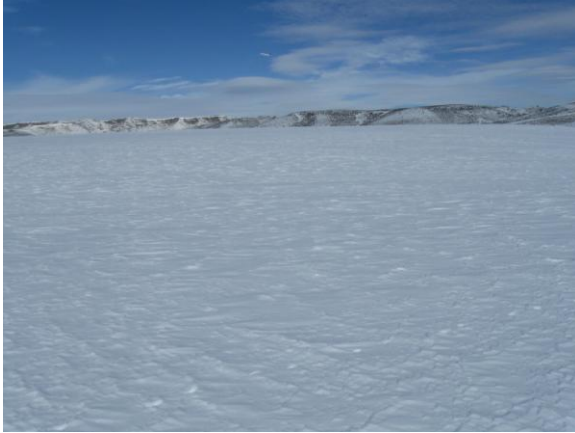
The remainder of topsoil stockpile No.2 was covered with snow and appeared stable. Topsoil stockpile No. 3 was covered in snow and since the pile is not very high, it blended in with the snow covered landscape, metal T-posts delineate the pile. Topsoil stockpile No. 1 was depleted during the reclamation of the facilities area. The area where this pile was located was covered in snow and appeared stable.

Topsoil stockpile No. 2.

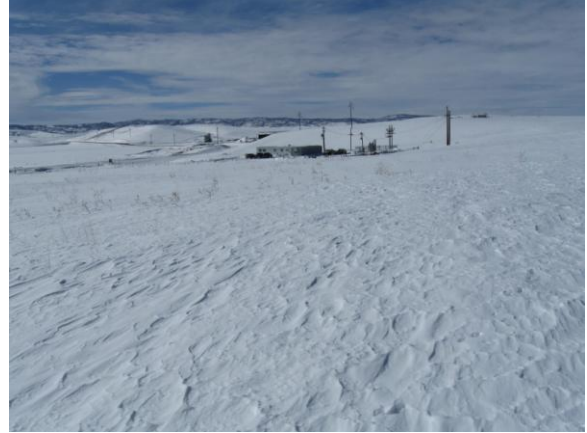
The facilities, parking and substation area was inspected and no problems were observed. The leach field was snow covered.

Office and Parking Area.
