**COLORADO DIVISION OF RECLAMATION, MINING AND SAFETY
COAL PROGRAM INSPECTION REPORT**

Permit Number: C-1982-057 Mine Name: Seneca II-W Mine Operator: Seneca Coal Company, LLC Operator Address: Mr Roy Karo 37796 Routt County Road 53 P.O. Box 670 Hayden, CO 81639	County: Routt Operation Type: Surface Permit Status: Permanent Cessation Ownership: Federal
	Operator Representative Present: Roy Karo
Operator Representative Signature: (Field Issuance Only)

Inspection Start Date: February 4, 2013 Inspection Start Time: 12:30 Inspection End Date: February 4, 2013 Inspection End Time: 14:00	Inspection Type: Coal Partial Inspection Inspection Reason: Normal I&E Program Weather: Clear
Joint Inspection Agency: None	Joint Inspection Contacts:
Post Inspection Agency: None	Post Inspection Contacts:
Inspector(s): Jared L. Ebert	Inspector's Signature:

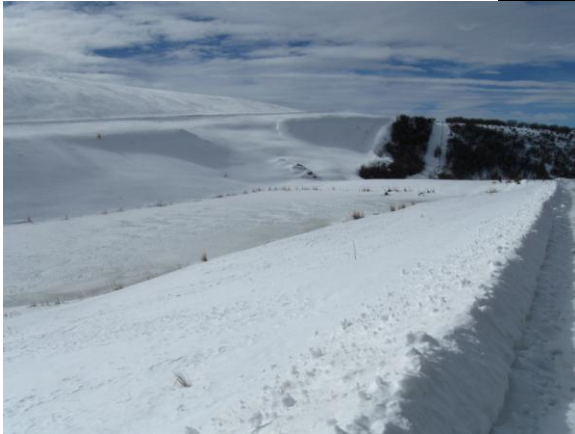
Pond 006 was accessible; the embankment was snow covered but appeared stable. The primary spillway was partially covered with snow and ice. The pond was holding water but was covered with ice. The emergency spillway was covered in snow. The pond was discharging clear water.

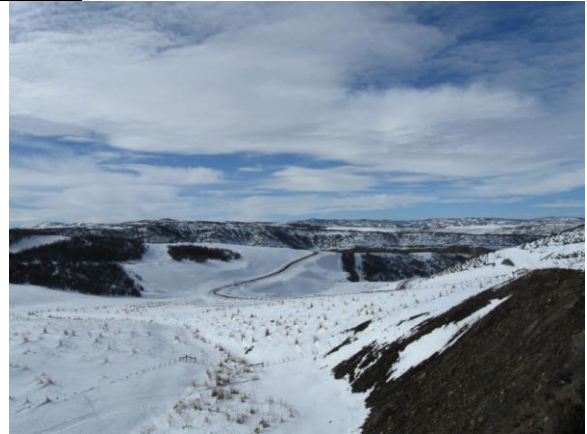
The 006-NE1, 006 Gulch and 006-SE1 drainage basins were partially visible from the oil well access road. These drainages and the surrounding area were covered in snow.

006 Gulch from oil well pad looking southwest

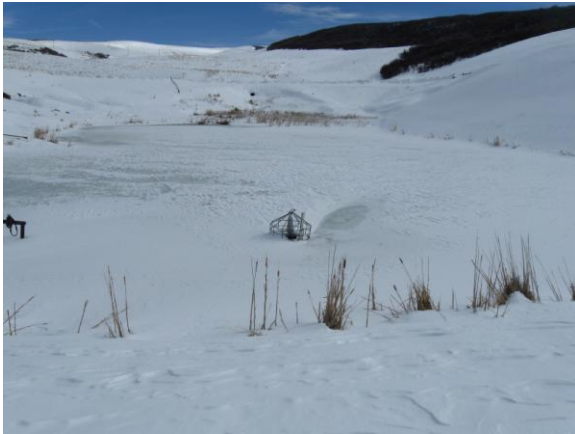
Pond 006, from embankment

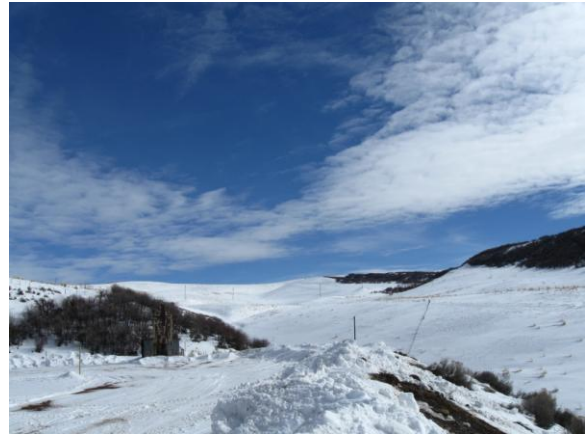
Looking east from oil well pad.

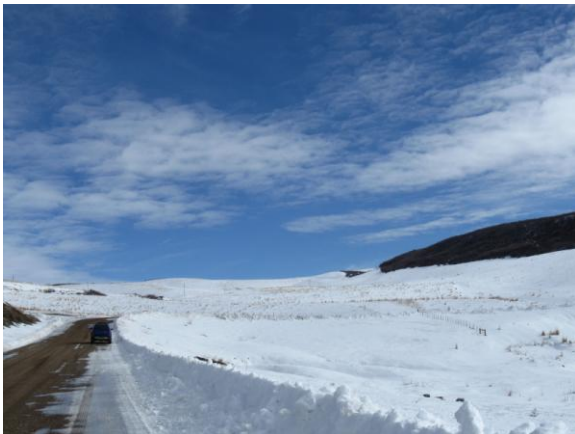
Looking northeast from the north side of Pond 006

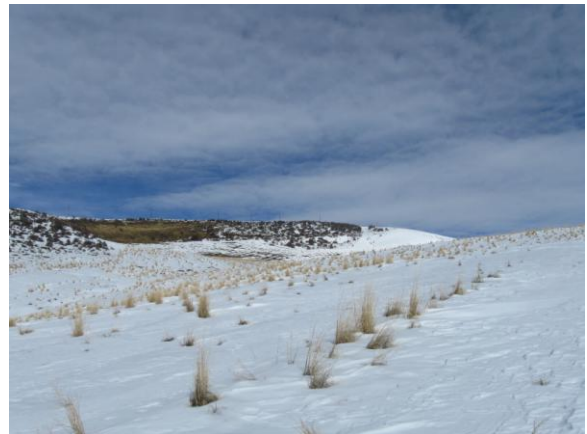
006-NE1 drainage view from oil well access road.
