**COLORADO DIVISION OF RECLAMATION, MINING AND SAFETY
COAL PROGRAM INSPECTION REPORT**

Permit Number: C-1994-082 Mine Name: Yoast Mine Operator: Seneca Coal Company, LLC Operator Address: Mr. Roy Karo 37796 Routt County Road 53 P.O. Box 670 Hayden, CO 81639	County: Routt Operation Type: Surface Permit Status: Permanent Cessation Ownership: Federal
	Operator Representative Present: Roy Karo
Operator Representative Signature: (Field Issuance Only)

Inspection Start Date: February 4, 2013 Inspection Start Time: 14:00 Inspection End Date: February 4, 2013 Inspection End Time: 16:30	Inspection Type: Coal Partial Inspection Inspection Reason: Normal I&E Program Weather: Clear
Joint Inspection Agency: None	Joint Inspection Contacts:
Post Inspection Agency: None	Post Inspection Contacts:
Inspector(s): Jared L. Ebert	Inspector's Signature:

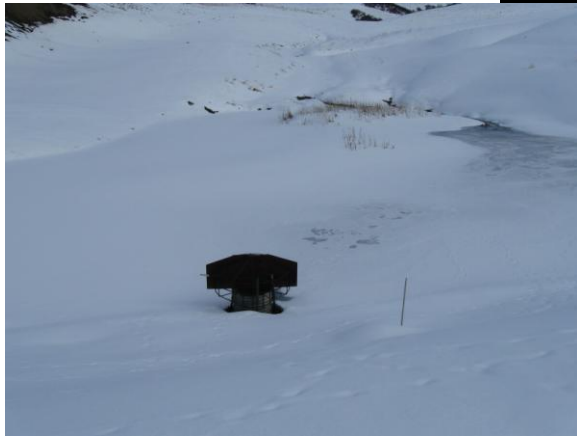
Pond 012 primary spillway

Pond 012 was discharging clear water. The embankment and pond slopes were covered with snow but appeared stable. The primary spillway was clear and functional. The emergency spillway was snow covered.

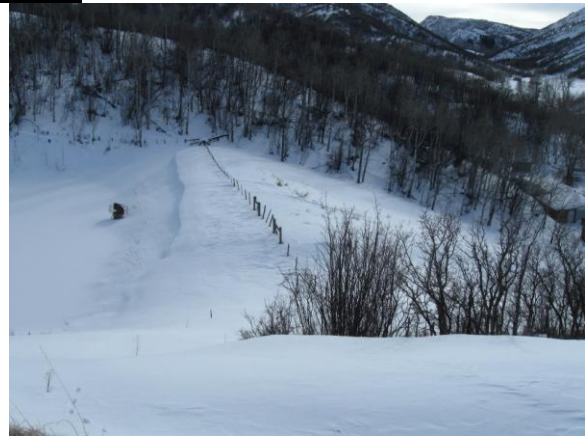
Pond 014 embankment and primary spillway

Pond 014 did not appear to be discharging. The embankment and emergency spillway was snow covered. The primary spillway was clear of debris and functional.

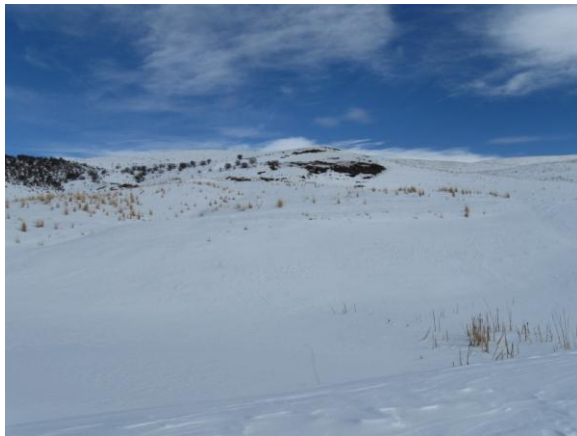
Pond 013 slide area

The Pond 013 slide was observed, this area does not appear to have changed since the last inspection. The top of the hill around the well cluster was very moist due to the melting snow.

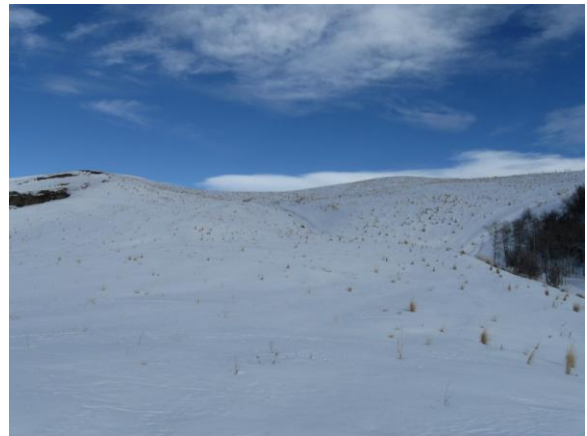
Drainages YPM-3-2 was visible, this area was snow covered.

YPM-3-2 drainage basin looking northeast from the north side of Pond 014.

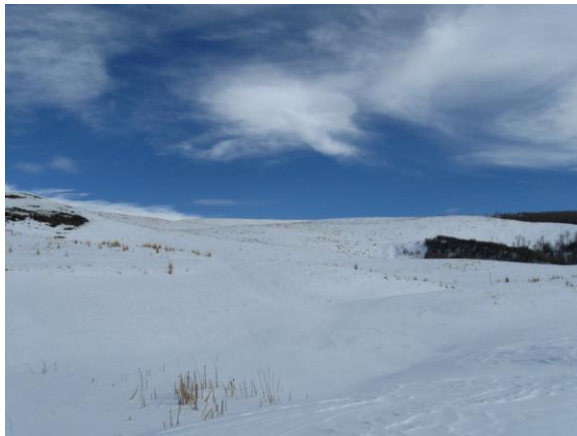
YPM-17 and 3-2 drainages from the Pond 013 embankment looking southeast

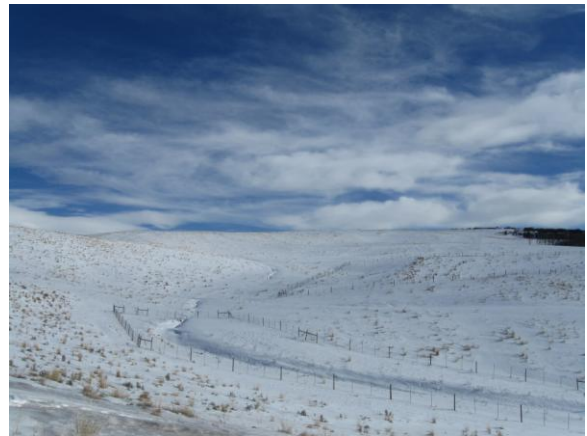
Shrub plots SP06-3 and SP05-1 were observed. These areas were snow covered.

Shrub plot SP06-3 and SP05-1, and surrounding drainage basin.

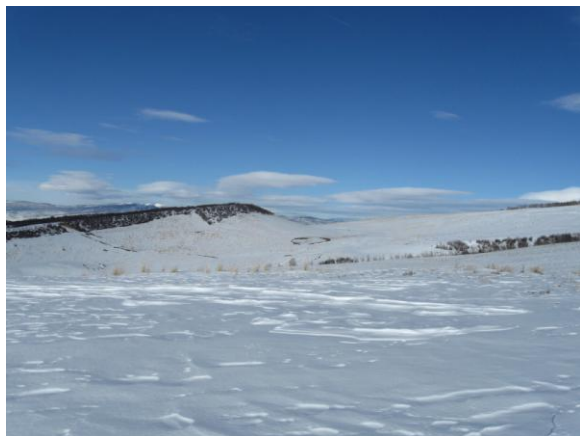
From on top of the Pond 013 slide looking north.
