**COLORADO DIVISION OF RECLAMATION, MINING AND SAFETY
COAL PROGRAM INSPECTION REPORT**

Permit Number: C-1981-010 Mine Name: Trapper Mine Operator: Trapper Mining, Inc. Operator Address: Mr. Forrest V Luke P.O. Box 187 Craig, CO 81626	County: Moffat Operation Type: Surface Permit Status: Active Ownership: Federal
	Operator Representative Present: Graham Roberts
Operator Representative Signature: (Field Issuance Only)

Inspection Start Date: February 5, 2013 Inspection Start Time: 07:30 Inspection End Date: February 5, 2013 Inspection End Time: 13:30	Inspection Type: Coal Partial Inspection Inspection Reason: Normal I&E Program Weather: Clear
Joint Inspection Agency: None	Joint Inspection Contacts:
Post Inspection Agency: None	Post Inspection Contacts:
Inspector(s): Jared L. Ebert	Inspector's Signature:

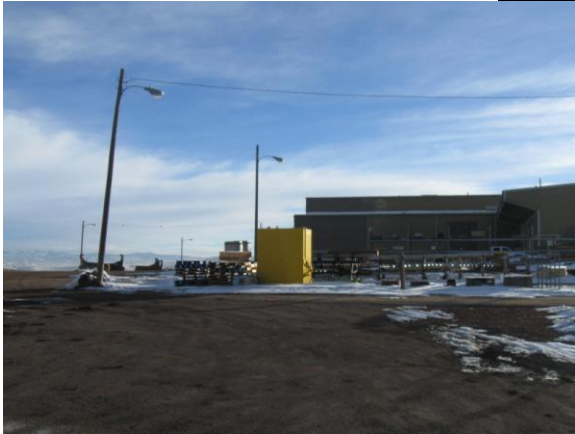
The shop and office area was observed, no problems were noted.

Mine workshop area.

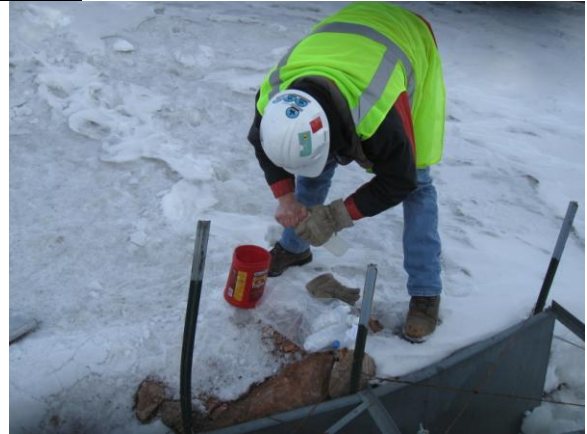
Middle Flume Pond No. 3 was observed; the pond was snow and ice covered. Many elk tracks were noted on the embankment and near the water's edge. The pond was discharging clear water and Mr. Roberts collected the required water samples. The water meter on the flume read .05. Mr. Roberts indicated the pH was 8.1.

Graham Roberts taking water samples.

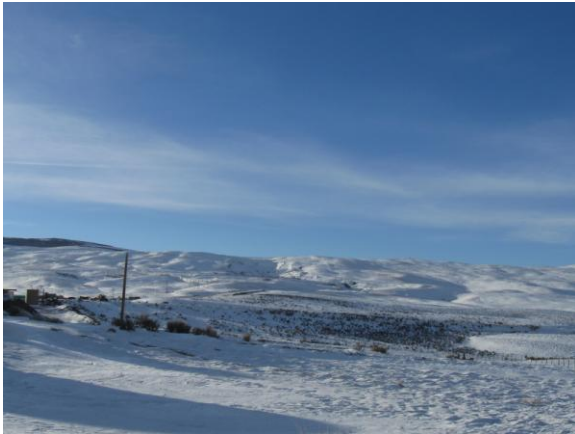
From the parking area looking south at the D Pit.

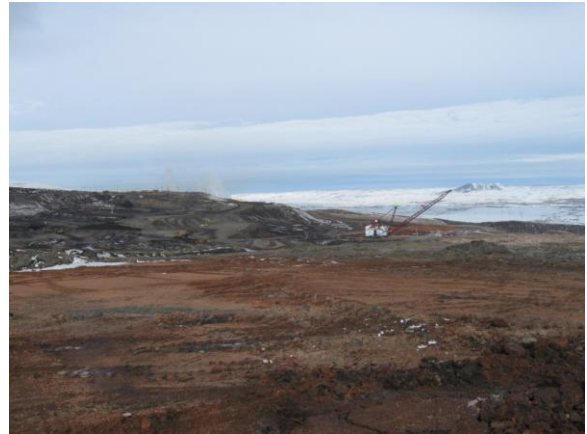
Active mine area from the east end looking northwest.

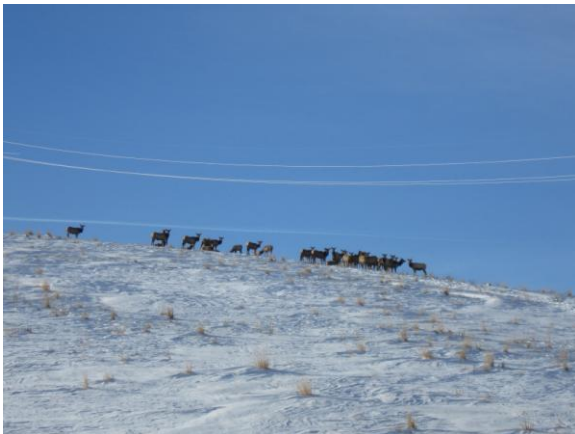
Elk were observed throughout the mined and reclaimed area. A large heard was observed in the southern end of the F Pit reclaimed area.

Heard of elk in the north end of the F Pit reclaimed area.

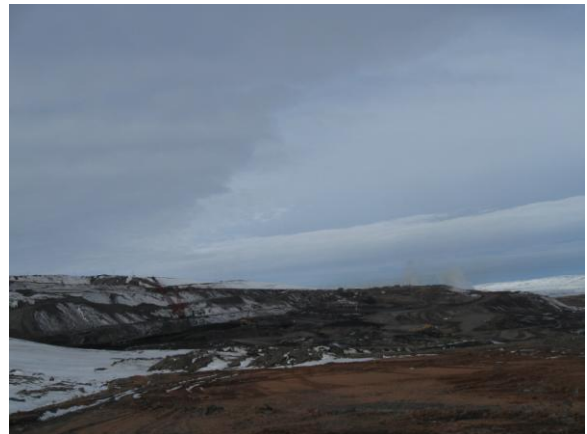
Active mine area from the east end looking west.

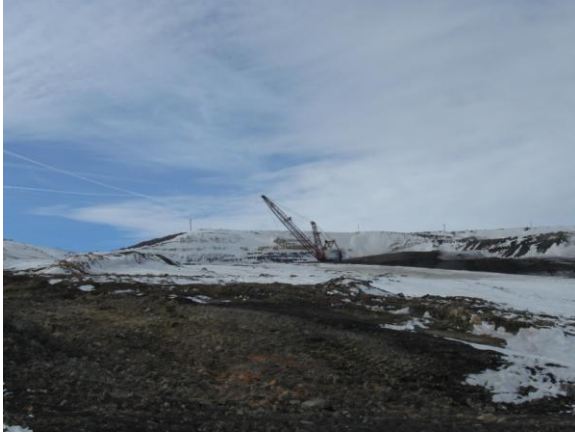
Active mine area from the east end looking southwest.

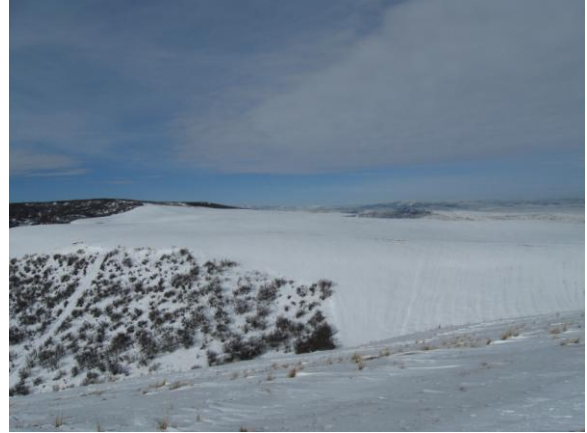
The F Pit backfilled area was observed from both the north and south end. The area was snow covered. According to Mr. Roberts, some of this area remains to be topsoiled.

Southern F Pit backfilled and regraded area.

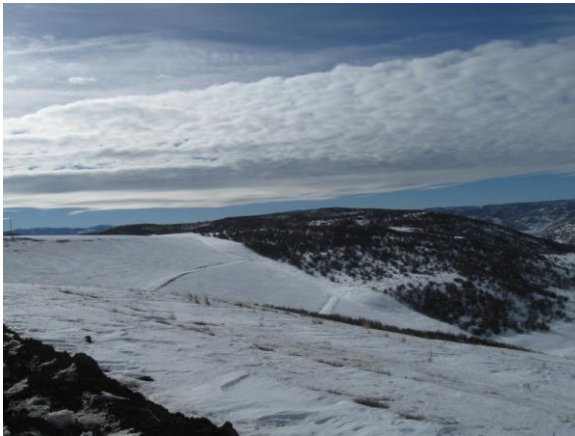
Horse Gulch Fill

The Horse Gulch fill was observed. The face of the fill and the side drains was covered with snow. No slumps were visible.
