COLORADO DIVISION OF RECLAMATION, MINING AND SAFETY COAL PROGRAM INSPECTION REPORT

Permit Number: C-1981-038 Mine Name: Bowie No. 1 Mine Operator: Bowie Resources, LLC Operator Address: Mr Basil Bear P.O. Box 1488 Paonia, CO 81428 County: Delta Operation Type: Underground Permit Status: Permanent Cessation Ownership: Federal

Inspection Start Date: January 10, 2013 Inspection Start Time: 09:15 Inspection End Date: January 10, 2013 Inspection End Time: 09:50			Inspection Type: Coal Partial Inspection Inspection Reason: Normal I&E Program Weather: Cloudy
Joint Inspection Agency:		Joint Inspection Contacts:	
None			
Post Inspection Agency:		Post Inspection Contacts:	
None			
Inspector(s):	Inspector's Signature: Signature Date:		
Susan L. Burgmaier	Susalburgmain January 14, 2013

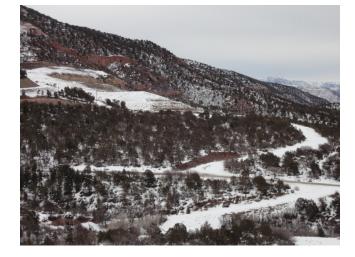
The west refuse disposal area at the East Mine appeared to be stable.

East Mine haul road and refuse area (center of photo)

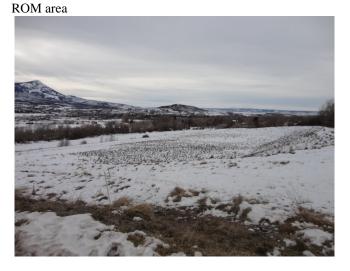
Coal stockpile area at west end of Loadout
