**COLORADO DIVISION OF RECLAMATION, MINING AND SAFETY  
MINERALS PROGRAM INSPECTION REPORT**

<b>MINE NAME:</b> Cresson Project	<b>MINE/PROSPECTING ID#:</b> M-1980-244	<b>MINERAL:</b> Gold	<b>COUNTY:</b> Teller
<b>INSPECTION TYPE:</b> Monitoring	<b>INSPECTOR(S):</b> Timothy A. Cazier	<b>INSP. DATE:</b> September 19, 2012	<b>INSP. TIME:</b> 09:00
<b>OPERATOR:</b> Cripple Creek & Victor Gold	<b>OPERATOR REPRESENTATIVE:</b> Mark Vanoni	<b>TYPE OF OPERATION:</b> 112d-3 - Designated Mining Operation

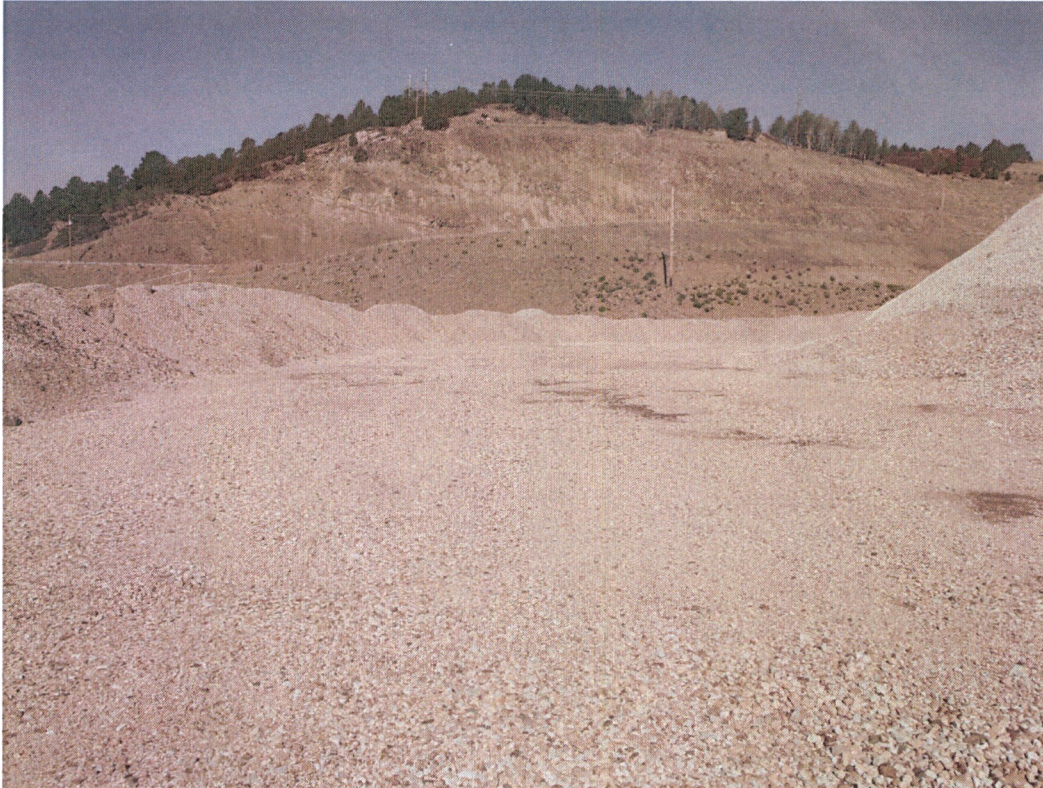
Mr. Vanoni pointed out where a new temporary structure is planned to store materials for the above ground PSES components (see **Photo 1**). A new "chevron" stormwater control ditch is planned for the area just south of the southern limit of the Phase V VLF (see **Photo 2**) Material placement and compaction for the proposed new mill platform is continuing (see **Photo 3**).

Photo 1. Phase II area pad for temporary above ground PSES material storage.

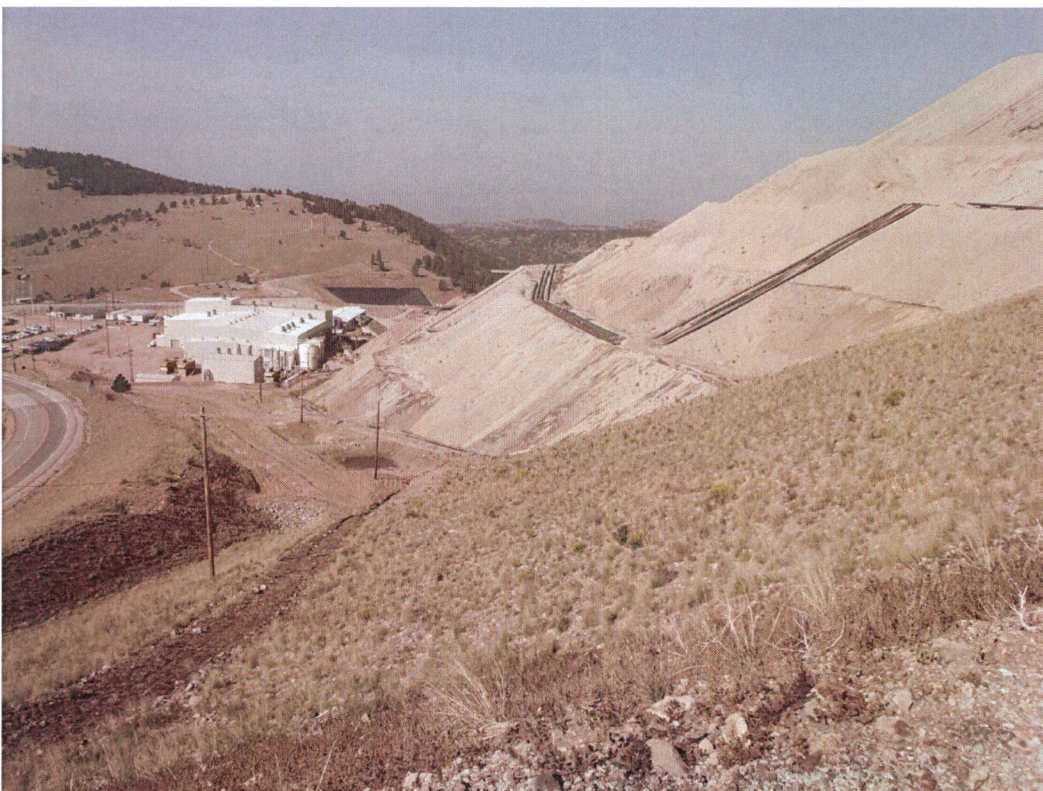
Photo 2. Area for planned chevron stormwater control ditch.

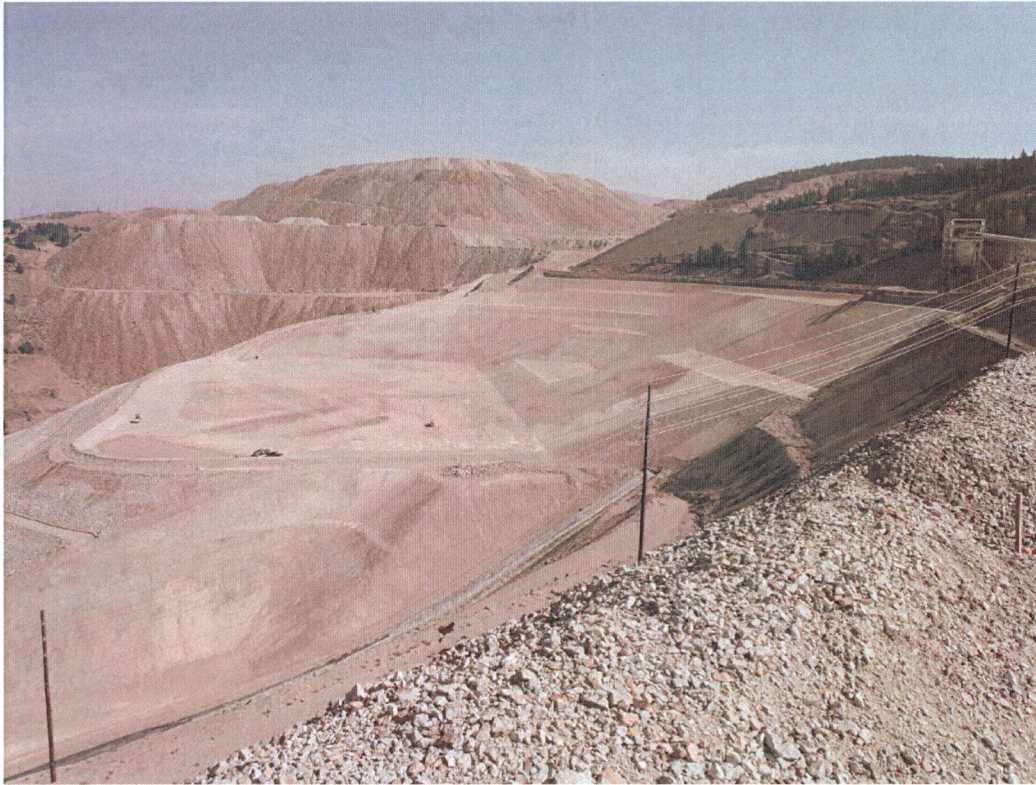
Photo 3. Proposed New Mill Platform construction.

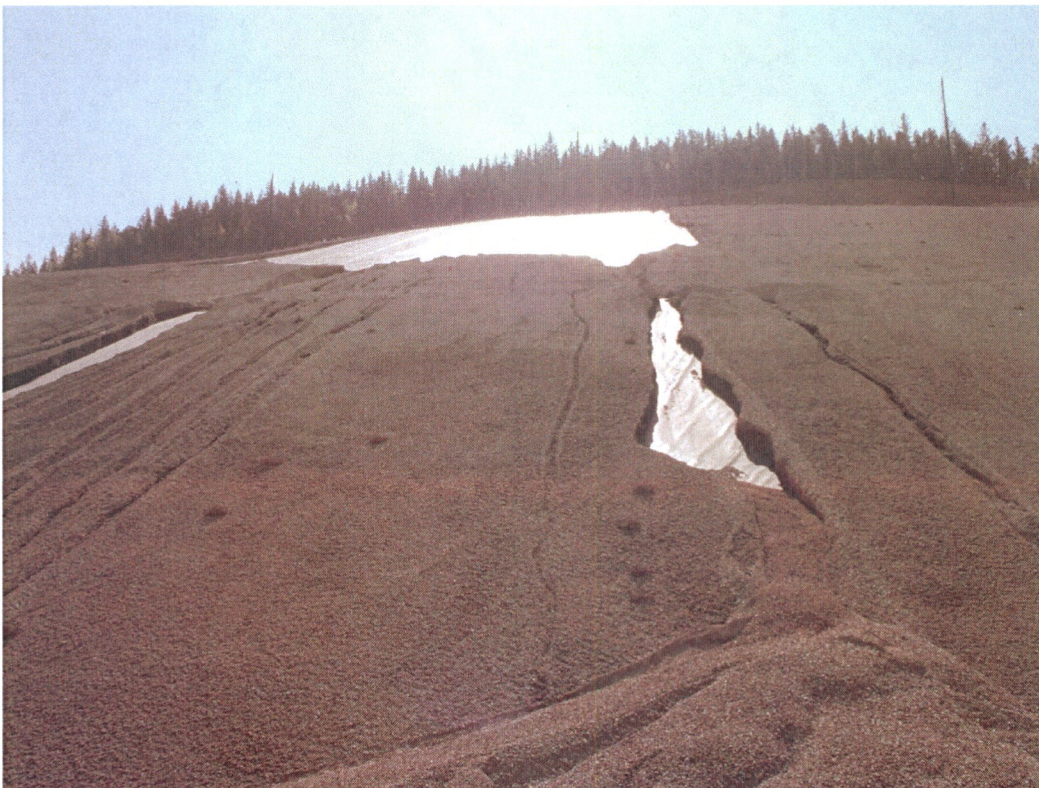
The Division conducted a monitoring inspection of the site on September 19, 2012. Mr. Mark Vanoni (CC&V) was present during the inspection. The primary focus of this inspection was to monitor solution levels. The approach to addressing the Phase V DCF sloughing from April 2012 and the Phase V berm raise construction were also inspected

The access ramp to the Phase V DCF failure area is complete. This inspector walked the DCF slough area (see **Photo 4**) with Mr. Vanoni while he summarized the testing planned and proposed recertification process.

Photo 4. Phase V DCF slough area.

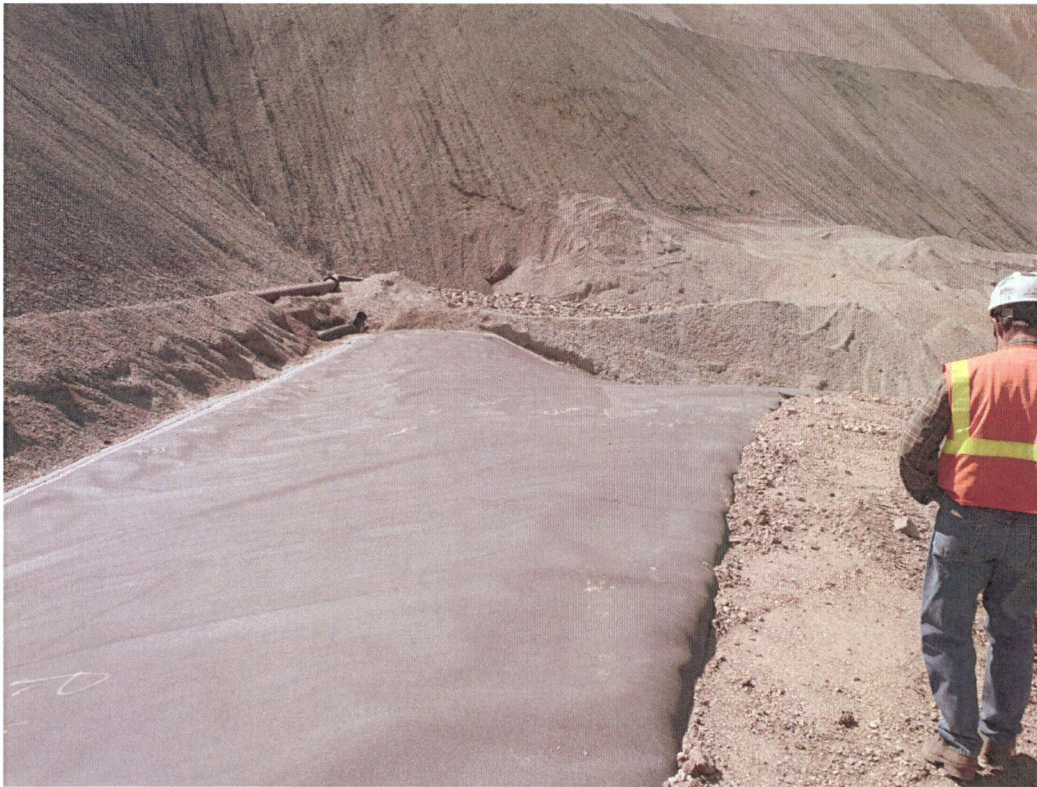
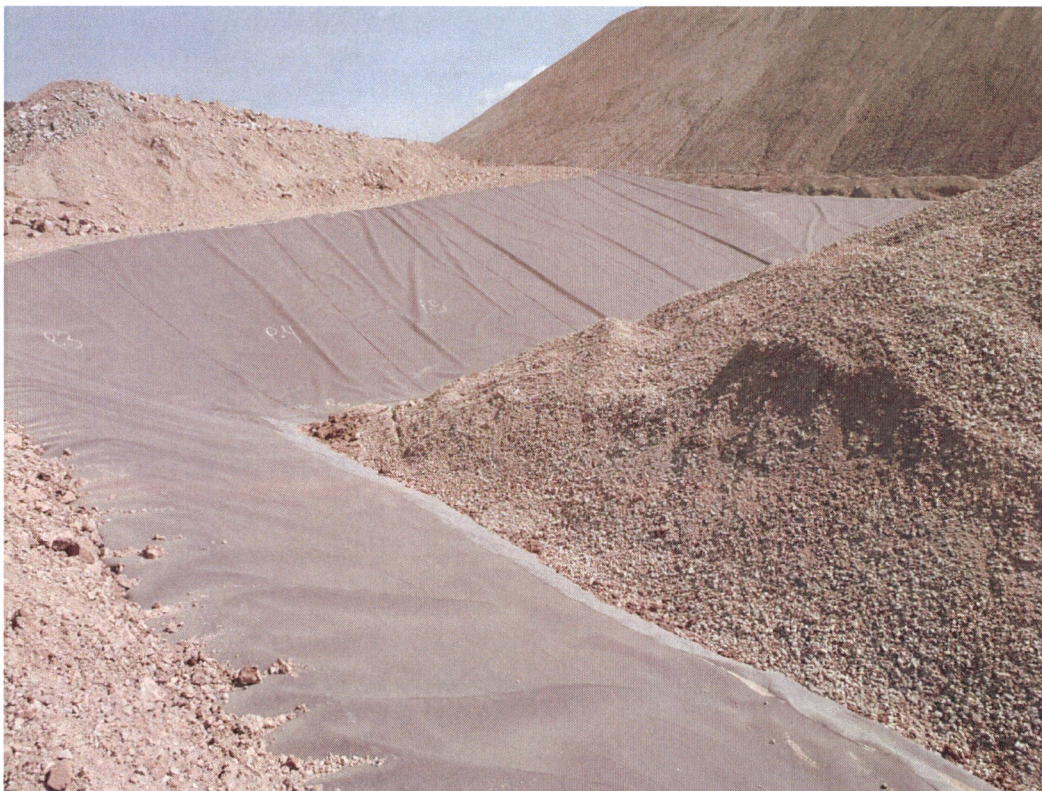
The installation of Phase V berm raise liner is complete (see **Photos 5 and 6**). The mine intends to cover the exposed liner with a coarse rock sometime in 2013.

Photo 5. Phase V berm raise liner installation (1 of 2).

Photo 6. Phase V berm raise liner installation (2 of 2).
