## COLORADO DIVISION OF RECLAMATION, MINING AND SAFETY COAL PROGRAM INSPECTION REPORT

| <b>Permit Number:</b> C-2010-089<br><b>Mine Name:</b> New Horizon North Mine<br><b>Operator:</b> Western Fuels - Colorado, LLC<br><b>Operator Address:</b><br>Mr. David G Anderson, P.L.S.<br>12050 N. Pecos St., Suite 100<br>Westminster, CO 80234 | <b>County:</b> Montrose<br><b>Operation Type:</b> Surface<br><b>Permit Status:</b> Active<br><b>Ownership:</b> Private |

| <b>Inspection Start Date:</b> February 19, 2013<br><b>Inspection Start Time:</b> 13:49<br><b>Inspection End Date:</b> February 19, 2013<br><b>Inspection End Time:</b> 13:50 | | <b>Inspection Type:</b> Aerial Inspection<br><b>Inspection Reason:</b> Normal I&E Program<br><b>Weather:</b> Cloudy | |

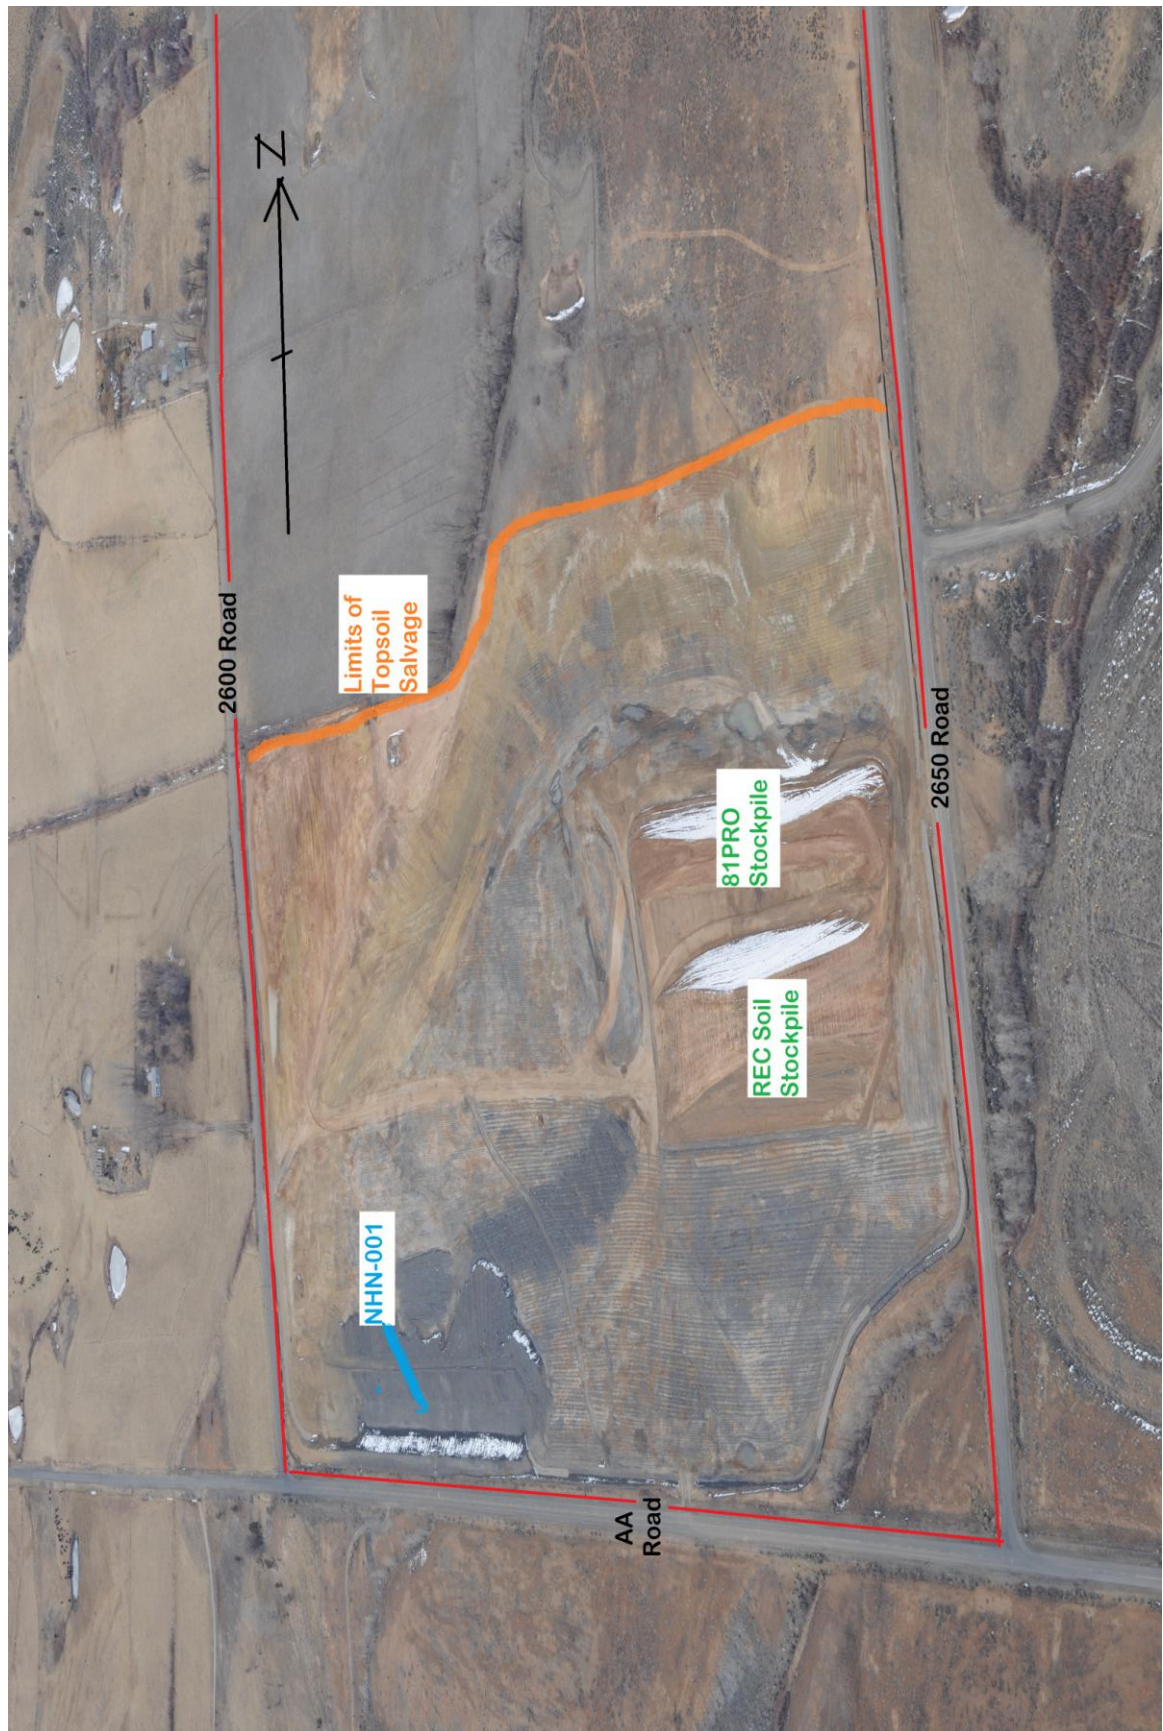
Southern portion of permit area, looking west
