COLORADO DIVISION OF RECLAMATION, MINING AND SAFETY COAL PROGRAM INSPECTION REPORT

Permit Number: C-1996-083 Mine Name: Bowie No. 2 Mine Operator: Bowie Resources, LLC Operator Address: Mr William A Bear P.O. Box 483 Paonia, CO 81428	County: Delta Operation Type: Underground Permit Status: Active Ownership: Federal
	Operator Representative Present: None Present - Aerial Inspection
Operator Representative Signature: (Field Issuance Only)

Inspection Start Date: February 19, 2013 Inspection Start Time: 12:21 Inspection End Date: February 19, 2013 Inspection End Time: 12:22	Inspection Type: Aerial Inspection Inspection Reason: Normal I&E Program Weather: Clear
Joint Inspection Agency: None	Joint Inspection Contacts:
Post Inspection Agency: None	Post Inspection Contacts:
Inspector(s): Susan L. Burgmaier Harry B. Ranney	Inspector's Signature:

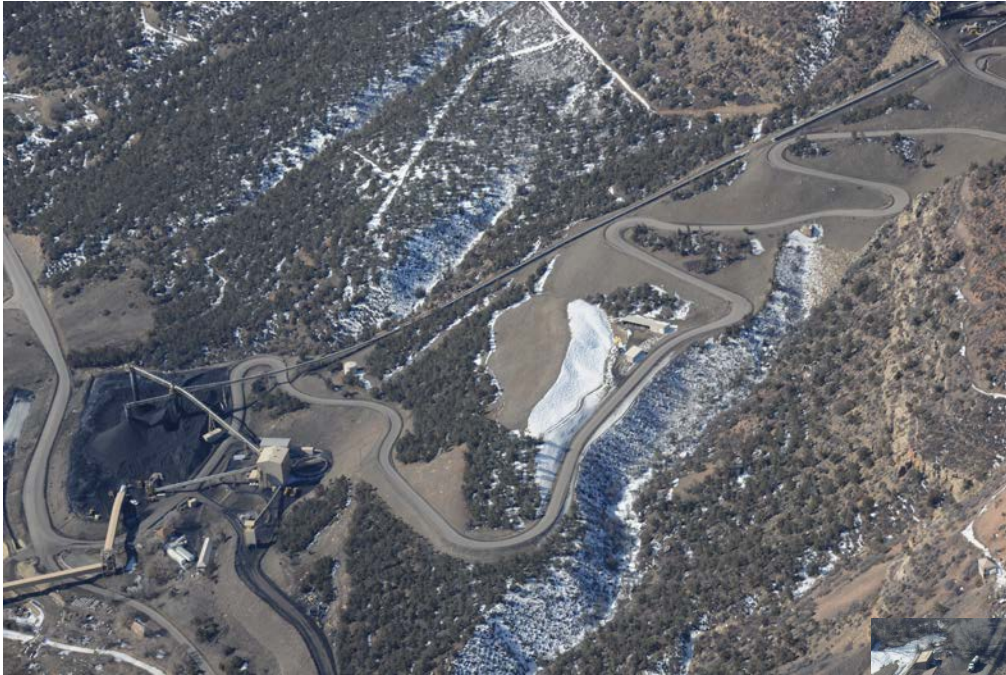
Pond B, coal stockpile area, coal handling facilities, topsoil stockpile, and material storage area.

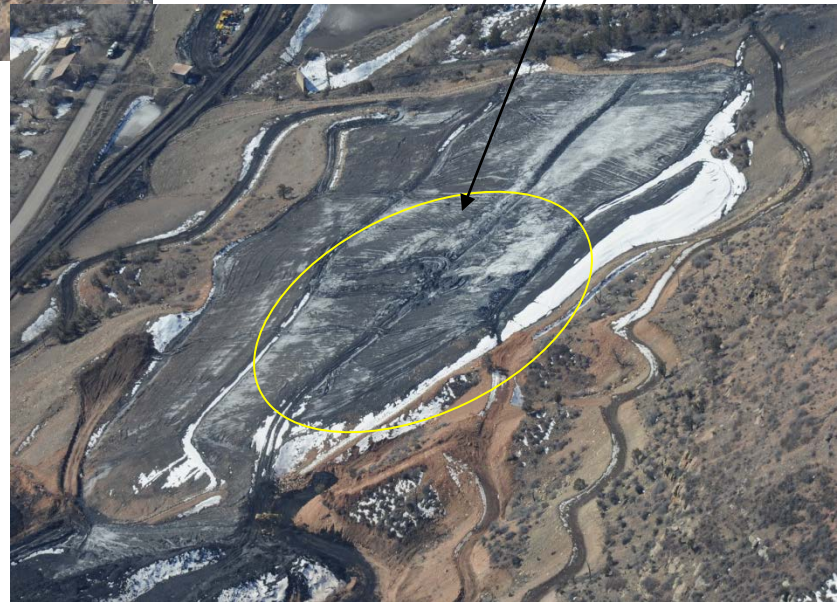
No activity was observed on Gob Pile #4. There were equipment tracks in the northeastern area of the pile, where slopes still need to be flattened prior to cover placement.

Area requiring regrading
– recent activity apparent

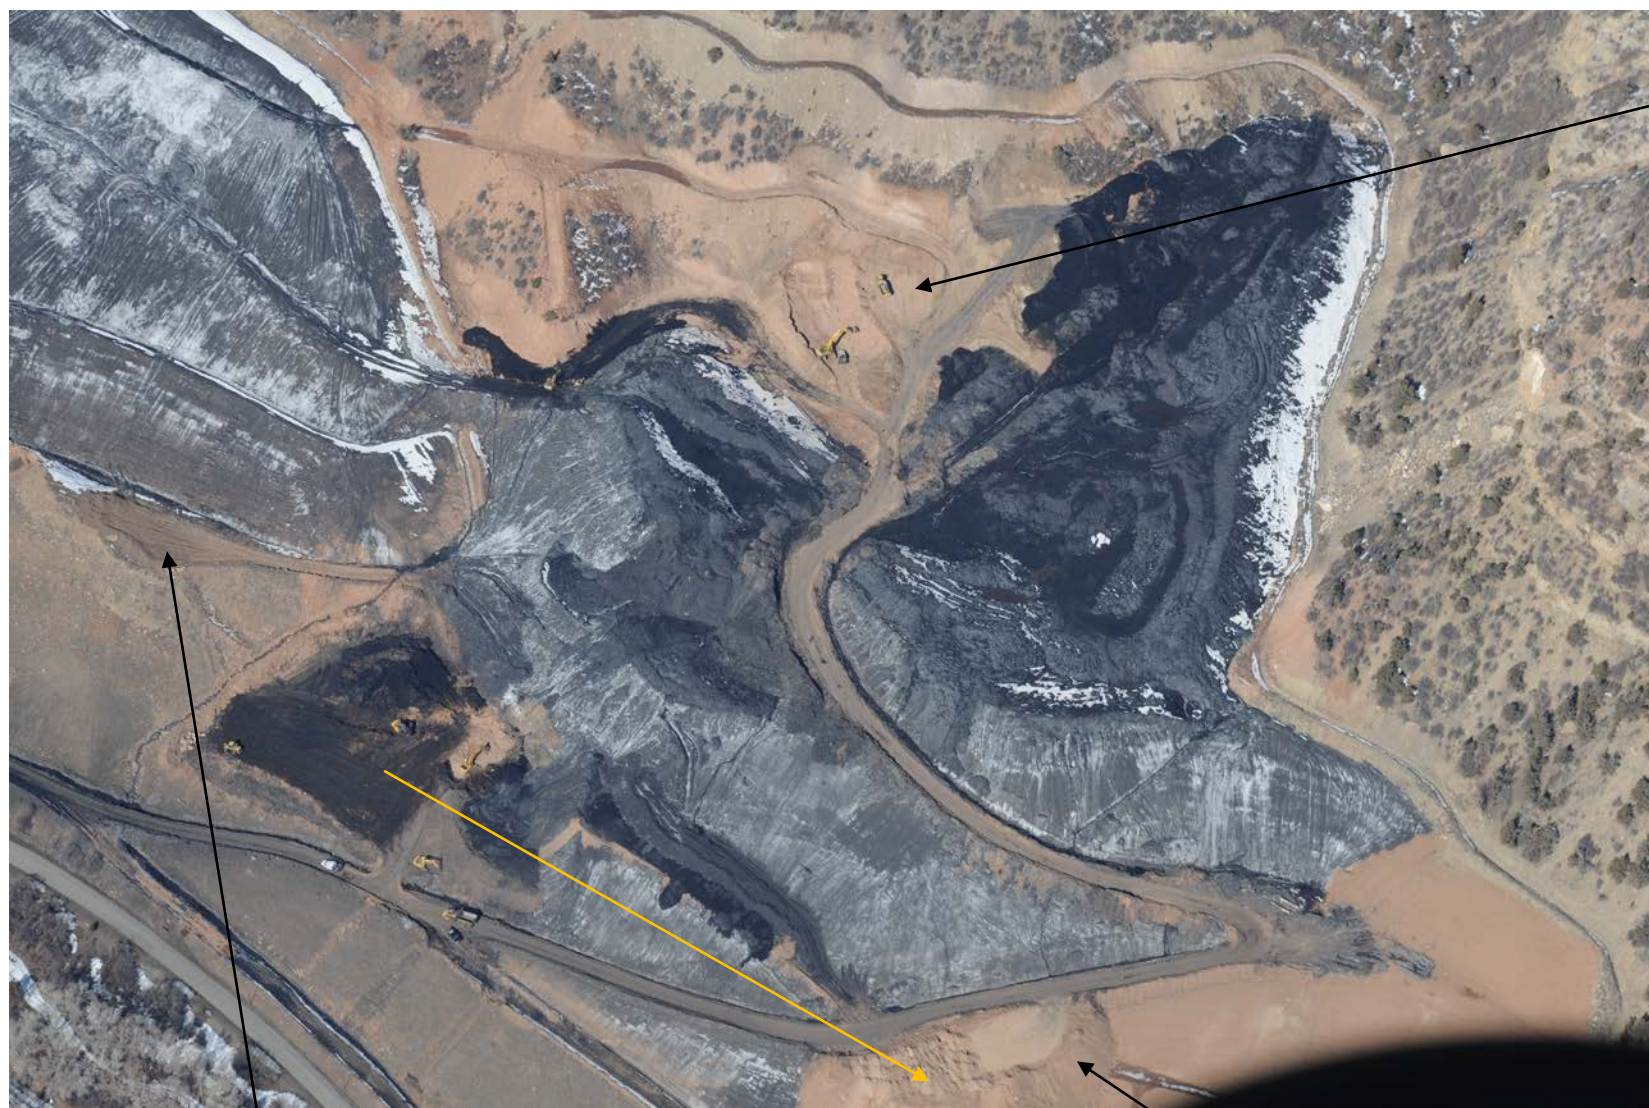
It appeared that topsoil salvaging operations had taken place in the Gob Pile #2 expansion area, with the topsoil being placed in the stockpile at the base of Gob Pile #4.

Excavation in
TR76 Gob Pile #2
expansion area

Newly stockpiled topsoil

Former cover stockpile moved east
