**COLORADO DIVISION OF RECLAMATION, MINING AND SAFETY  
COAL PROGRAM INSPECTION REPORT**

| <b>Permit Number:</b> C-1981-010<br><b>Mine Name:</b> Trapper Mine<br><b>Operator:</b> Trapper Mining, Inc.<br><b>Operator Address:</b><br>Mr Forrest V Luke<br>P.O. Box 187<br>Craig, CO 81626 | <b>County:</b> Moffat<br><b>Operation Type:</b> Surface<br><b>Permit Status:</b> Active<br><b>Ownership:</b> Federal |

| <b>Inspection Start Date:</b> February 19, 2013<br><b>Inspection Start Time:</b> 11:20<br><b>Inspection End Date:</b> February 19, 2013<br><b>Inspection End Time:</b> 11:30 | <b>Inspection Type:</b> Aerial Inspection<br><b>Inspection Reason:</b> Normal I&E Program<br><b>Weather:</b> Clear |

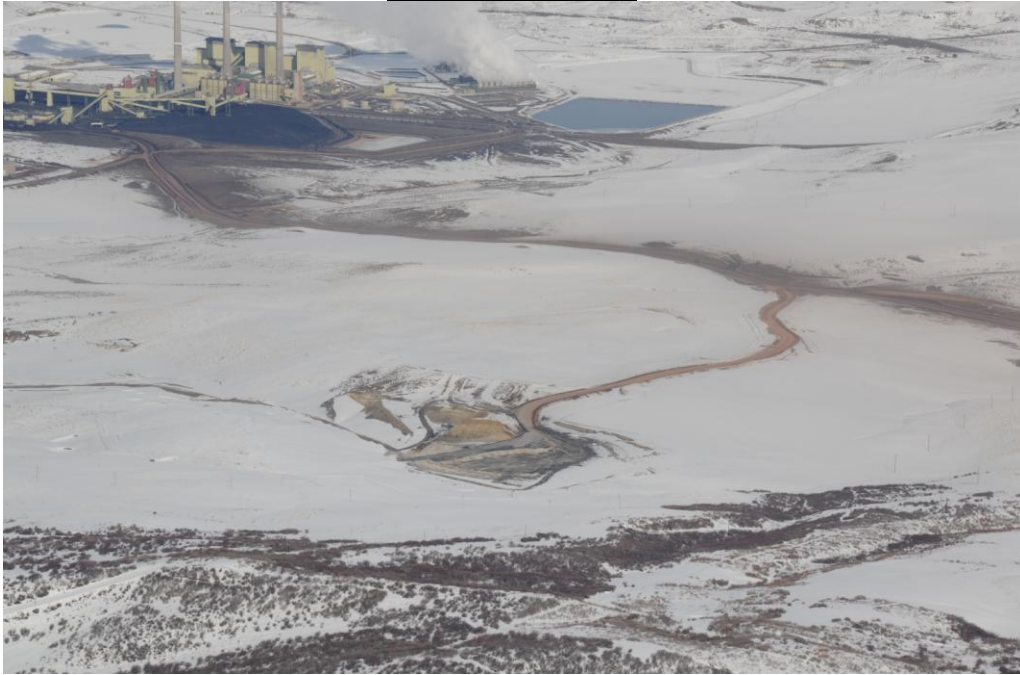
Ash Pit

The Ash pit was observed and it appears fly ash is continuing to be deposited on the south end of the pit.

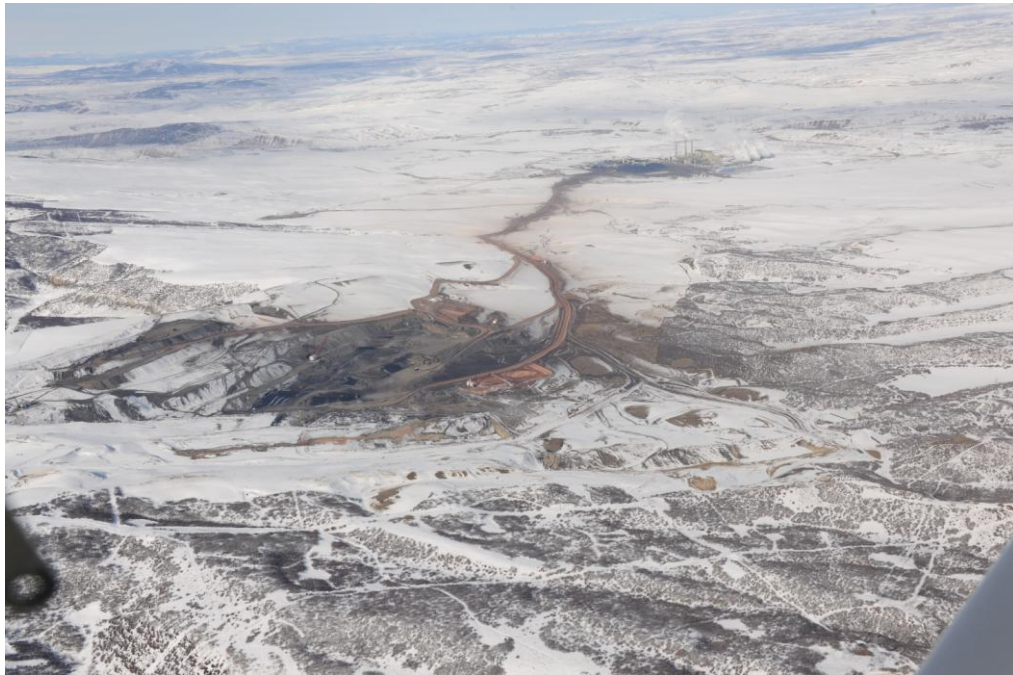
Active mine area from the southeast end looking northwest.

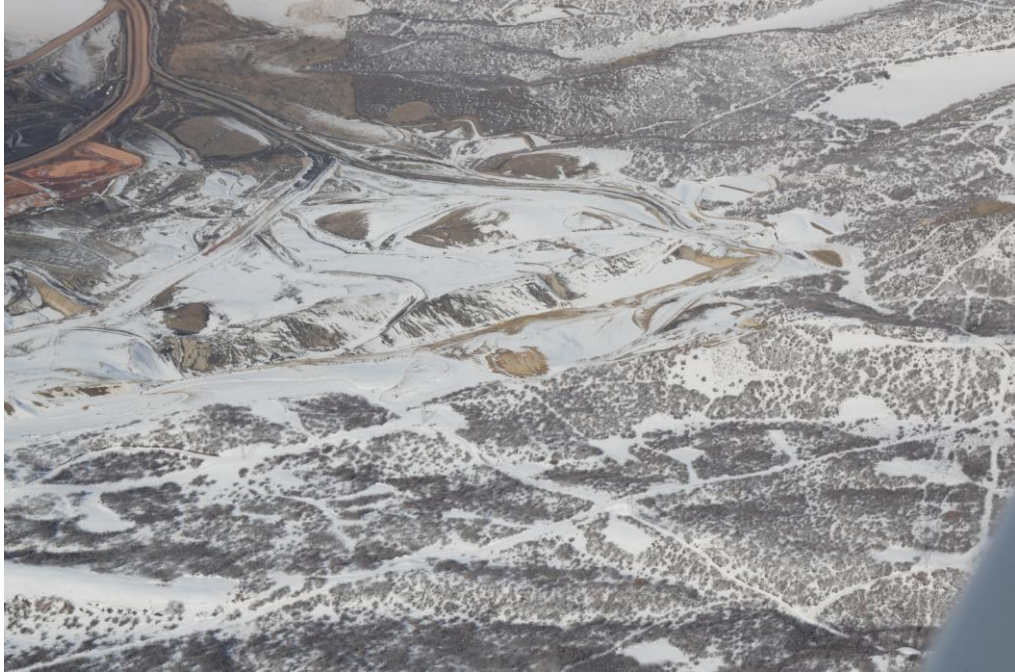
East A Pit

The surrounding area was covered with snow and the ponds were not observed. The East A pit appears to be

holding water but it is ice and snow covered.

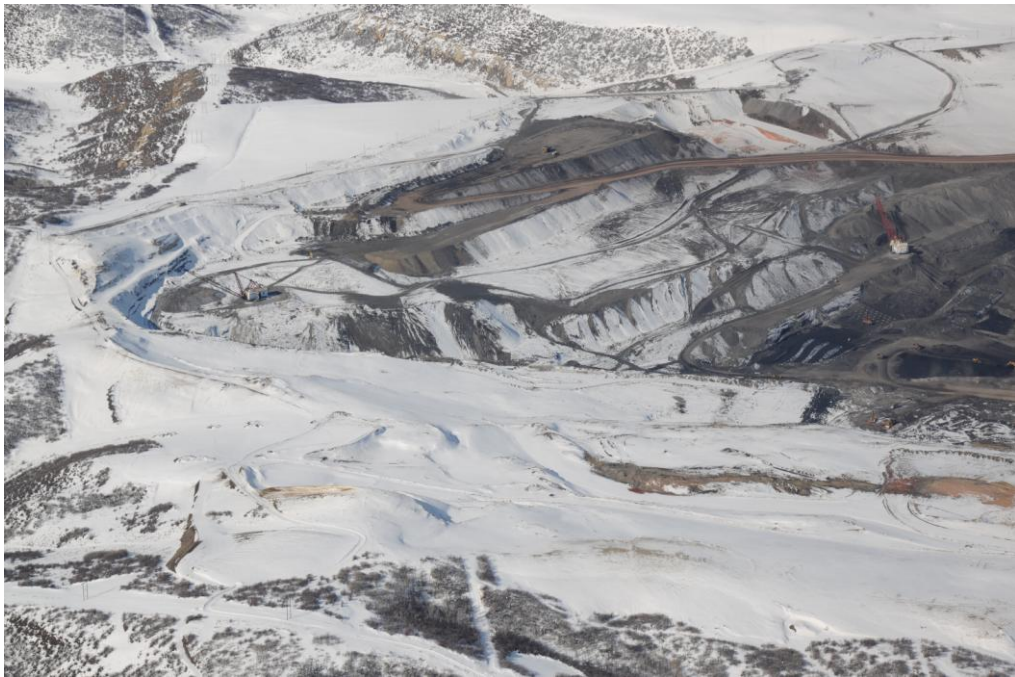
Two draglines appear to be actively mining at the time of the inspection. One dragline was mining in the K-Strike pit area and the other appears to be mining in the K-Dip pit area. It also appears a truck/loader and a truck/shovel was working at the time of the inspection.

Active mine area, K-Pit Operations

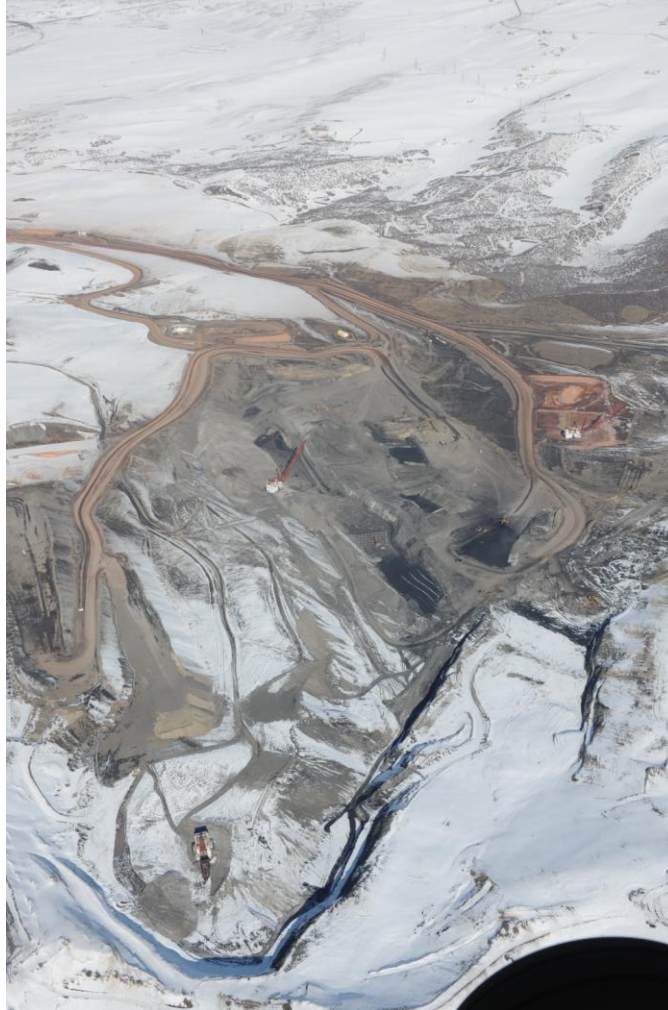
Active mine area from the south end looking north.
