## COLORADO DIVISION OF RECLAMATION, MINING AND SAFETY COAL PROGRAM INSPECTION REPORT

<b>Permit Number:</b> C-1980-006 <b>Mine Name:</b> Marr Mine <b>Operator:</b> Kerr Coal Company <b>Operator Address:</b> Mr. George Patterson C/O Energy Fuels Coal, Inc. P.O. Box 459 Florence, CO 81226	<b>County:</b> Jackson <b>Operation Type:</b> Surface <b>Permit Status:</b> Permanent Cessation <b>Ownership:</b> Federal
	<b>Operator Representative Present:</b>  None
<b>Operator Representative Signature:</b> (Field Issuance Only)

<b>Inspection Start Date:</b> February 19, 2013 <b>Inspection Start Time:</b> 14:00 <b>Inspection End Date:</b> <b>Inspection End Time:</b>	<b>Inspection Type:</b> Coal Partial Inspection <b>Inspection Reason:</b> Normal I&E Program <b>Weather:</b> Clear
<b>Joint Inspection Agency:</b>  None	<b>Joint Inspection Contacts:</b>
<b>Post Inspection Agency:</b>  None	<b>Post Inspection Contacts:</b>
<b>Inspector(s):</b>  Robert D. Zuber	<b>Inspector's Signature:</b>

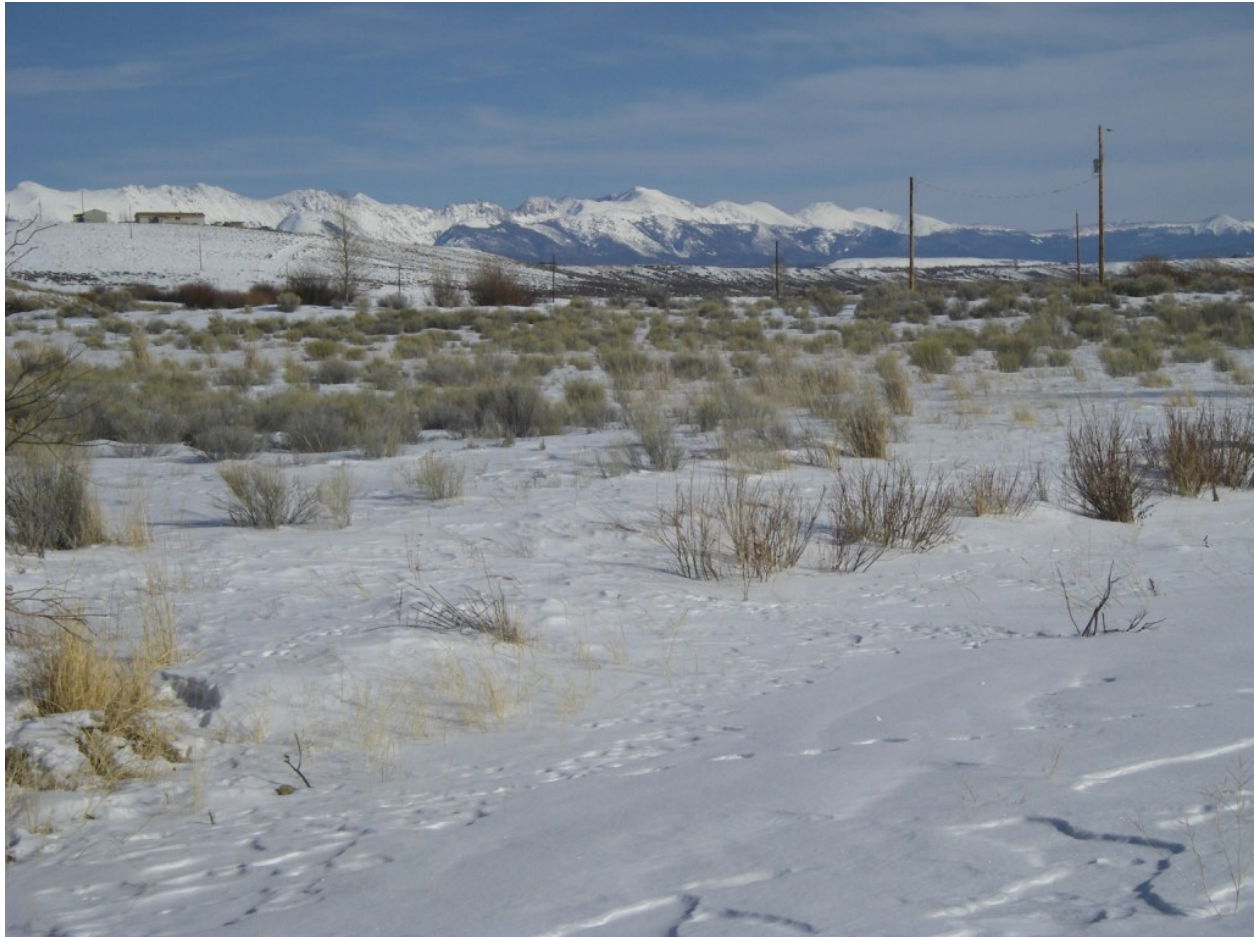
**Loadout looking east**

At the loadout, no erosion, large weed patches, or other problems were seen, but the snow prevented a thorough investigation.
